Inventory of Hazardous Materials (IHM)

Task – T2189020
“FPSO FLUMINENSE”, Class No. 7428908
KOCKUMS MEKANISKA VERKSTADS AB., Hull: 546
Flag: The Commonwealth of the Bahamas

FPSO Fluminense - Inventory Hazardous Materials Prior to Recycling

Project	Bijupira Salema Decommissioning
Document Title	FPSO Fluminense - Inventory Hazardous Materials Prior to Recycling
Document Number	BJSA-SHL-100-MA-ASE-0001
DCAF Control ID Number	
Document Revision	03
Document Status	Issued for Approval
Document Type	Analysis & Design
Owner	Dilip Naik
Issue Date	03/09/22
Expiry Date	None
ECCN	
Security Classification	Restricted
Disclosure	
<i>Revision History shown on next page</i>

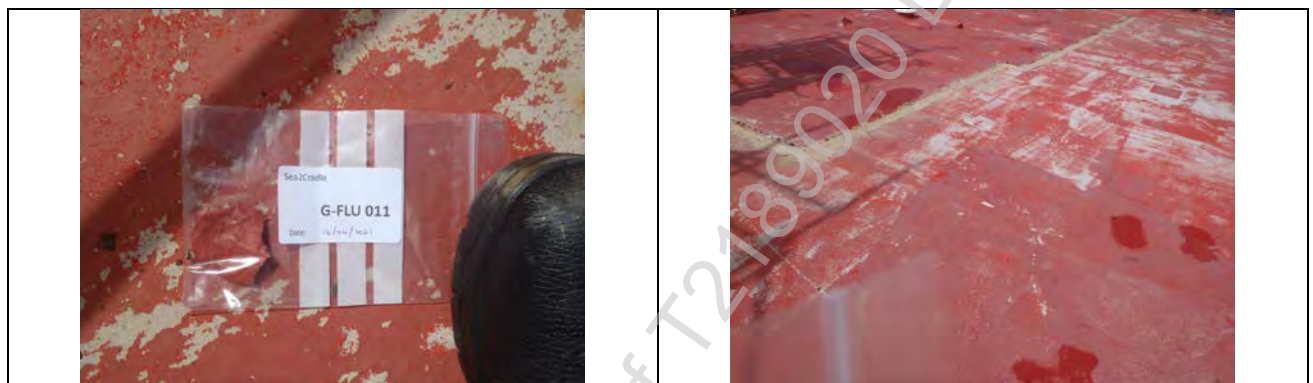
<p>Sample : G-FLU 11 Location : 00. Top of Nav. Deck Description : External Paint - Red</p>	<p>Tested for : PCB, Pb, Cd, Cr Result PCB: 0.00 mg/kg Pb: 170 mg/kg Cd: 0.14 mg/kg Cr: 20 mg/kg</p>
-----------------------------------------------------------------------------------------------------------------------	----------------------------------------------------------------------------------------------------------------------------------------------------------

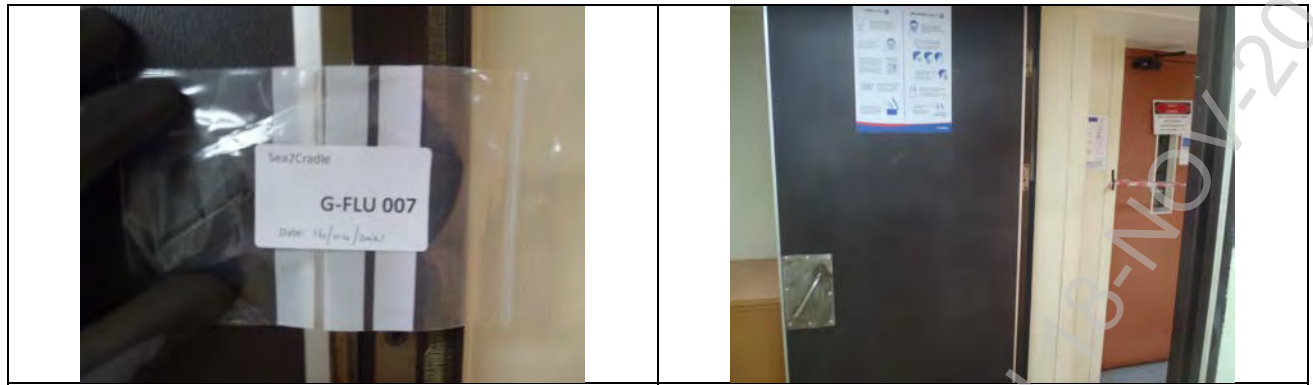
Sample	: G-FLU 07	Tested for	: PCB
Location	: 01. Nav. Deck	Result	: 16.20 mg/kg
Description	: Internal Door Seal		:
			:

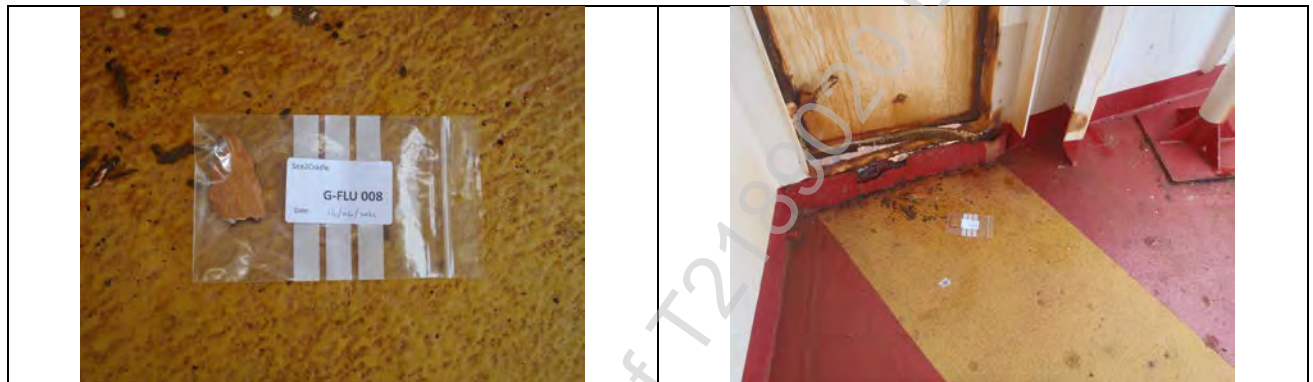
Sample	: G-FLU 08	Tested for	: PCB, Pb, Cd, Cr
Location	: 01. Nav. Deck	Result	PCB: 19.05 mg/kg
Description	: External Paint - Yellow		Pb: 10600 mg/kg
			Cd: 4.2 mg/kg
			Cr: 270 mg/kg

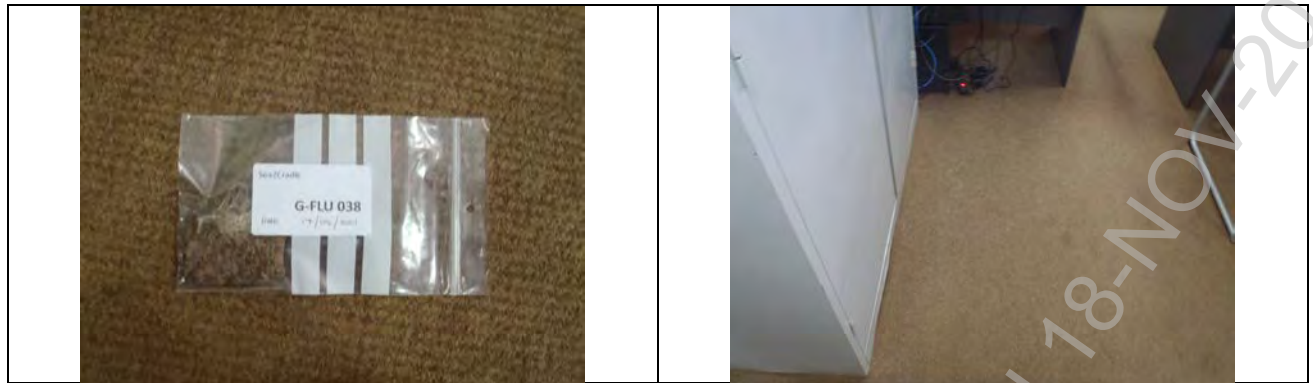
<p>Sample : G-FLU 38 Location : 01. Nav. Deck Description : Carpet Material</p>	<p>Tested for : PFOS Result : 0.028 mg/kg : :</p>
-----------------------------------------------------------------------------------------------------------	------------------------------------------------------------------------------------------

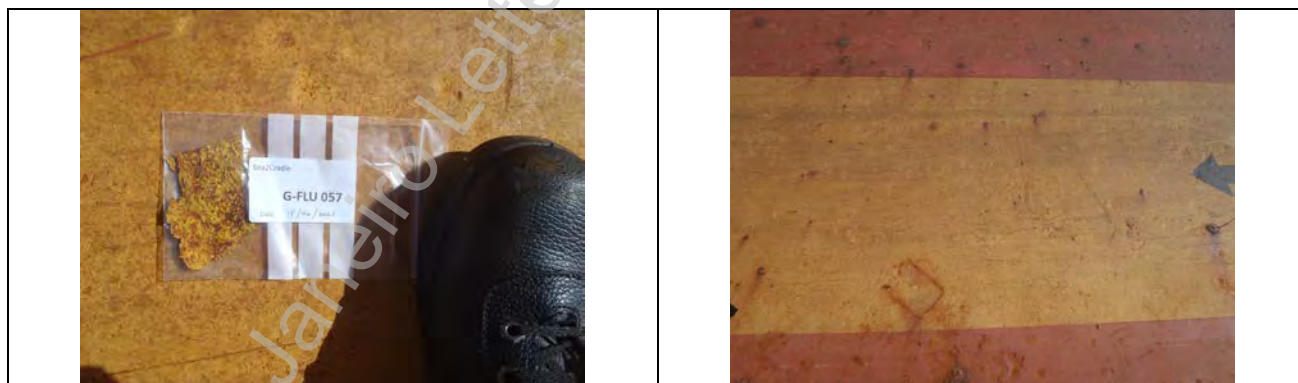
<p>Sample : G-FLU 57 Location : 05B. Upper Deck Description : External Paint - Yellow</p>	<p>Tested for : PCB, Pb, Cd, Cr Result PCB: 0.00 mg/kg Pb: 30 mg/kg Cd: 0.47 mg/kg Cr: 81 mg/kg</p>
---------------------------------------------------------------------------------------------------------------------	---------------------------------------------------------------------------------------------------------------------------------------------------------

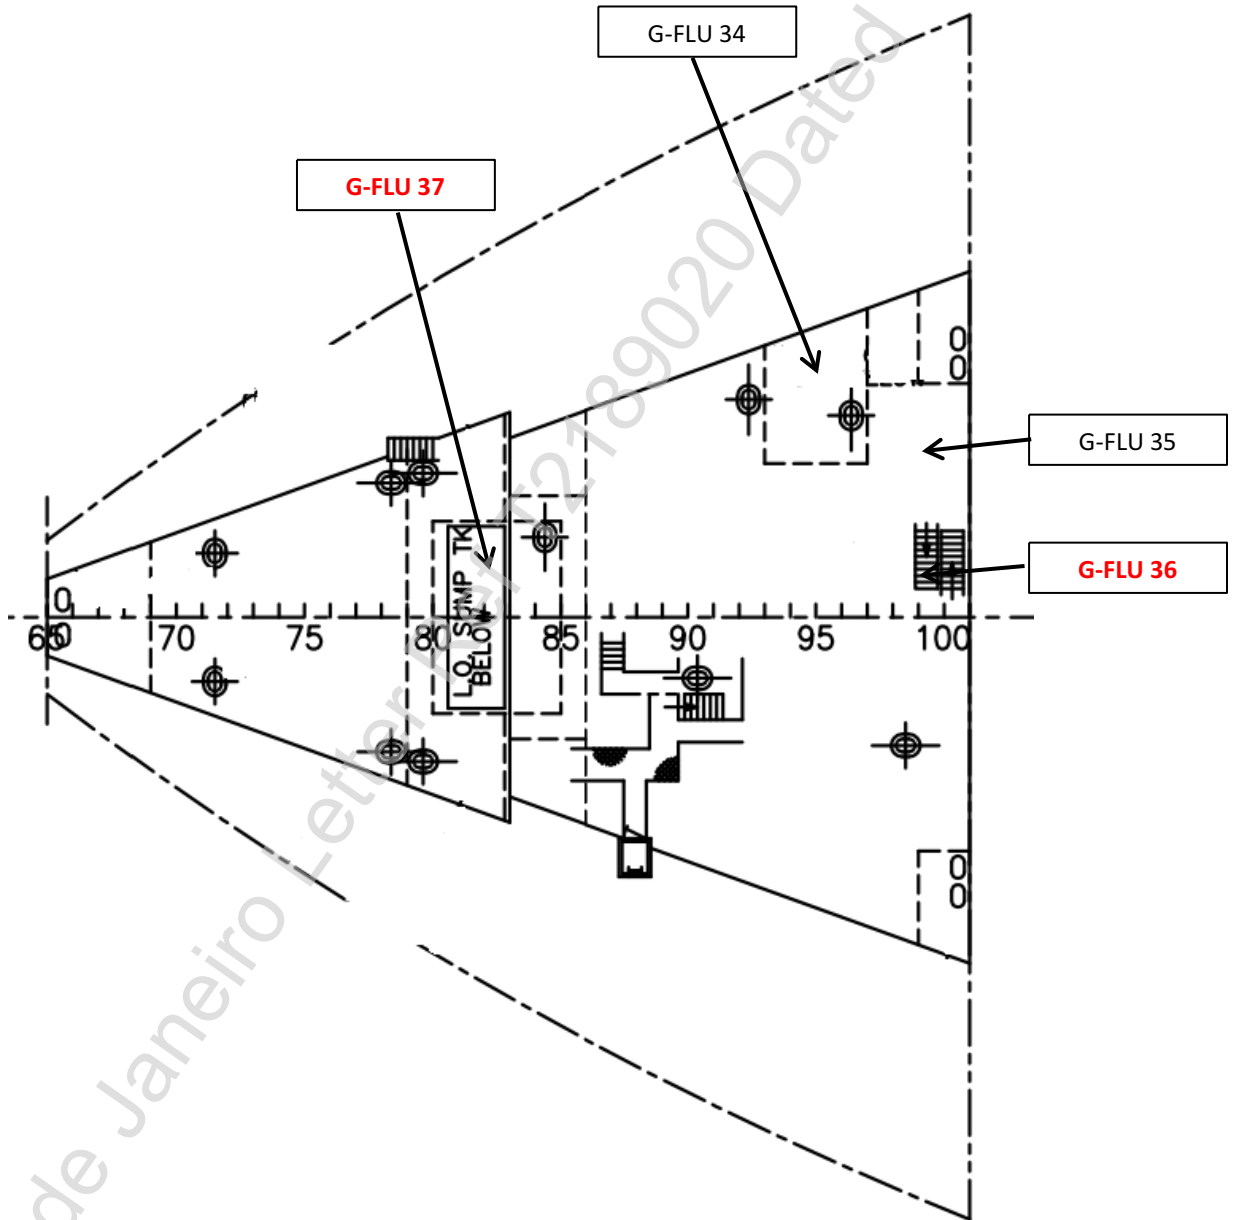
<p>Sample : G-FLU 34 Location : 09. Tank Top Engine Room Description : Valve Gasket</p>	<p>Tested for : PCB Result : 5.45 mg/kg : :</p>

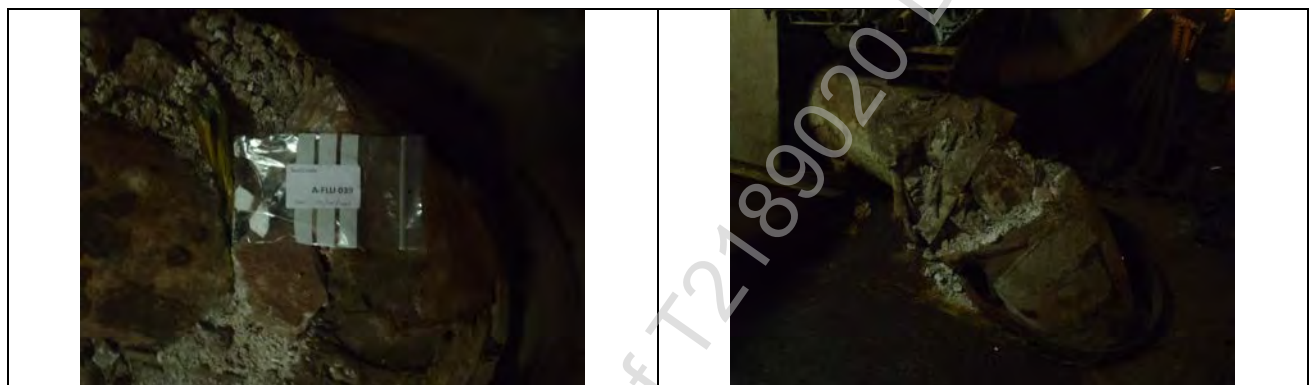
Sample : A-FLU 39	Tested for : Asbestos
Location : 07. Main Steam Pipe	Result : 5% to 10% Chrysotile
Description : Damaged	:
	:

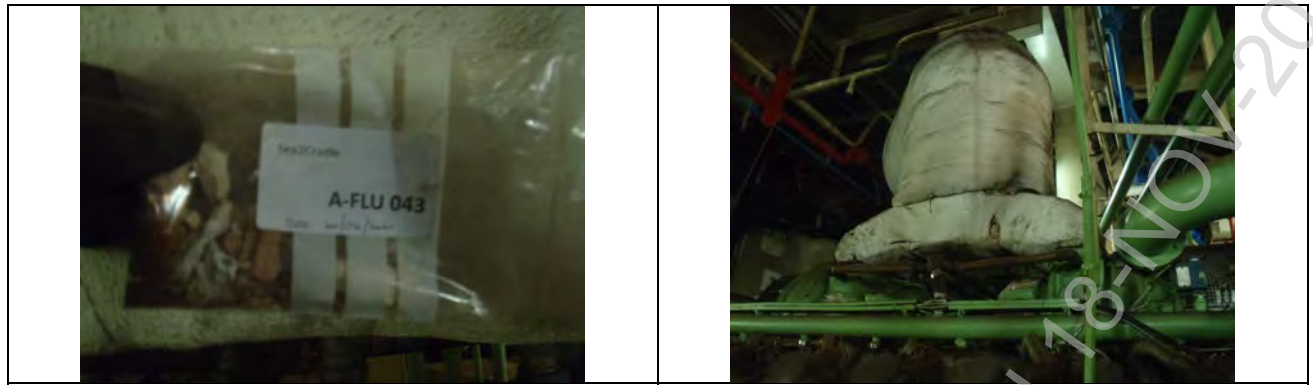
<p>Sample : A-FLU 43 Location : 08. Generator Exhaust Description : Heat Insulation (Gypsum)</p>	<p>Tested for : Asbestos Result : 2% to 5% Chrysotile : 2% to 5% Amosite :</p>
----------------------------------------------------------------------------------------------------------------------------	---------------------------------------------------------------------------------------------------------------------------------------------------------
