Annex 06: Inventory of Hazardous Materials – Complementary Information to Block 12 of the *Notification Document for Transboundary Movements/Shipments of Waste*

Inventory Hazardous Materials FPSO Cidade de Niteroi MV18

FPSO Cidade de Niteroi MV18

PROJECT 193.23

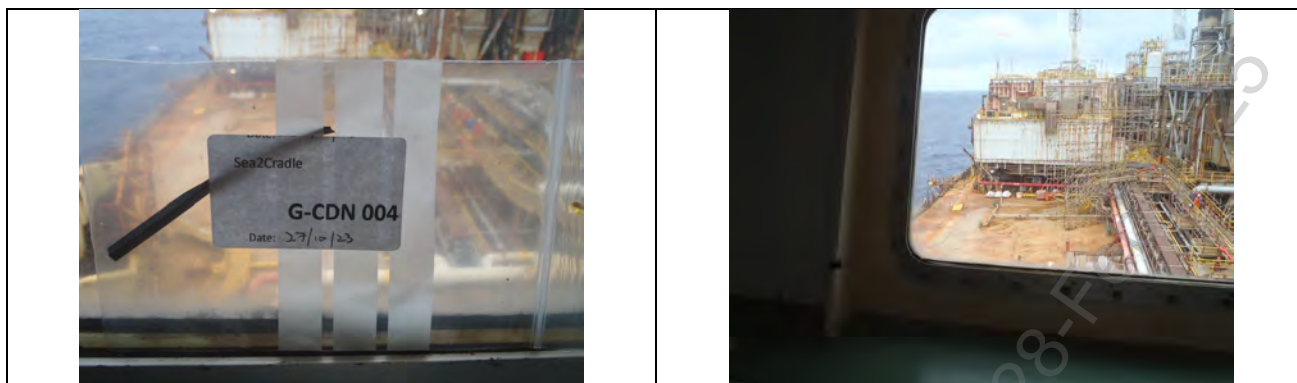
Sample	: G CDN 004	Tested for	: PCB
Location	: 01 Navigation Deck	Result	: 0.00 mg/kg
Description	: Window Seal		:
			:

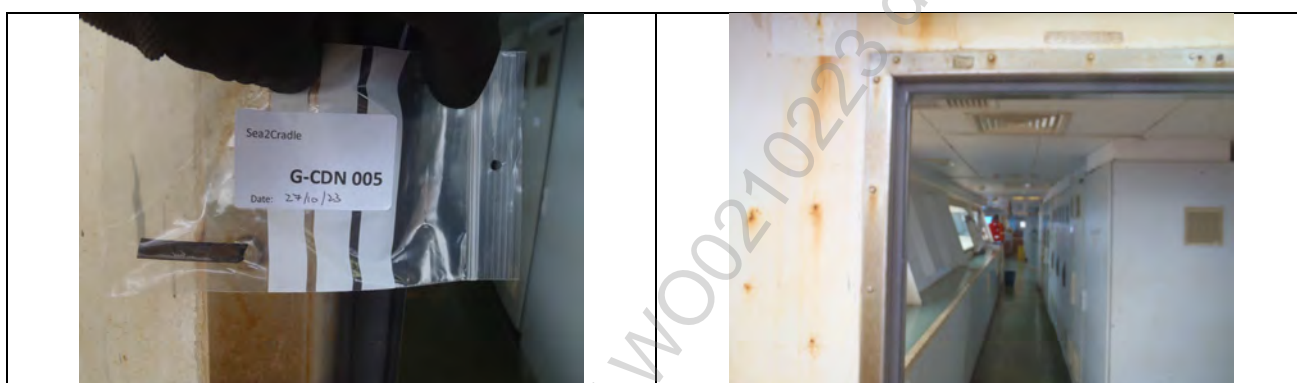
Sample	: G CDN 005	Tested for	: PCB
Location	: 01 Navigation Deck	Result	: 0.00 mg/kg
Description	: Bridge Wing Door Seal		:
			:

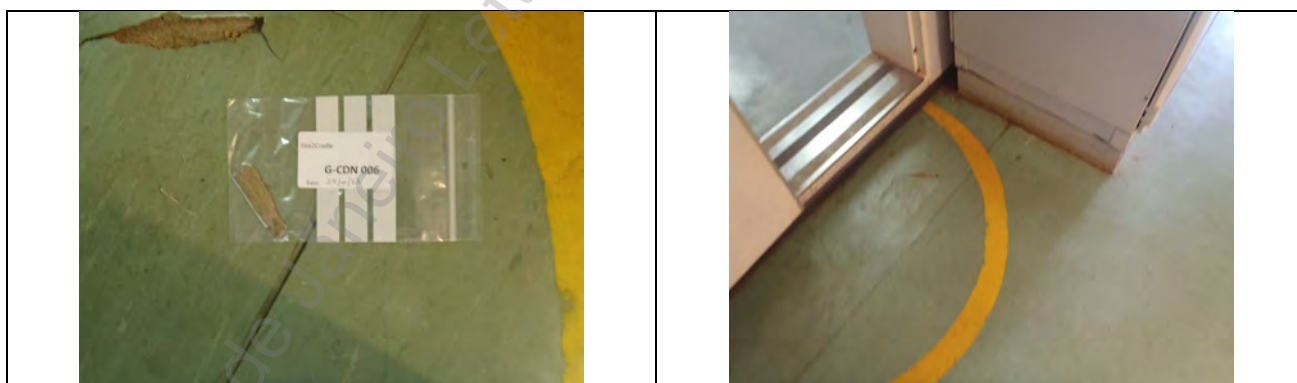
Sample	: G CDN 006	Tested for	: PCB
Location	: 01 Navigation Deck	Result	: 0.00 mg/kg
Description	: Vinyl Flooring		:
			:

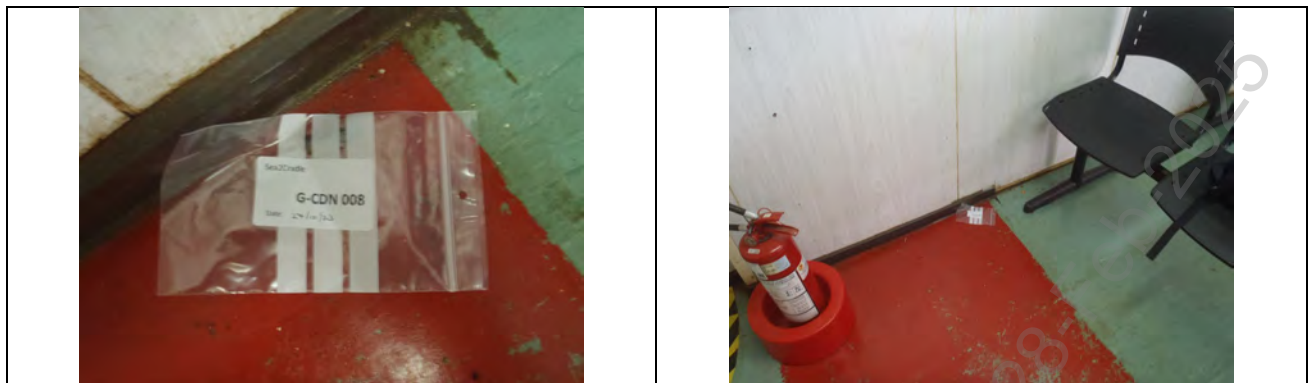
Sample	: G CDN 008	Tested for	: PCB
Location	: 01 Navigation Deck	Result	: 0.00 mg/kg
Description	: Skirting		:
			:

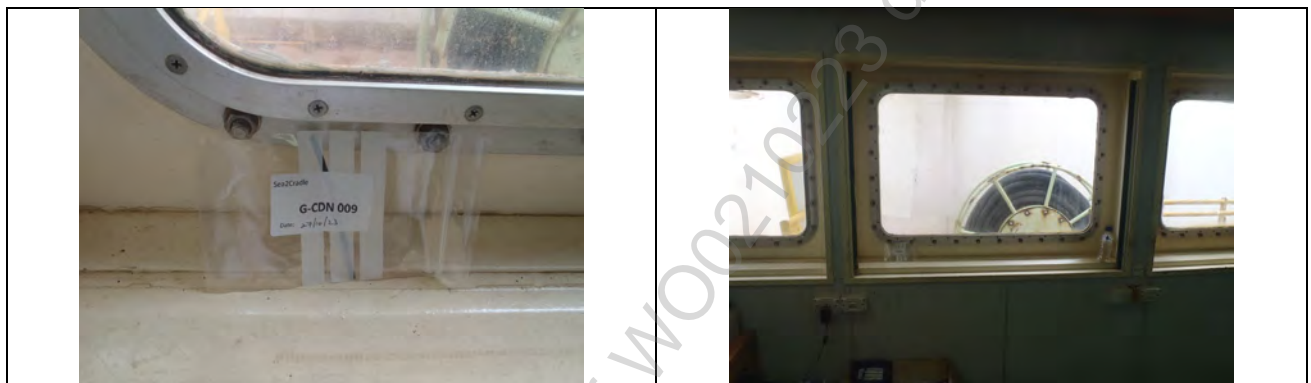
Sample	: G CDN 009	Tested for	: PCB
Location	: 01 Navigation Deck	Result	: 10.40 mg/kg
Description	: Window Seal		:
			:

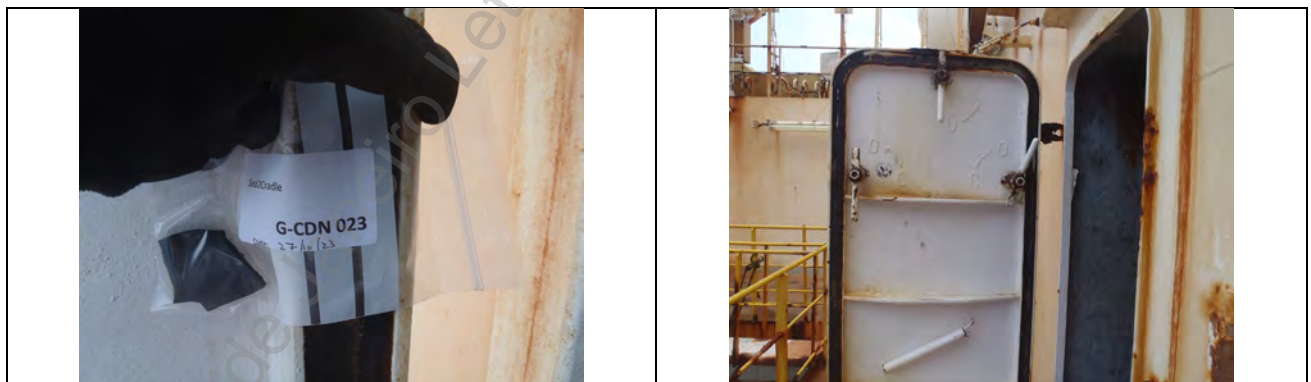
Sample	: G CDN 023	Tested for	: PCB
Location	: 01 Navigation Deck	Result	: 0.00 mg/kg
Description	: W/T Door Seal		:
			:

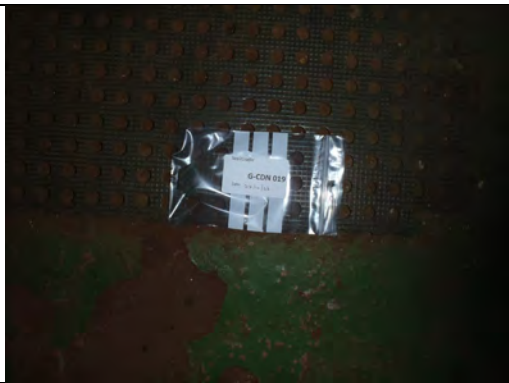
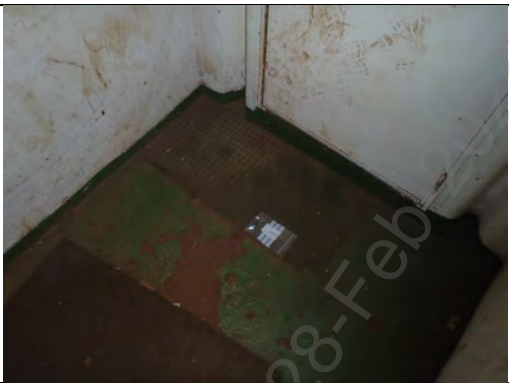
<p>Sample : G CDN 019 Location : 06 Upper Deck Accommodation Description : Anti-Slip Mat</p>	<p>Tested for : PCB Result : 9.15 mg/kg : :</p>

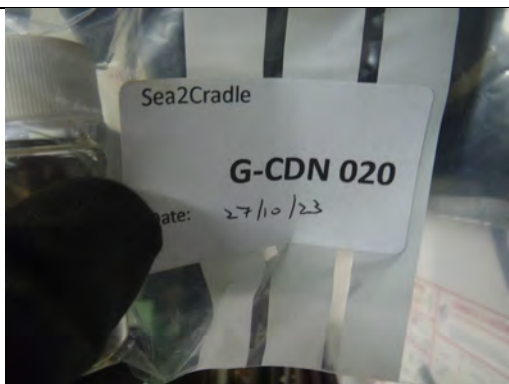
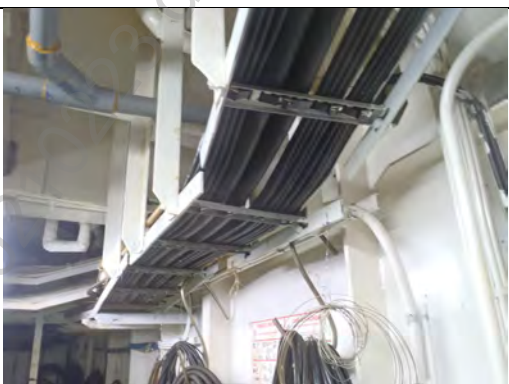
<p>Sample : G CDN 020 Location : 06 Upper Deck Accommodation Description : Cable Run Wipe</p>	<p>Tested for : PCB Result : 0.235 µg abs : :</p>

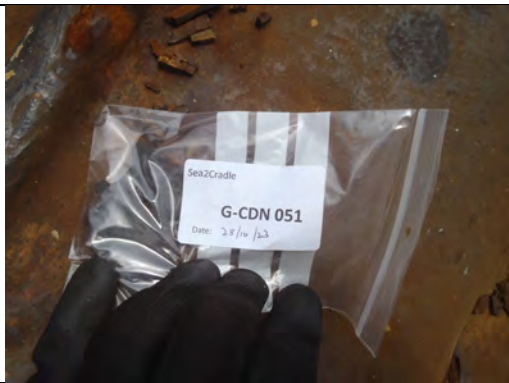
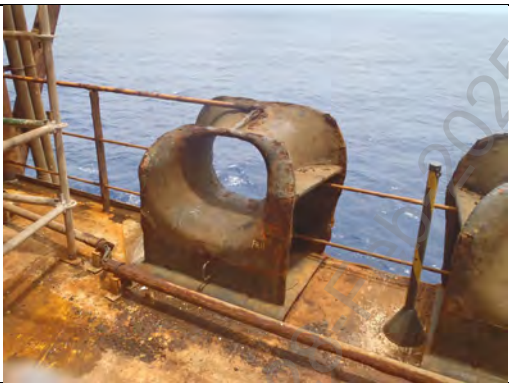
<p>Sample : G CDN 051 Location : 06 Upper Deck Description : Fairlead Paint - Black</p>	<p>Tested for : PCB, Pb, Cd, Cr Result PCB: 0.00 mg/kg Pb: 290 mg/kg Cd: 0.18 mg/kg Cr: 130 mg/kg</p>

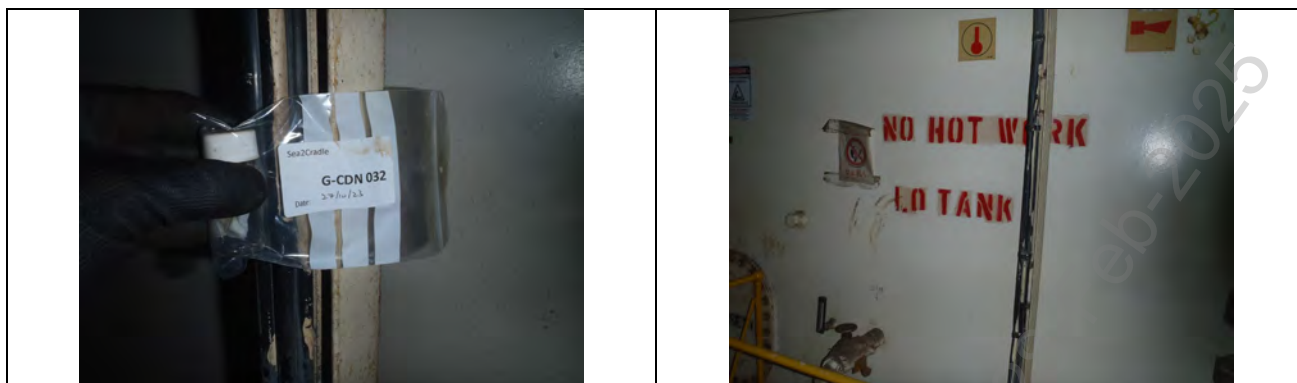
Sample	: G CDN 032	Tested for	: PCB
Location	: 07 Engine Room 2 nd Floor	Result	: 0.270 µg abs
Description	: Cable Run - Wipe		:
			:

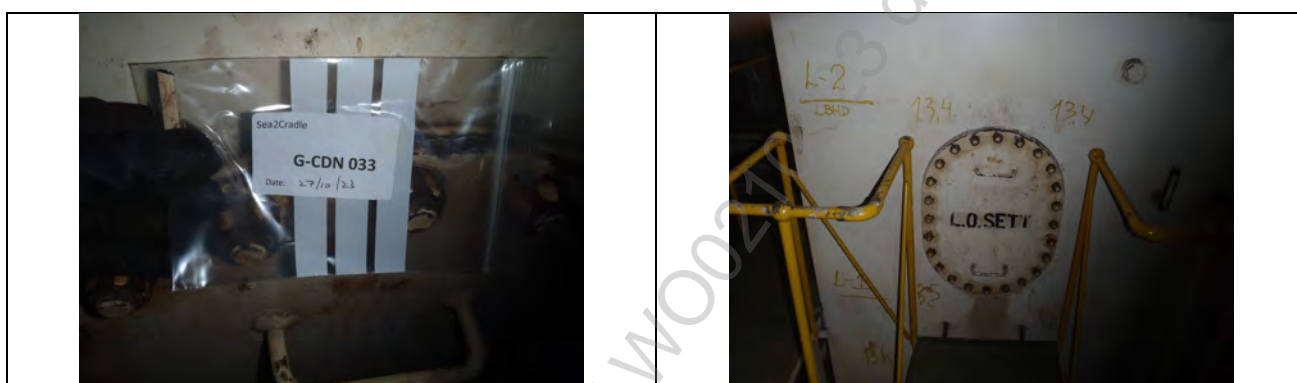
Sample	: G CDN 033	Tested for	: PCB
Location	: 07 Engine Room 2 nd Floor	Result	: 0.00 mg/kg
Description	: Manhole Door Joint		:
			:

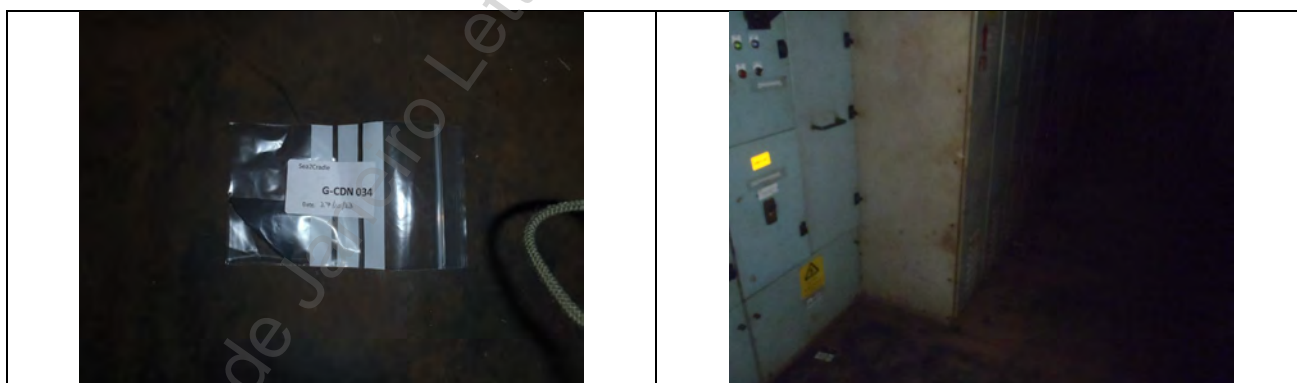
Sample	: G CDN 034	Tested for	: PCB
Location	: 07 Engine Room 2 nd Floor	Result	: 0.00 mg/kg
Description	: Electrical Mat		:
			:

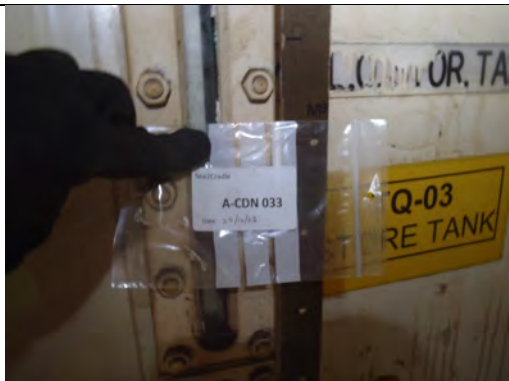
<p>Sample : A CDN 033 Location : 07 Engine Room 2nd Floor Description : Gauge Glass Joint</p>	<p>Tested for : Asbestos Result : Chrysotile >60% : :</p>

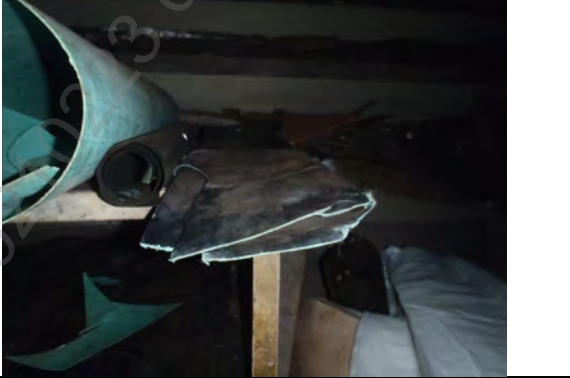
<p>Sample : A CDN 040 Location : 08 ER Upper Floor Stores Description : Jointing</p>	<p>Tested for : Asbestos Result : Chrysotile 15-30% : :</p>

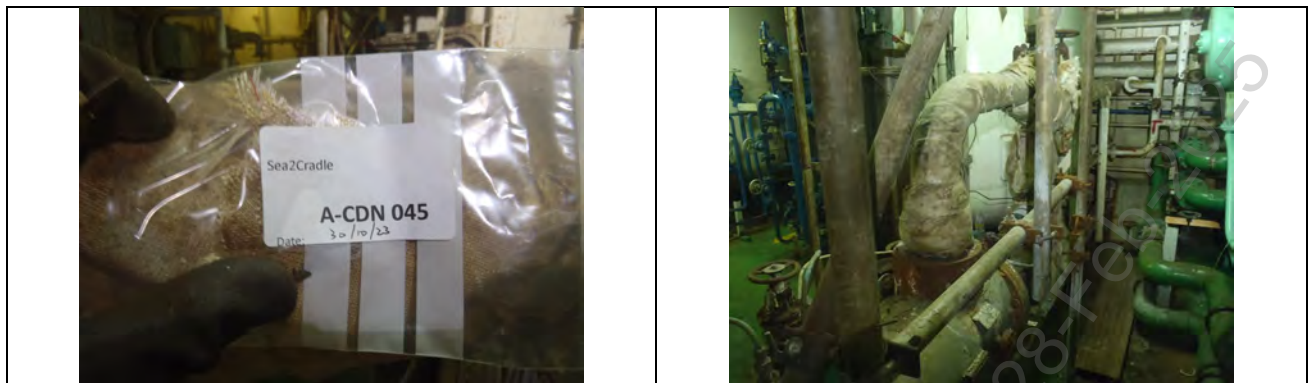
Sample	: A CDN 045	Tested for	: Asbestos
Location	: 08 ER Upper Floor	Result	: <0.1%
Description	: Purifier Heater Lagging		:
			:

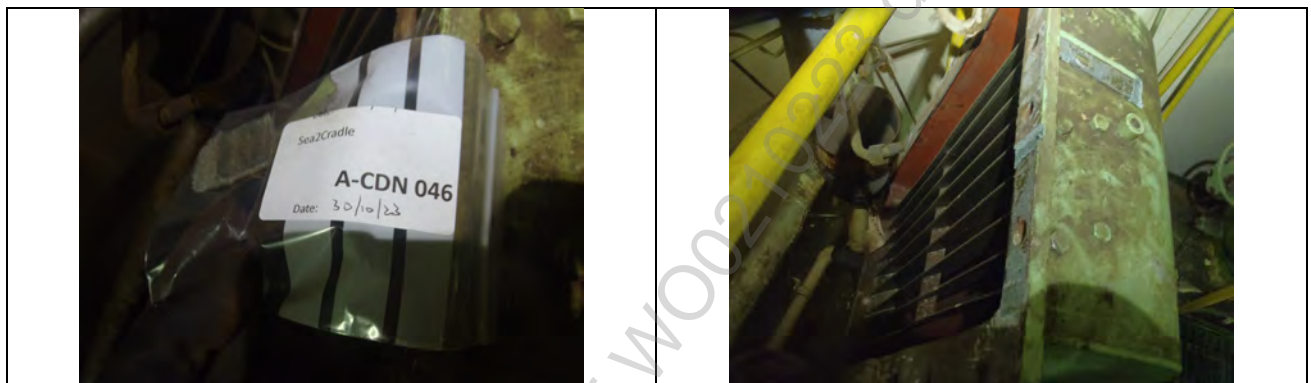
Sample	: A CDN 046	Tested for	: Asbestos
Location	: 08 ER Upper Floor	Result	: Chrysotile 30-60%
Description	: Aux. Diesel Joint		:
			:

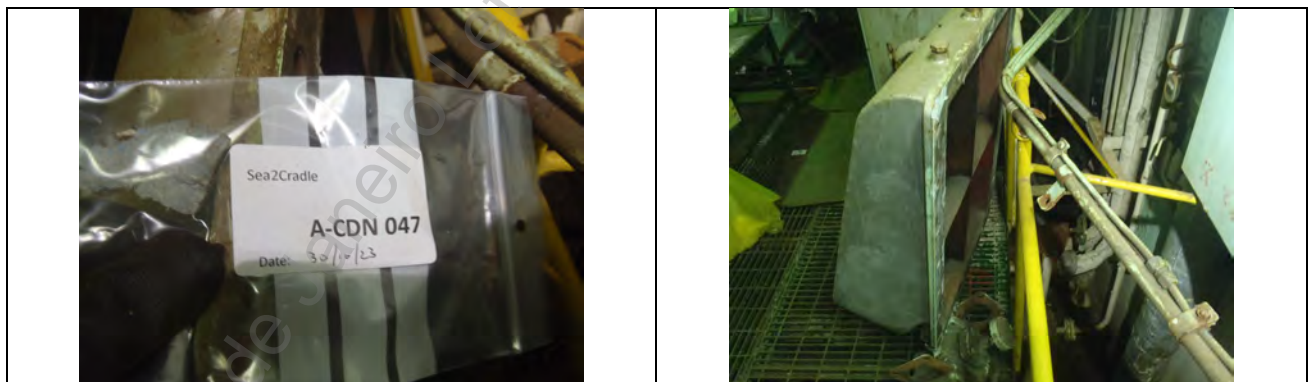
Sample	: A CDN 047	Tested for	: Asbestos
Location	: 08 ER Upper Floor	Result	: Chrysotile 30-60%
Description	: Aux. Diesel Joint		:
			:
