HAZARDOUS MATERIALS INVESTIGATION REPORT

[NSS FELINTO PERRY]

Project description:	Develop the Inventory of Hazardous Materials in accordance with resolution MEPC 269(68), with two additional Hazardous Materials (PFOS and HBCDD) required in Regulation (EU) No 1257/2013
Client:	ROTA SHIPPING INC.
Report Number	INC 24017 C
Report Version	[1.0]
Date of issue	[14 June, 2024]
Onboard inspection period	Between 04.04.2024- 08.04.2024 and Between 22.05.2024- 24.05.2024
Inspection location	[Rio De Janeiro, Brazil]
Project Team	Lead Inspector:

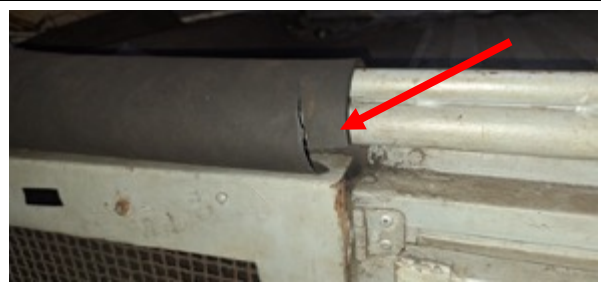
32 (Close shot)

29	32	A	Asbestos	A Deck, corridor	Air conditioner unit pipe	Covering	-	NIL	Unknown	S	N	NIL	
30	33	A	Asbestos	A Deck, corridor	Deck covering	Cement	-	NIL	Unknown	S	N	NIL	
31	34	A	Asbestos	A Deck, corridor	Electrical cabinet	Paint	-	NIL	Unknown	S	N	NIL	
32	35	A	Asbestos	A Deck, corridor	Deck covering	PVC	-	NIL	Unknown	S	N	NIL	
33	36	A	Asbestos	A Deck, Owner Cabin	Electrical cabinet	Rubber	-	NIL	Unknown	S	N	NIL	
34	37	A	Asbestos	A Deck, Owner Cabin	Deck covering		-	NIL	Unknown	S	N	NIL	
35	38	A	Asbestos	A Deck, Owner Cabin WC	Deck covering	Tile	-	NIL	Unknown	S	N	NIL	
36	39	A	Asbestos	A Deck, Cabin	Deck covering		-	NIL	Unknown	S	N	NIL	
37	40	A	Asbestos	A Deck, Staircase	Deck covering		-	NIL	Unknown	S	N	NIL	
38	41	A	Asbestos	A Deck, Staircase	Skirting	Skirting line	-	NIL	Unknown	S	N	NIL

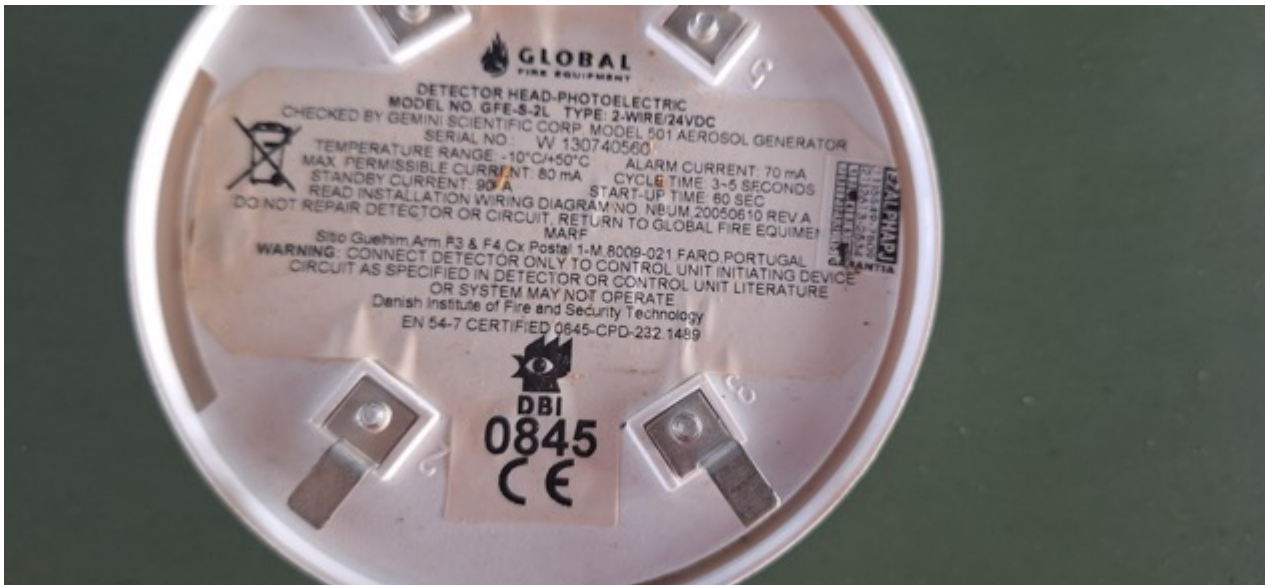
DOCUMENT FOR SMOKER DETECTORS ONBOARD

-Photoelectric smoke detector
