Inventory of Hazardous Materials (IHM)

Task – T2189020
“FPSO FLUMINENSE”, Class No. 7428908
KOCKUMS MEKANISKA VERKSTADS AB., Hull: 546
Flag: The Commonwealth of the Bahamas

FPSO Fluminense - Inventory Hazardous Materials Prior to Recycling

Project	Bijupira Salema Decommissioning
Document Title	FPSO Fluminense - Inventory Hazardous Materials Prior to Recycling
Document Number	BJSA-SHL-100-MA-ASE-0001
DCAF Control ID Number	
Document Revision	03
Document Status	Issued for Approval
Document Type	Analysis & Design
Owner	Dilip Naik
Issue Date	03/09/22
Expiry Date	None
ECCN	
Security Classification	Restricted
Disclosure	
<i>Revision History shown on next page</i>

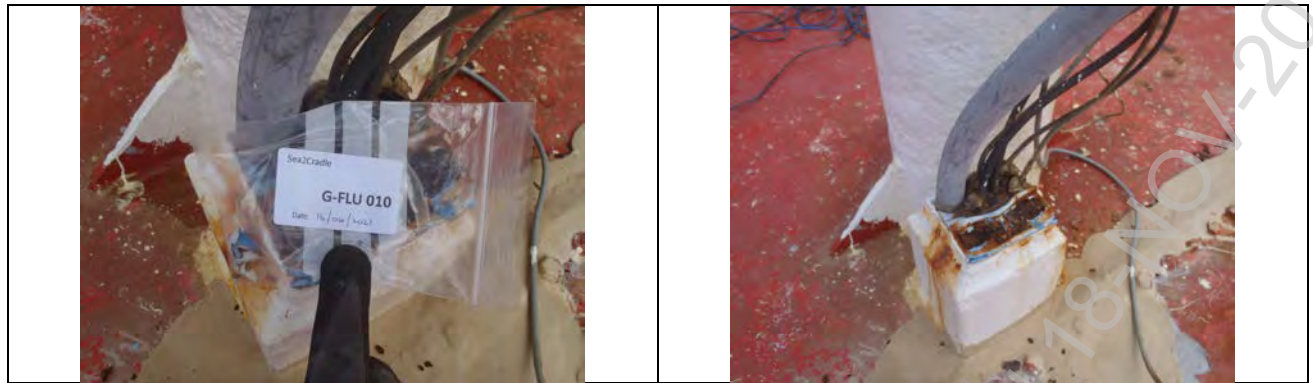
<p>Sample : G-FLU 10 Location : 00. Top of Nav. Deck Description : Cable Penetration</p>	<p>Tested for : PCB Result : 0.00 mg/kg : :</p>
--------------------------------------------------------------------------------------------------------------------	----------------------------------------------------------------------------------------

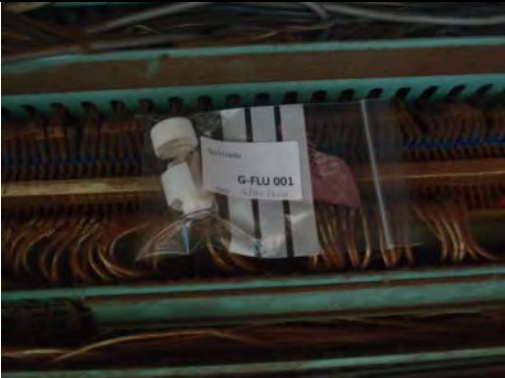
<p>Sample : G-FLU 01 Location : 01. Nav. Deck Description : Cable Run Wipe</p>	<p>Tested for : PCB Result : 0.285 µg abs : :</p>

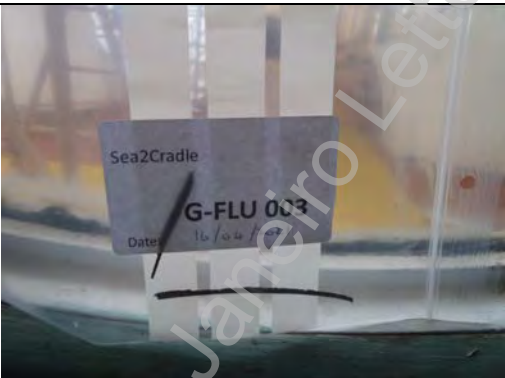
<p>Sample : G-FLU 03 Location : 01. Nav. Deck Description : Window Seal</p>	<p>Tested for : PCB Result : 47.45 mg/kg : :</p>

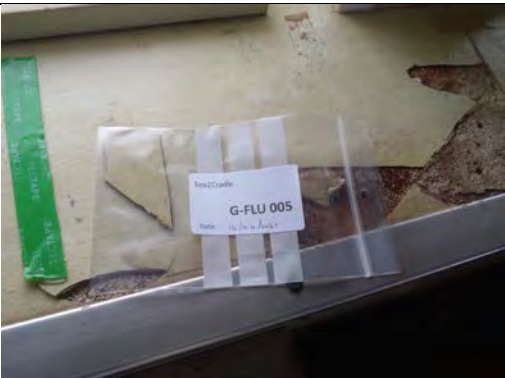
<p>Sample : G-FLU 05 Location : 01. Nav. Deck Description : Vinyl Shelving</p>	<p>Tested for : PCB Result : 0.00 mg/kg : :</p>

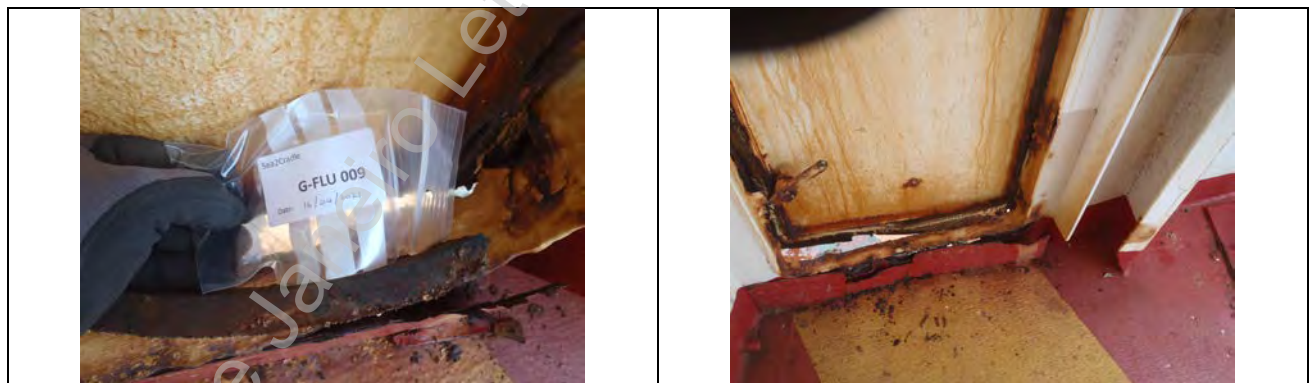
Sample	: G-FLU 09	Tested for	: PCB
Location	: 01. Nav. Deck	Result	: 0.00 mg/kg
Description	: W/T Door Seal		:
			:

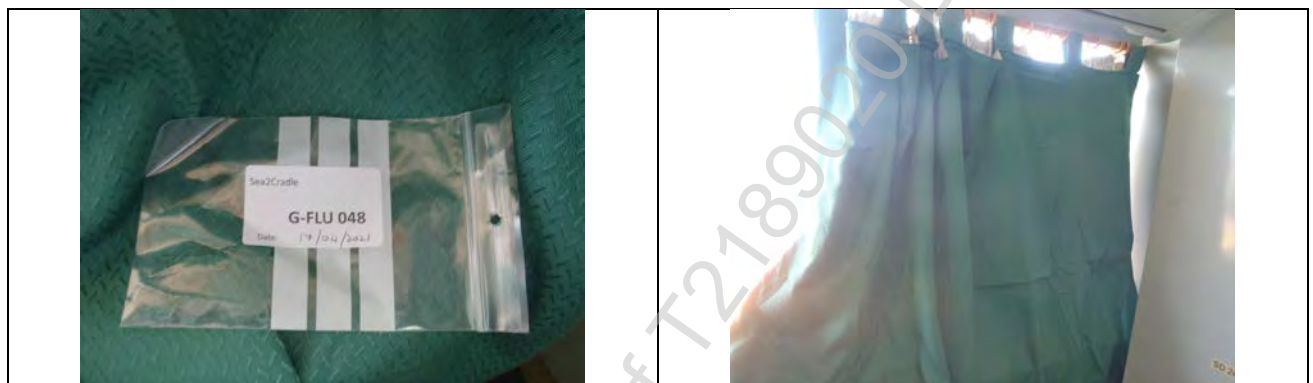
<p>Sample : G-FLU 48 Location : 01. Nav. Deck Description : Curtain Fabric</p>	<p>Tested for : PFOS Result : <0.01 mg/kg : :</p>
----------------------------------------------------------------------------------------------------------	---------------------------------------------------------------------------------------------

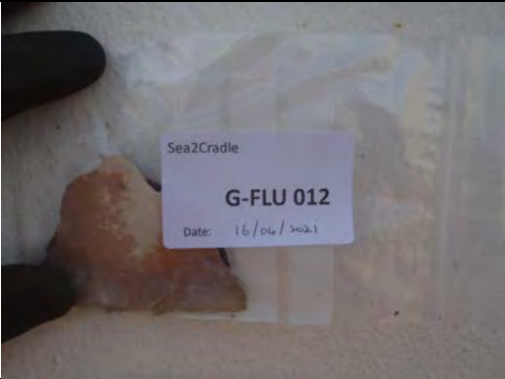
<p>Sample : G-FLU 12 Location : 02. D Deck Description : External Paint - White</p>	<p>Tested for : PCB, Pb, Cd, Cr Result PCB: 0.55 mg/kg Pb: 45 mg/kg Cd: 0.13 mg/kg Cr: 21 mg/kg</p>

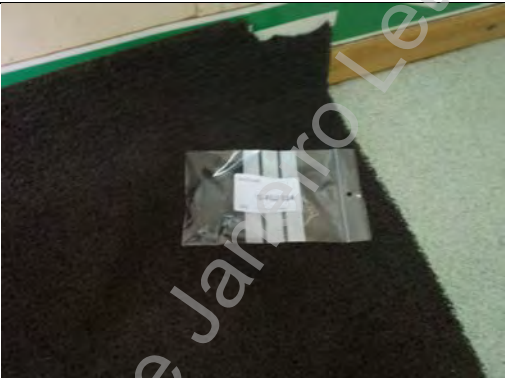
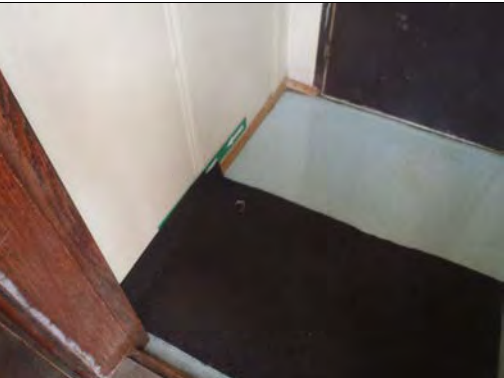
<p>Sample : G-FLU 14 Location : 02. D Deck Description : Rubber Backed Mat</p>	<p>Tested for : PCB Result : 0.00 mg/kg : :</p>

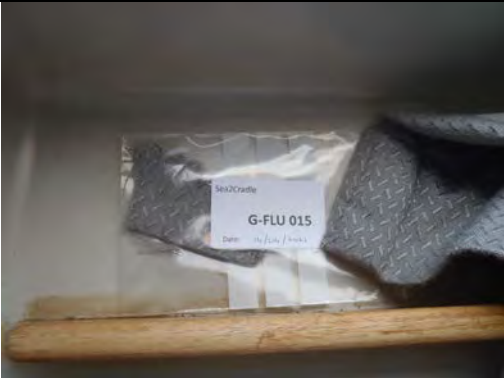
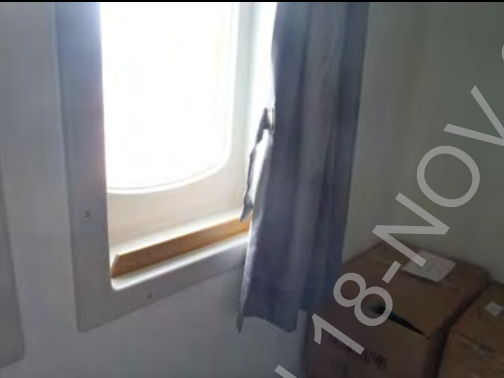
<p>Sample : G-FLU 15 Location : 02. D Deck Description : Curtain Material</p>	<p>Tested for : PFOS Result : <0.04 mg/kg : :</p>

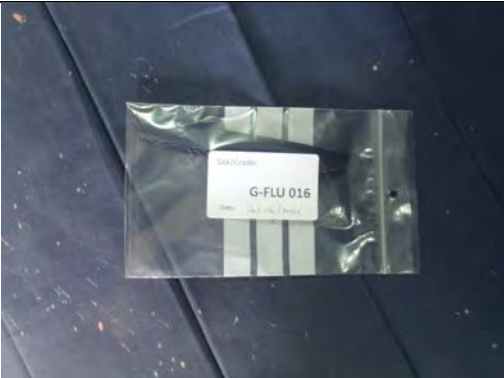
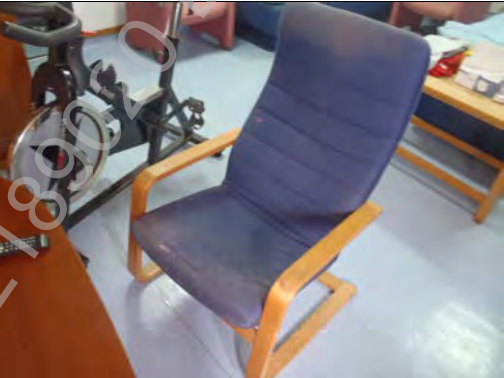
<p>Sample : G-FLU 16 Location : 02. D Deck Description : Chair Covering Material</p>	<p>Tested for : PFOS Result : <0.03 mg/kg : :</p>

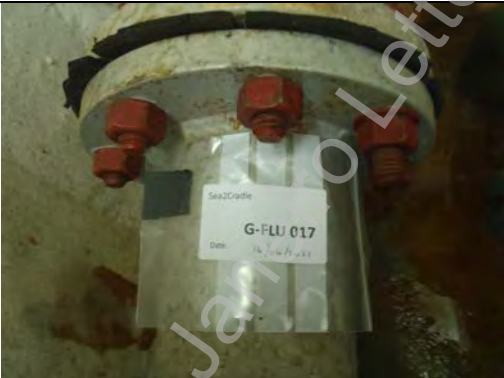
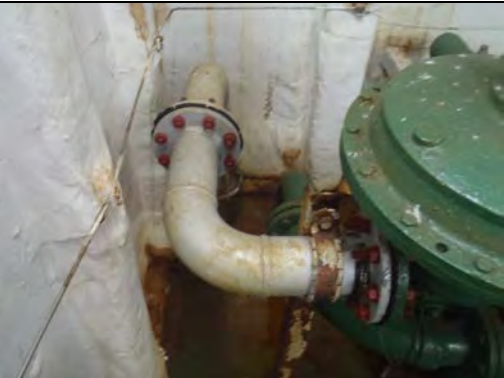
<p>Sample : G-FLU 17 Location : 02. D Deck Description : Rubber Pipe Flange</p>	<p>Tested for : PCB Result : 0.00 mg/kg : :</p>

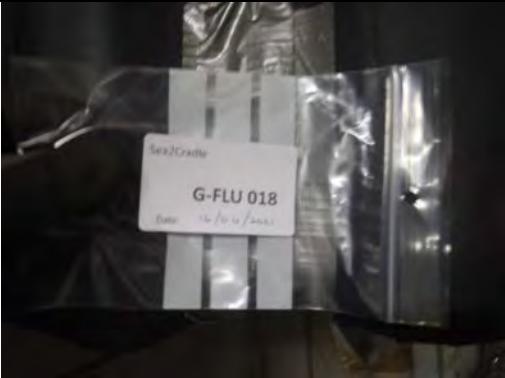
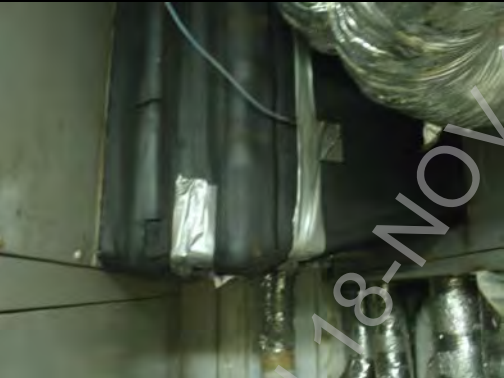
<p>Sample : G-FLU 18 Location : 02. D Deck Description : Reefer Trunk Lagging</p>	<p>Tested for : ODS Result : <5.00 mg/kg [R11] : :</p>

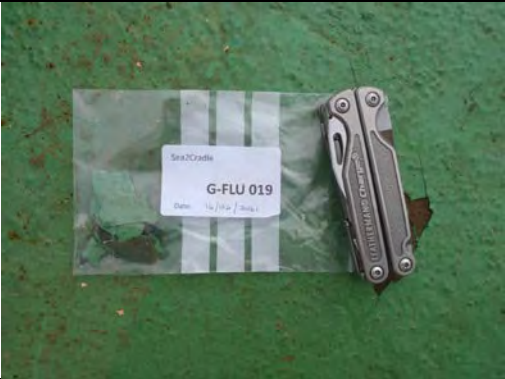
<p>Sample : G-FLU 19 Location : 03. Heli Deck Description : Special Paint Coating</p>	<p>Tested for : PCB, Pb, Cd, Cr Result PCB: 0.00 mg/kg Pb: 28 mg/kg Cd: <0.1 mg/kg Cr: 17 mg/kg</p>

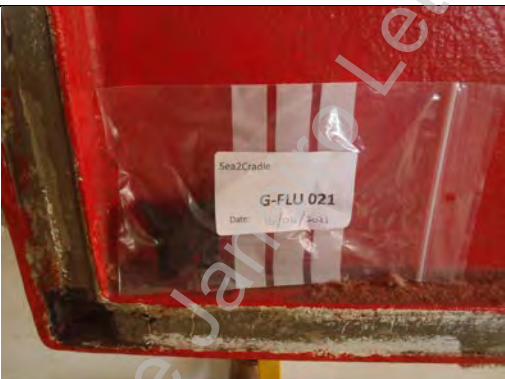
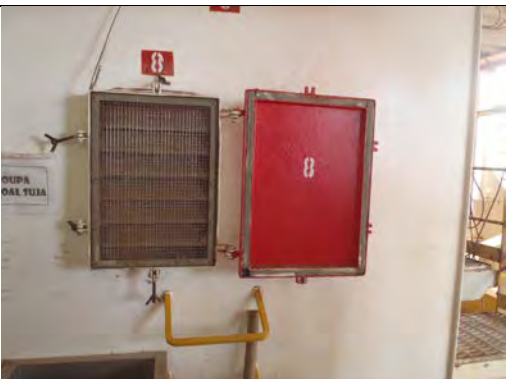
<p>Sample : G-FLU 21 Location : 03.C Deck Description : W/T Vent Seal</p>	<p>Tested for : PCB Result : 12.35 mg/kg : :</p>

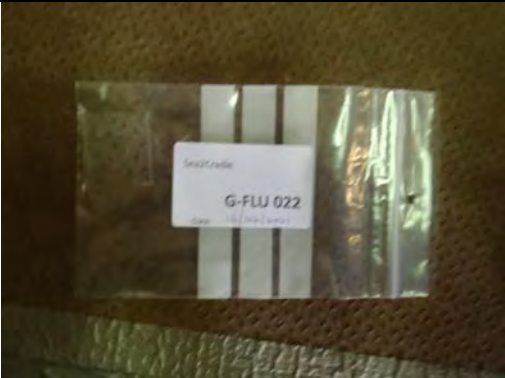
<p>Sample : G-FLU 22 Location : 04. B Deck Description : Anti-Slip Mat</p>	<p>Tested for : PCB Result : 0.00 mg/kg : :</p>

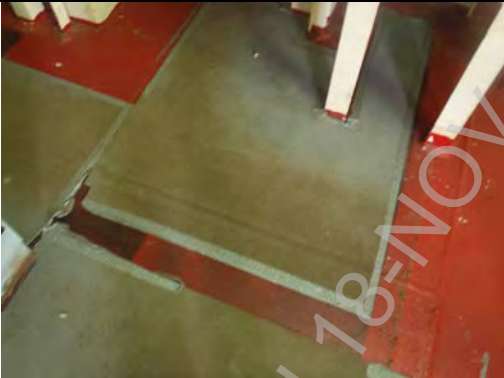
<p>Sample : G-FLU 23 Location : 04. B Deck Description : Vinyl Flooring</p>	<p>Tested for : PCB Result : 0.00 mg/kg : :</p>

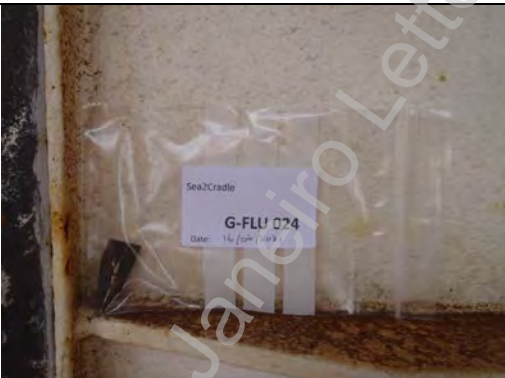
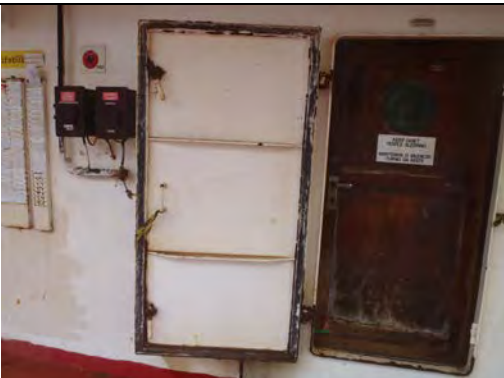
<p>Sample : G-FLU 24 Location : 04. B Deck Description : W/T Door Seal</p>	<p>Tested for : PCB Result : 3.50 mg/kg : :</p>

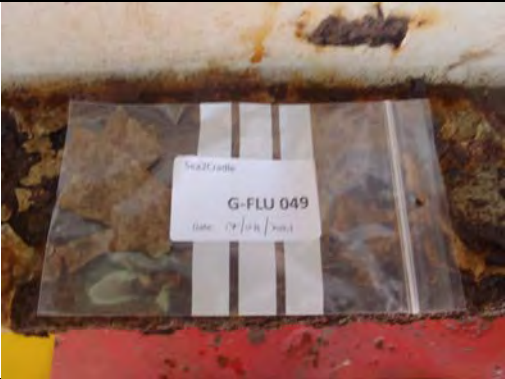
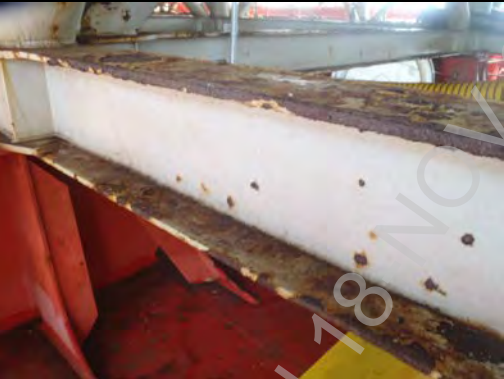
<p>Sample : G-FLU 49 Location : 05A. Upper Deck Description : Deck Girder Paint</p>	<p>Tested for : PCB, Pb, Cd, Cr Result PCB: 0.00 mg/kg Pb: 35 mg/kg Cd: 2.1 mg/kg Cr: 93 mg/kg</p>

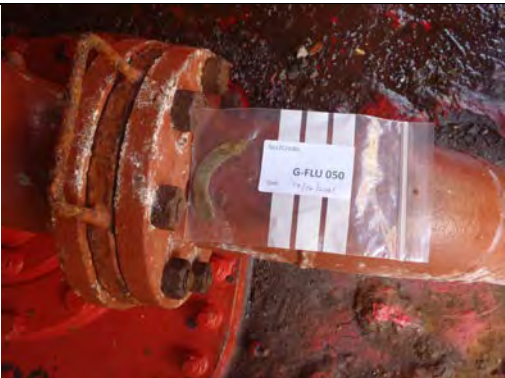
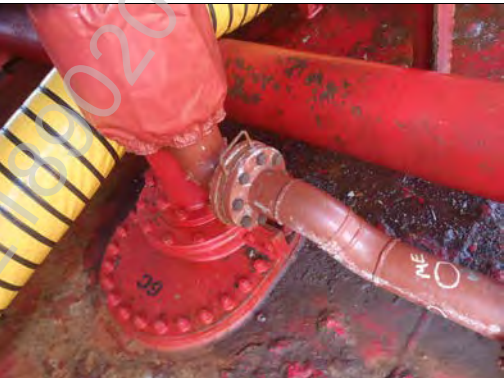
<p>Sample : G-FLU 50 Location : 05A. Upper Deck Description : Valve Gasket</p>	<p>Tested for : PCB Result : 2.50 mg/kg : :</p>

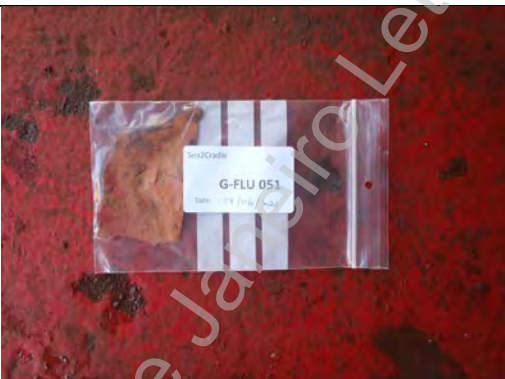
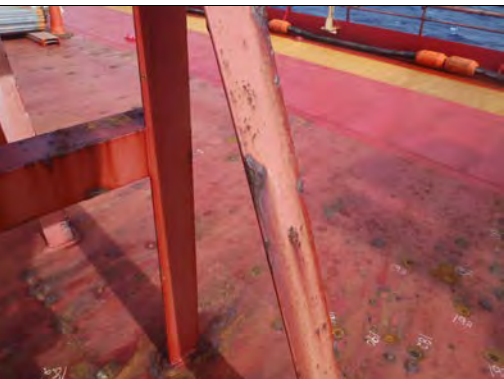
<p>Sample : G-FLU 51 Location : 05A. Upper Deck Description : Deck Bracket Paint</p>	<p>Tested for : PCB, Pb, Cd, Cr Result PCB: 0.00 mg/kg Pb: 1450 mg/kg Cd: 1.6 mg/kg Cr: 360 mg/kg</p>

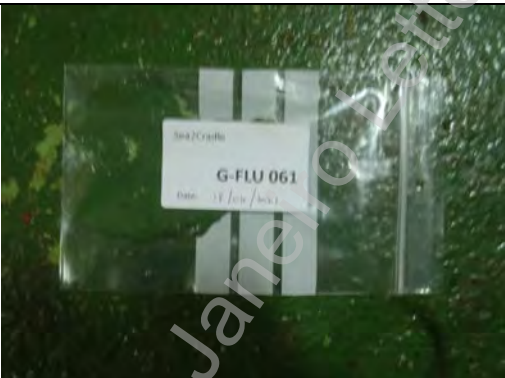
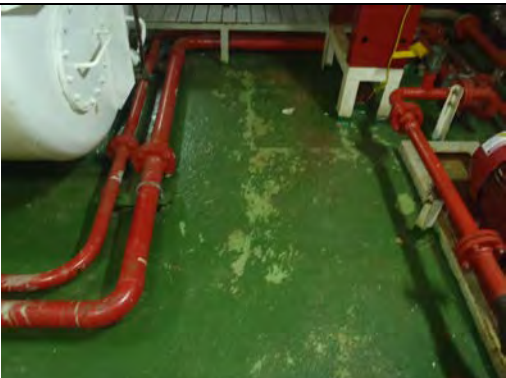
<p>Sample : G-FLU 61 Location : 05. Upper Deck Foam Tank Room Description : Internal Paint - Green</p>	<p>Tested for : PCB Result : 0.70 mg/kg : :</p>

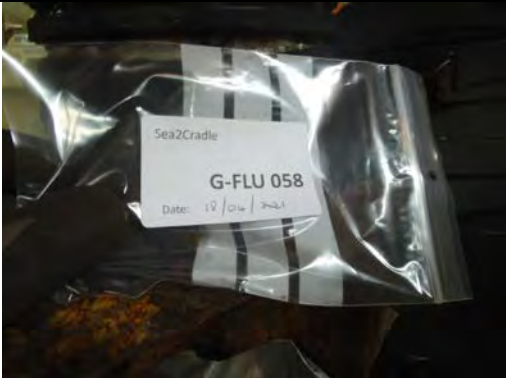
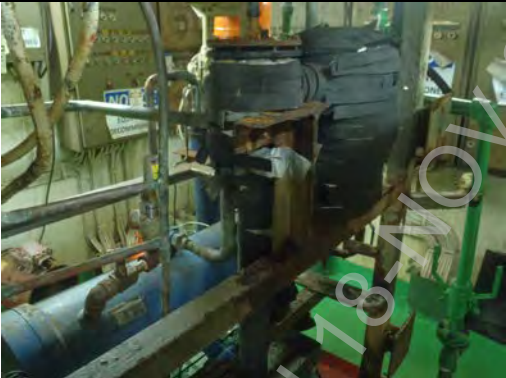
<p>Sample : G-FLU 58 Location : 06. Upper Platform E.R. Description : Reefer Pipe Lagging</p>	<p>Tested for : ODS Result : <5.00 mg/kg [R11] : :</p>

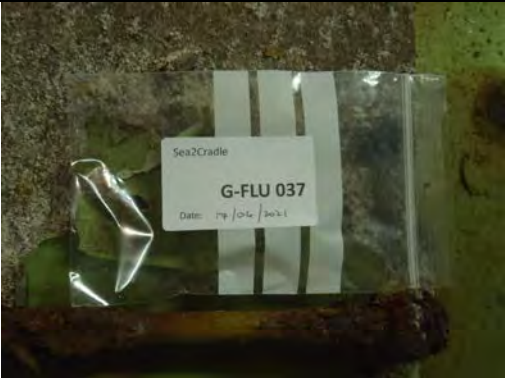
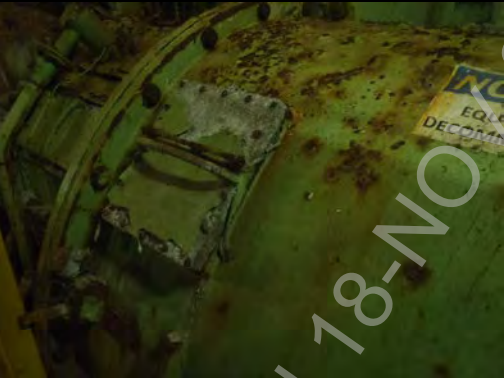
<p>Sample : G-FLU 37 Location : 09. Tank Top Engine Room Description : Machinery Paint - Green</p>	<p>Tested for : PCB, Pb, Cd, Cr Result PCB: 4.10 mg/kg Pb: 5320 mg/kg Cd: <0.1 mg/kg Cr: 280 mg/kg</p>

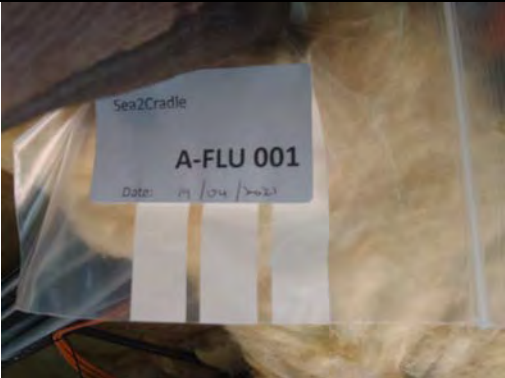
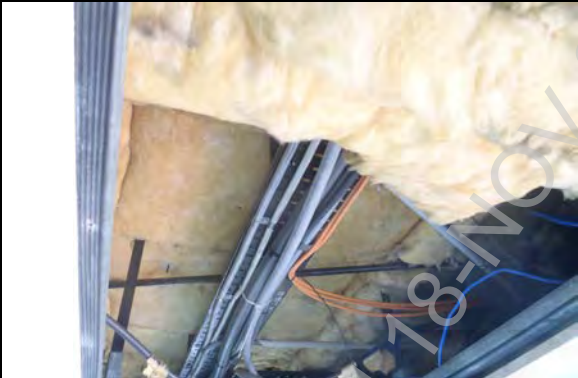
<p>Sample : A-FLU 01 Location : 01. Nav. Deck Bridge Description : Deckhead Insulation</p>	<p>Tested for : Asbestos Result : <0.1% : :</p>

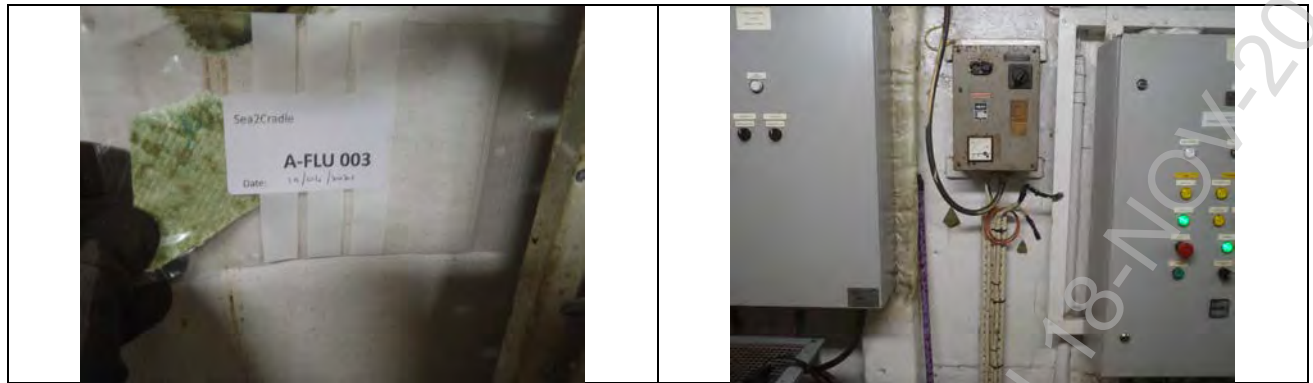
Sample : A-FLU 03	Tested for : Asbestos
Location : 02. D Deck Fan Room	Result : <0.1%
Description : Bulkhead Insulation Cover	:
	:

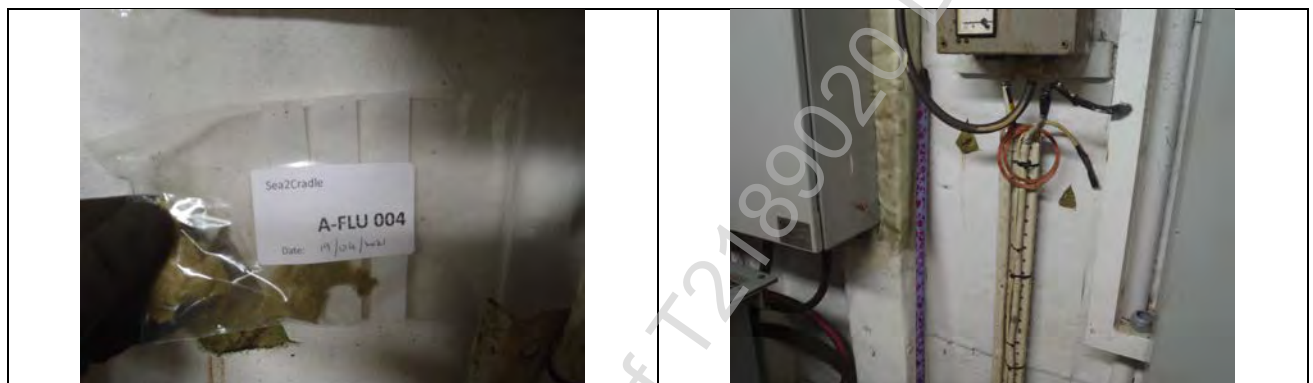
Sample : A-FLU 04	Tested for : Asbestos
Location : 02. D Deck Fan Room	Result : <0.1%
Description : Bulkhead Insulation	:
	:

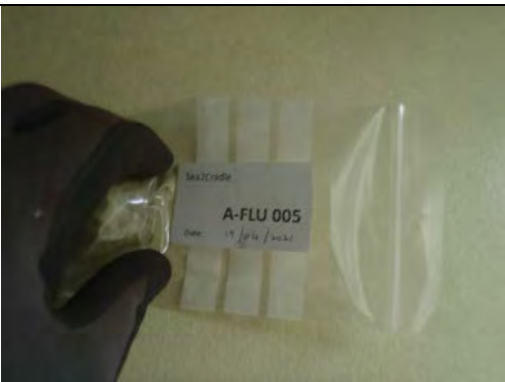
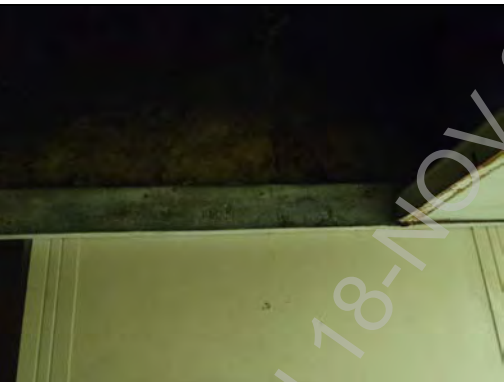
<p>Sample : A-FLU 05 Location : 03. C Deck Alleyway Description : Bulkhead Insulation</p>	<p>Tested for : Asbestos Result : <0.1% : : :</p>

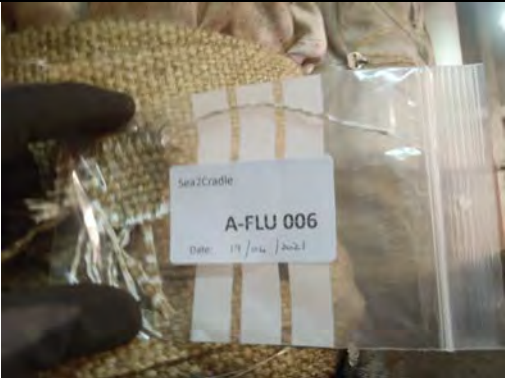
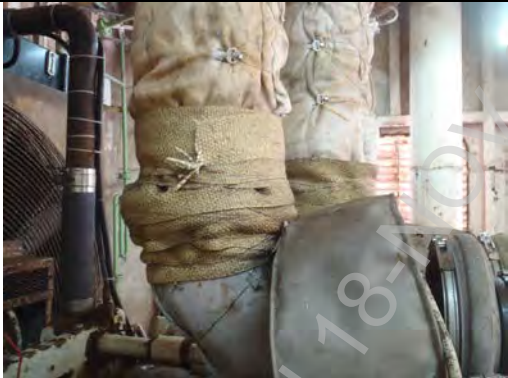
<p>Sample : A-FLU 06 Location : Emergency Generator Description : Exhaust Uptake Cordage</p>	<p>Tested for : Asbestos Result : <0.1% : :</p>

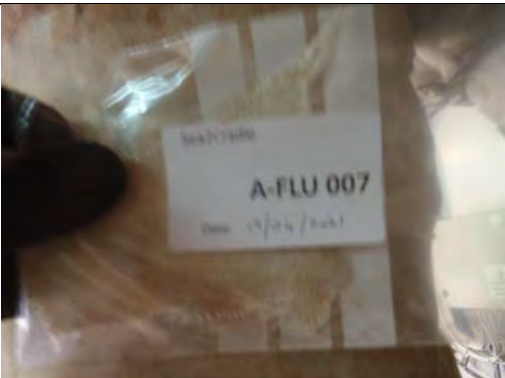
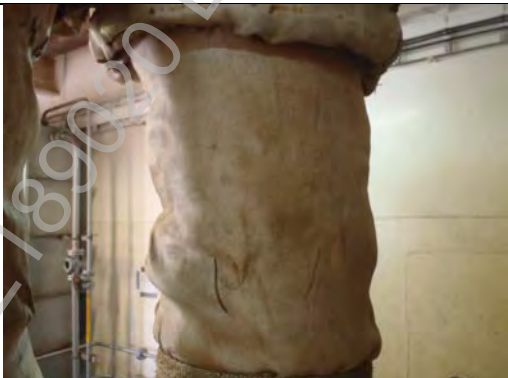
<p>Sample : A-FLU 07 Location : Emergency Generator Description : Exhaust Uptake Lagging</p>	<p>Tested for : Asbestos Result : <0.1% : :</p>

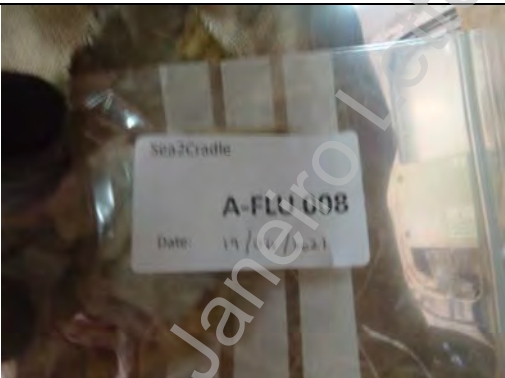
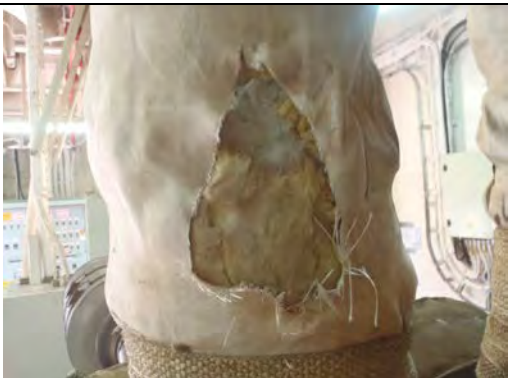
<p>Sample : A-FLU 08 Location : Emergency Generator Description : Exhaust Uptake Lagging</p>	<p>Tested for : Asbestos Result : <0.1% : :</p>

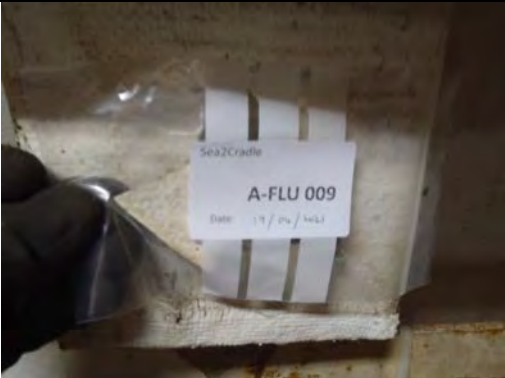
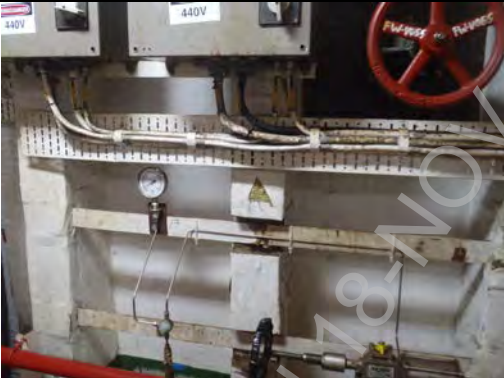
<p>Sample : A-FLU 09 Location : 05. Foam Room Description : Bulkhead insulation (Canvas)</p>	<p>Tested for : Asbestos Result : <0.1% : :</p>

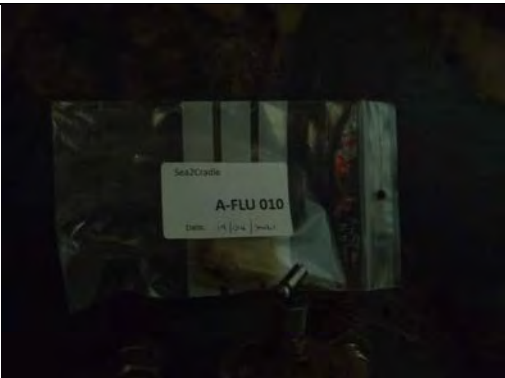
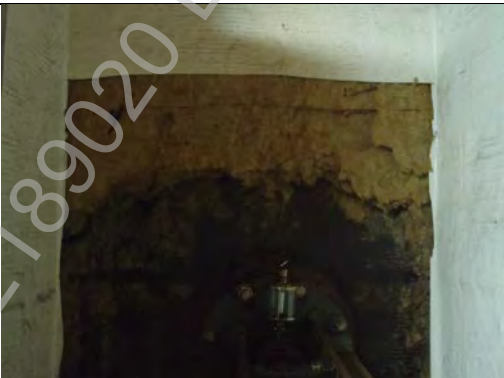
<p>Sample : A-FLU 10 Location : 05. Foam Room Description : Bulkhead Insulation (Fibre)</p>	<p>Tested for : Asbestos Result : <0.1% : :</p>

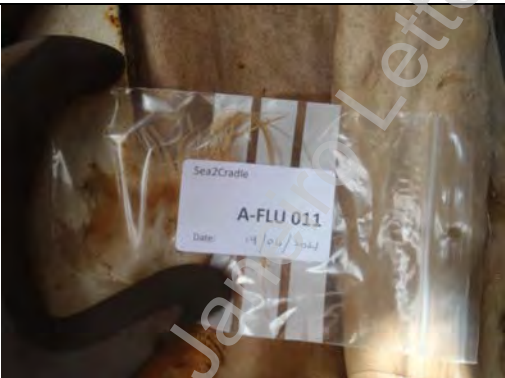
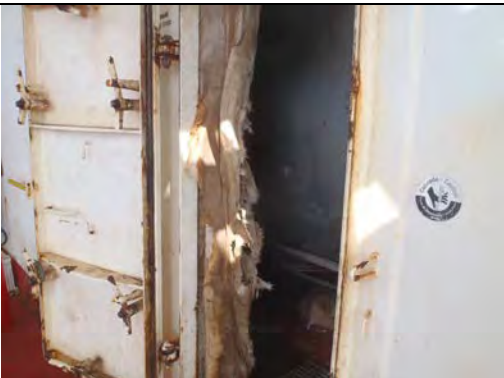
<p>Sample : A-FLU 11 Location : 05. CO2 Room Description : Bulkhead Insulation (Canvas)</p>	<p>Tested for : Asbestos Result : <0.1% : :</p>

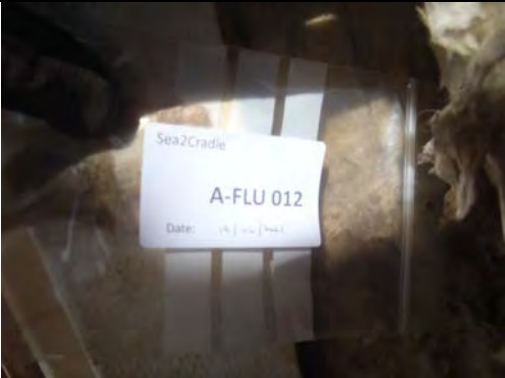
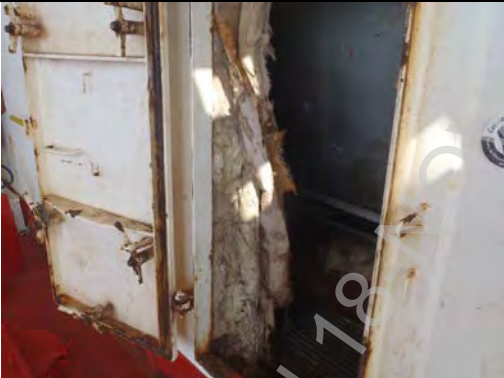
<p>Sample : A-FLU 12 Location : 05. CO2 Room Description : Bulkhead Insulation (Fibre)</p>	<p>Tested for : Asbestos Result : <0.1% : :</p>

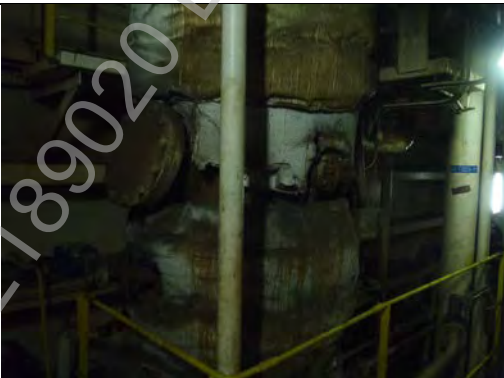
<p>Sample : A-FLU 13 Location : 05. Boiler Uptake Description : Heat Insulation (Canvas)</p>	<p>Tested for : Asbestos Result : <0.1% : :</p>

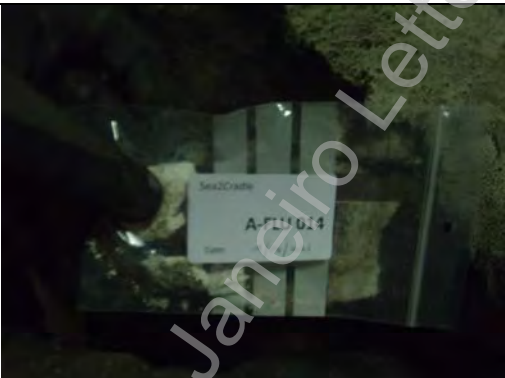
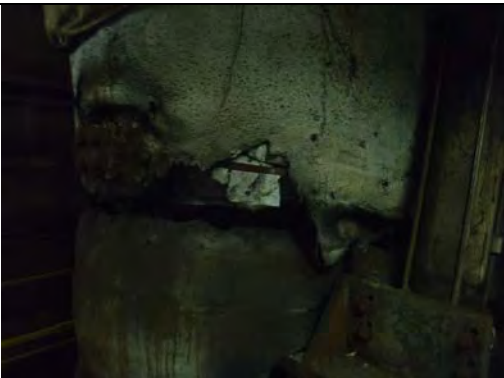
<p>Sample : A-FLU 14 Location : 05. Boiler Uptake Description : Heat Insulation (Gypsum)</p>	<p>Tested for : Asbestos Result : <0.1% : :</p>

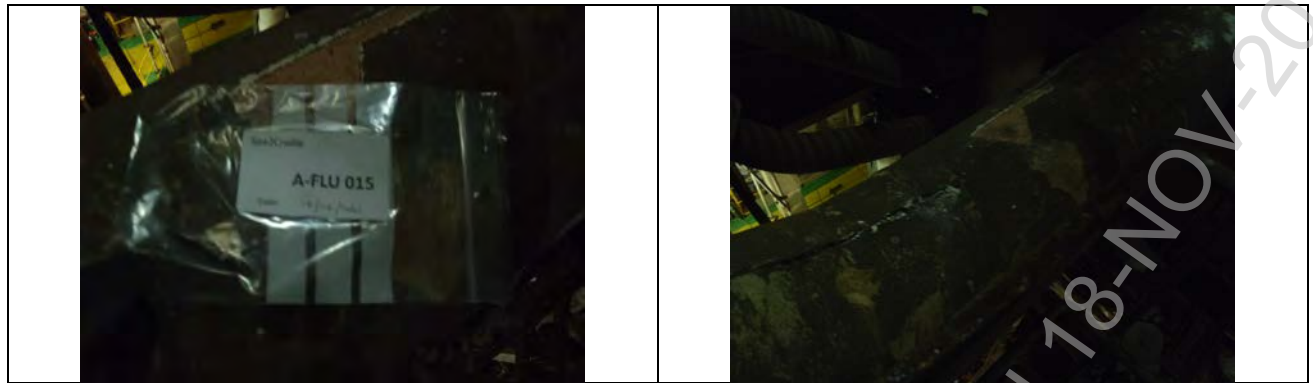
<p>Sample : A-FLU 15 Location : 05. Pipework Description : Heat Insulation</p>	<p>Tested for : Asbestos Result : <0.1% : :</p>
----------------------------------------------------------------------------------------------------------	-------------------------------------------------------------------------------------------

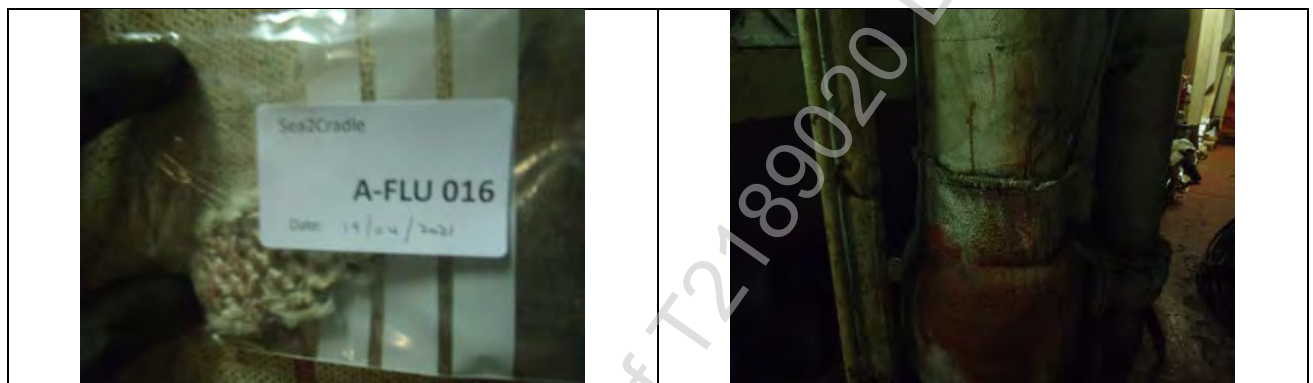
<p>Sample : A-FLU 16 Location : 05. Exhaust Uptake Description : Cordage Bandage</p>	<p>Tested for : Asbestos Result : <0.1% : :</p>
----------------------------------------------------------------------------------------------------------------	-------------------------------------------------------------------------------------------

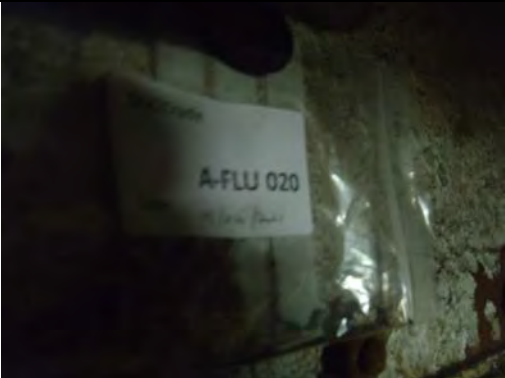
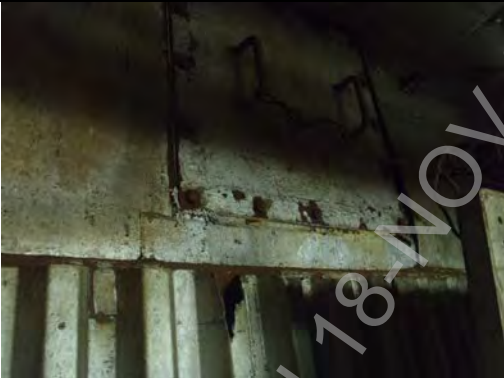
<p>Sample : A-FLU 20 Location : 06. Boiler Access Door Description : Door Joint</p>	<p>Tested for : Asbestos Result : >60% Chrysotile : :</p>

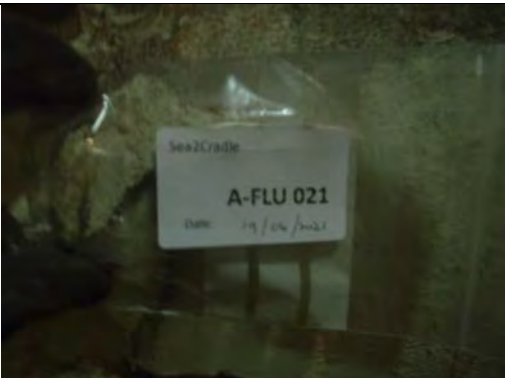
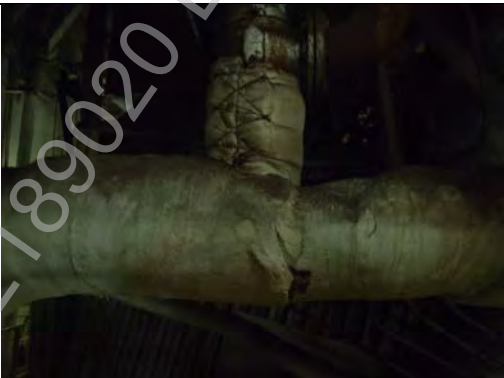
<p>Sample : A-FLU 21 Location : 06. Main Steam Pipe Description : Heat Insulation (Canvas)</p>	<p>Tested for : Asbestos Result : <0.1% : :</p>

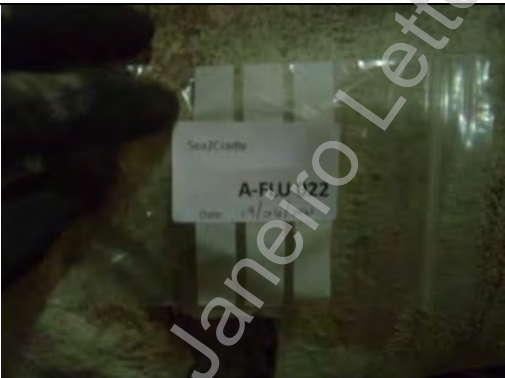
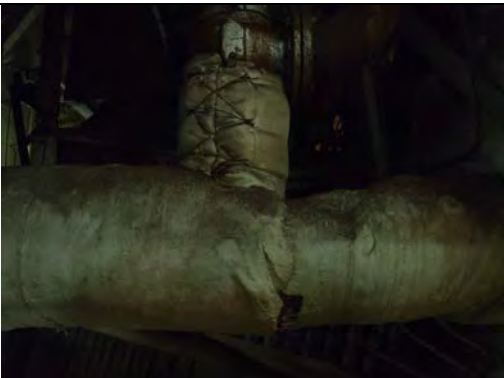
<p>Sample : A-FLU 22 Location : 06. Main Steam Pipe Description : Heat Insulation (Fibre)</p>	<p>Tested for : Asbestos Result : <0.1% : :</p>

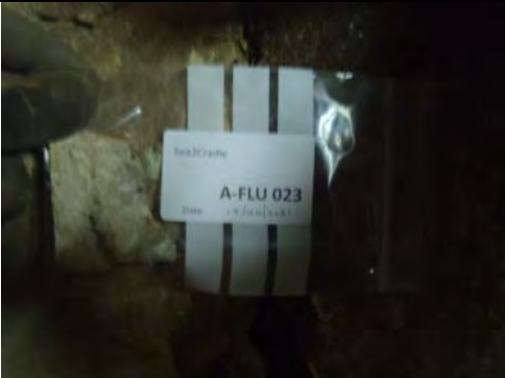
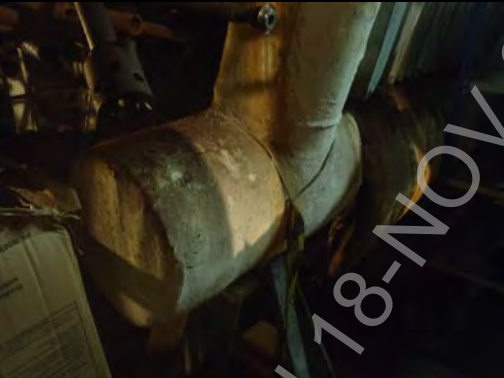
<p>Sample : A-FLU 23 Location : 07. Boiler Bottom Header Description : Heat Insulation (Canvas)</p>	<p>Tested for : Asbestos Result : <0.1% : :</p>

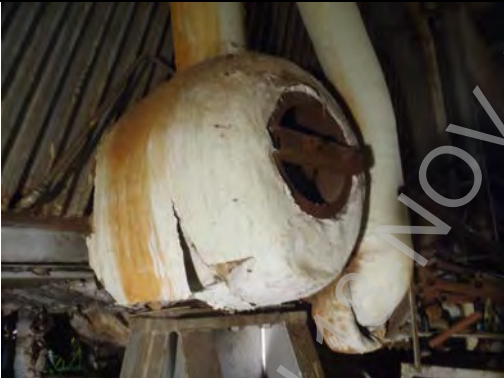
<p>Sample : A-FLU 26 Location : 07. Boiler Water Drum Description : Heat Insulation (Gypsum)</p>	<p>Tested for : Asbestos Result : 2% to 5% Chrysotile : 2% to 5% Amosite :</p>

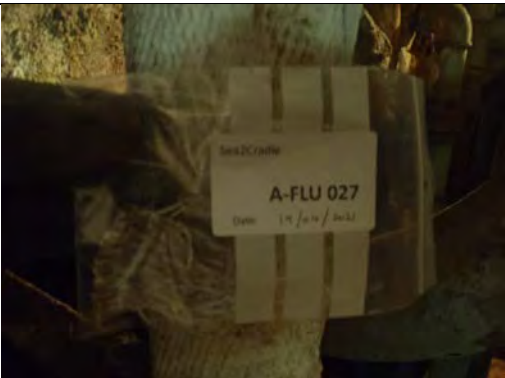
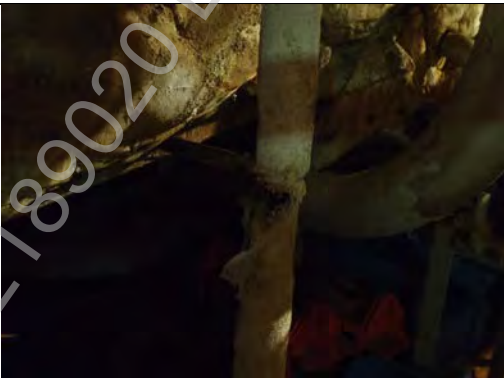
<p>Sample : A-FLU 27 Location : 07. Boiler Feed Pipe Description : Heat Insulation (Cordage)</p>	<p>Tested for : Asbestos Result : >60% Chrysotile : :</p>

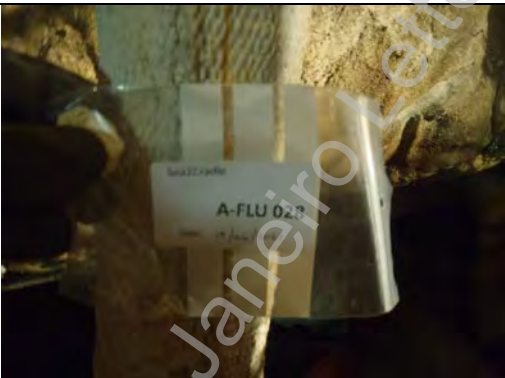
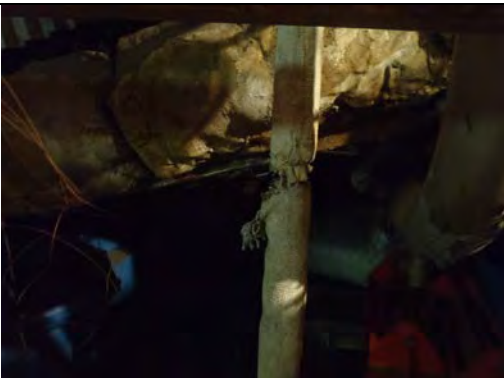
<p>Sample : A-FLU 28 Location : 07. Boiler Feed Pipe Description : Heat Insulation (Gypsum)</p>	<p>Tested for : Asbestos Result : <0.1% : :</p>

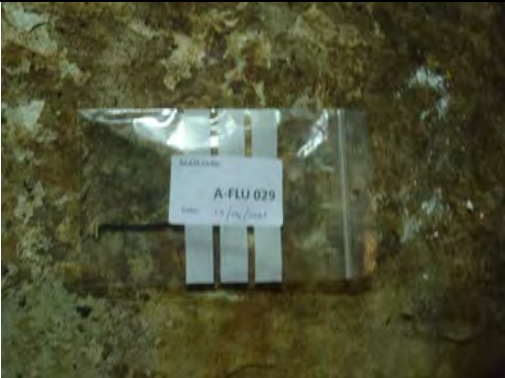
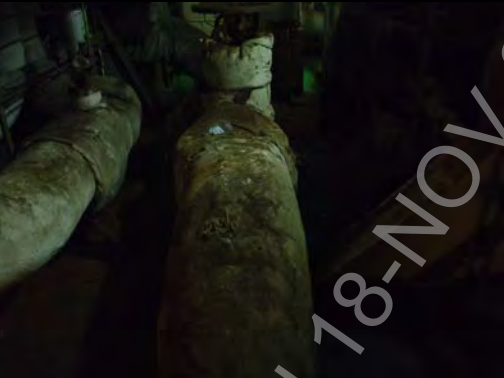
<p>Sample : A-FLU 29 Location : 07. Boiler Steam Pipe Description : Heat Insulation (Canvas)</p>	<p>Tested for : Asbestos Result : <0.1% : :</p>

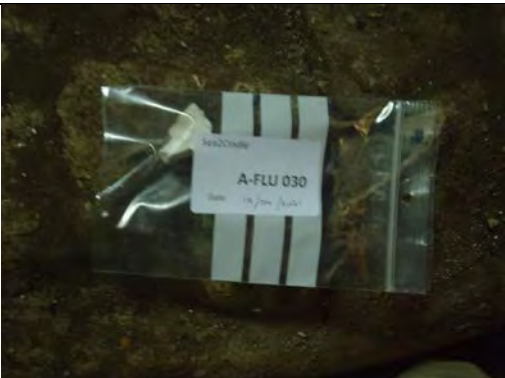
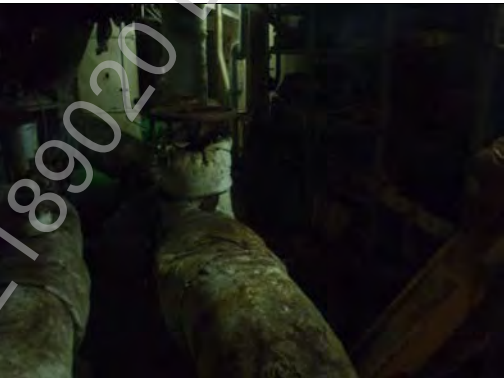
<p>Sample : A-FLU 30 Location : 07. Boiler Steam Pipe Description : Heat Insulation (Gypsum)</p>	<p>Tested for : Asbestos Result : 5% to 10% Chrysotile : :</p>

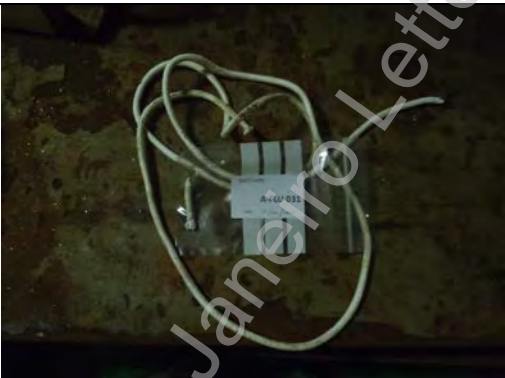
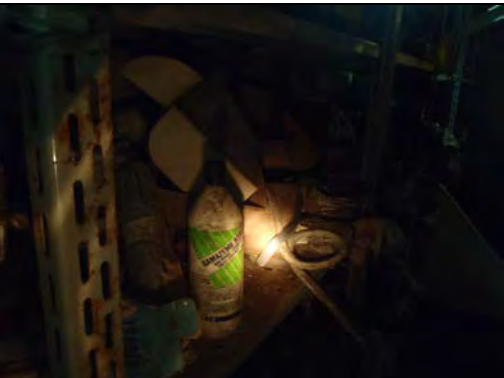
<p>Sample : A-FLU 31 Location : 07. Starboard Shelving Description : Valve Packing (Cord)</p>	<p>Tested for : Asbestos Result : <0.1% : :</p>

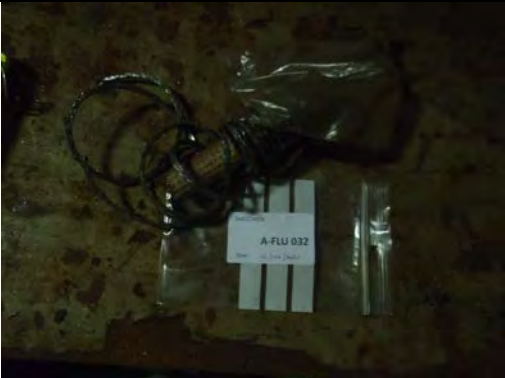
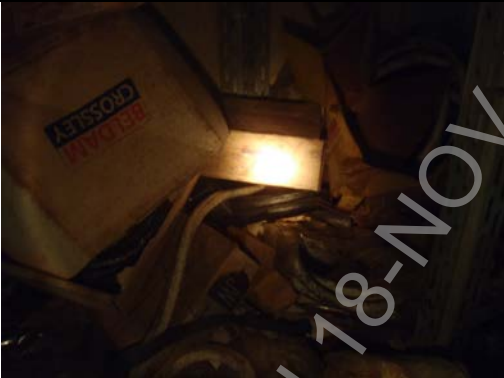
<p>Sample : A-FLU 32 Location : 07. Starboard Shelving Description : Valve Packing (Cord)</p>	<p>Tested for : Asbestos Result : <0.1% : :</p>

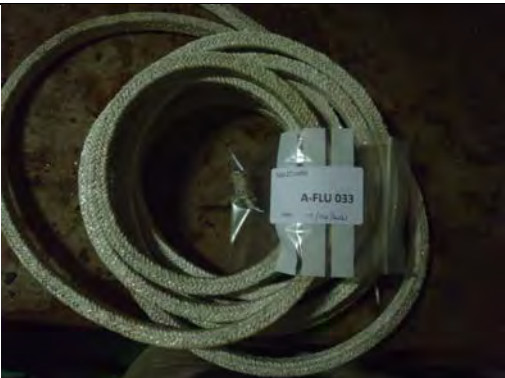
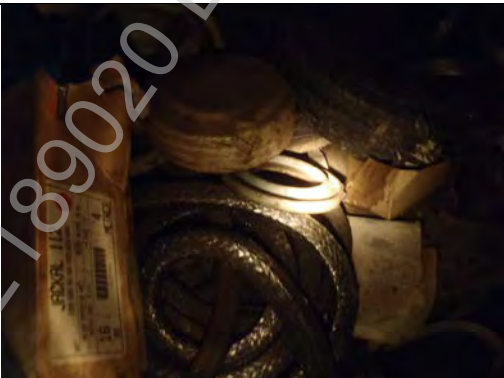
<p>Sample : A-FLU 33 Location : 07. Starboard Shelving Description : Valve Packing (Cord)</p>	<p>Tested for : Asbestos Result : >60% Chrysotile : :</p>

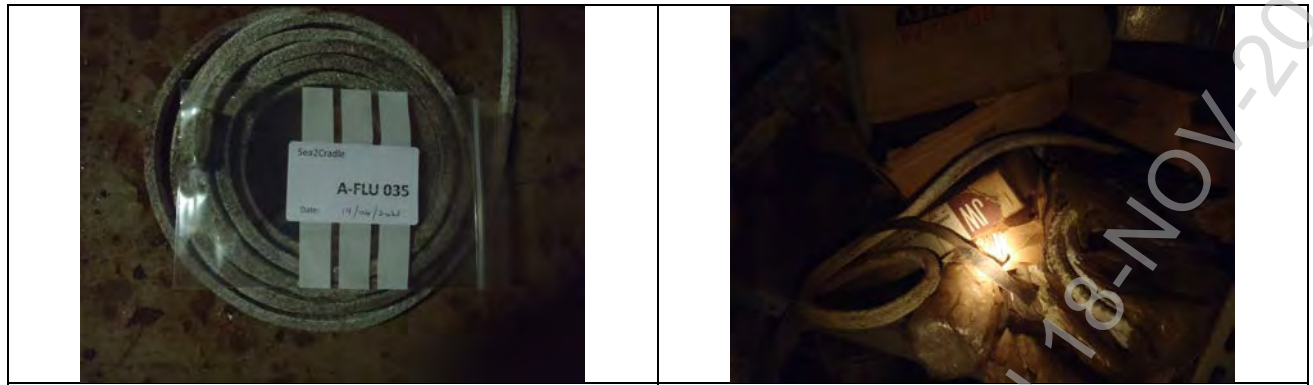
Sample : A-FLU 35	Tested for : Asbestos
Location : 07. Starboard Shelving	Result : <0.1%
Description : Valve Packing (Cord)	:
	:

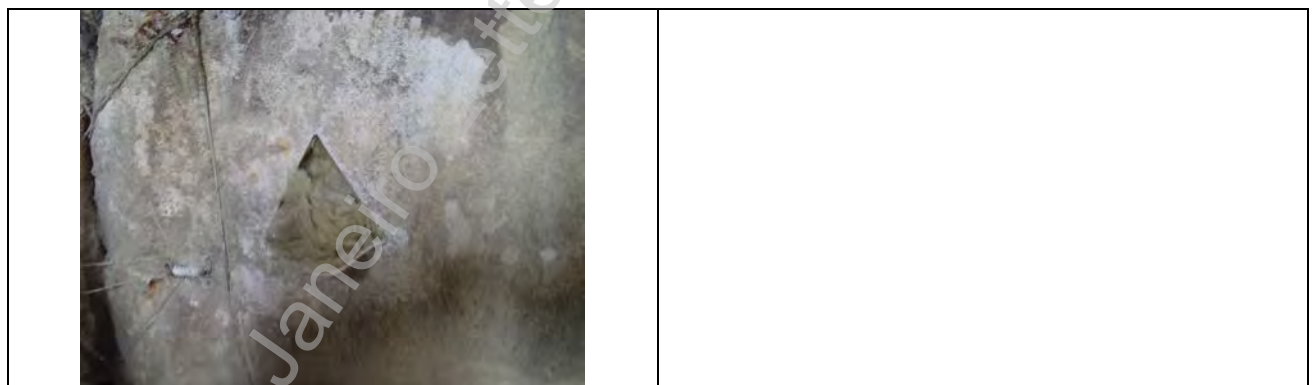
Sample : Visual	Observed : Canvas & Rockwool
Location : 07. Steam Pipe	:
Description : Heat Insulation	:
	:

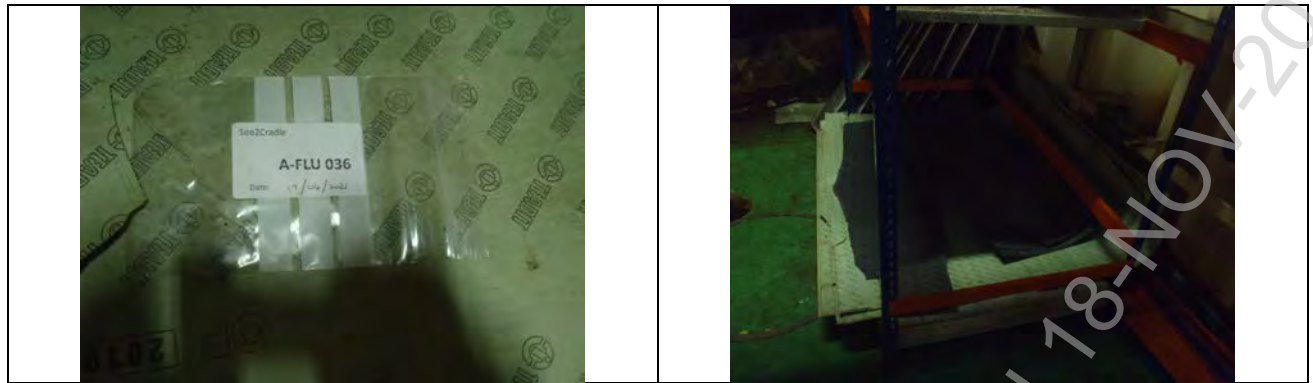
Sample : A-FLU 36	Tested for : Asbestos
Location : 08. Port Shelving	Result : <0.1%
Description : Card Jointing Roll	:
	:

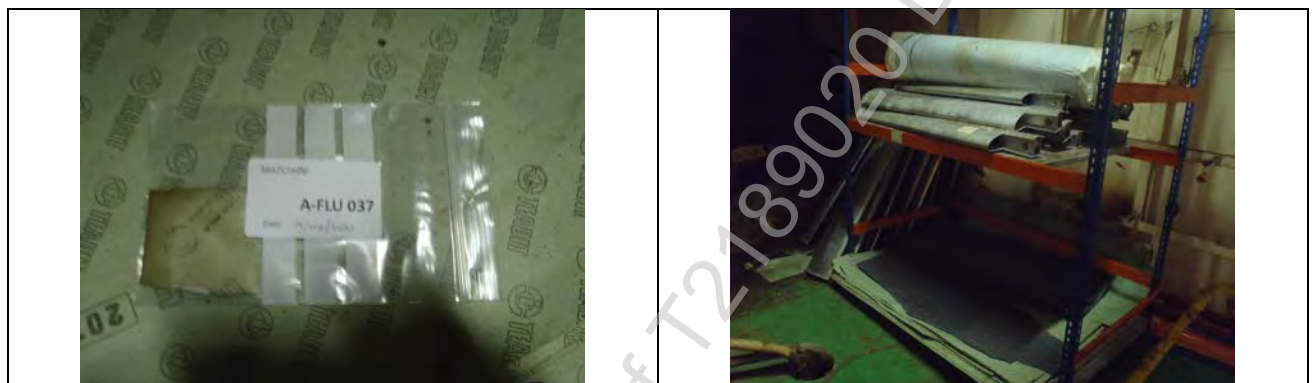
Sample : A-FLU 37	Tested for : Asbestos
Location : 08. Port Shelving	Result : <0.1%
Description : Card Jointing Roll	:
	:
