Inventory of Hazardous Materials (IHM)

Task – T2189020
“FPSO FLUMINENSE”, Class No. 7428908
KOCKUMS MEKANISKA VERKSTADS AB., Hull: 546
Flag: The Commonwealth of the Bahamas

FPSO Fluminense - Inventory Hazardous Materials Prior to Recycling

Project	Bijupira Salema Decommissioning
Document Title	FPSO Fluminense - Inventory Hazardous Materials Prior to Recycling
Document Number	BJSA-SHL-100-MA-ASE-0001
DCAF Control ID Number	
Document Revision	03
Document Status	Issued for Approval
Document Type	Analysis & Design
Owner	Dilip Naik
Issue Date	03/09/22
Expiry Date	None
ECCN	
Security Classification	Restricted
Disclosure	
<i>Revision History shown on next page</i>

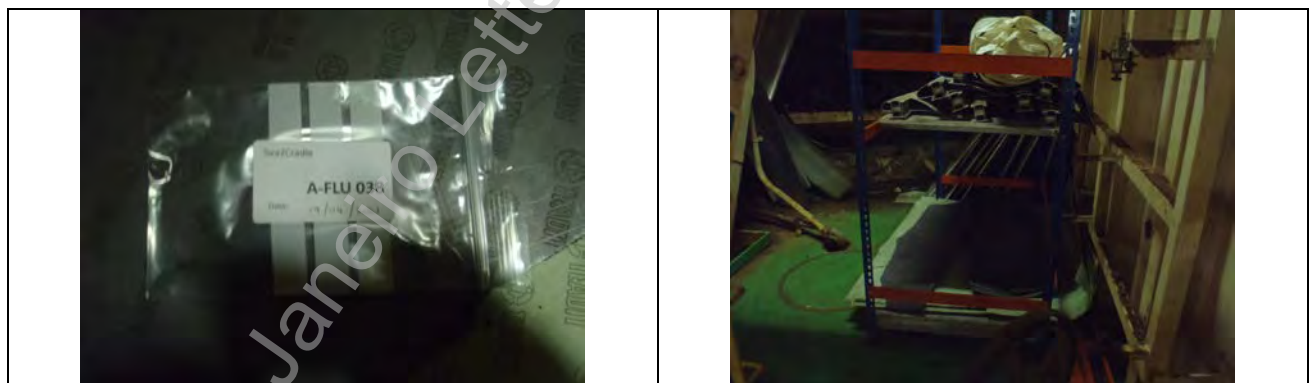
Sample : A-FLU 38	Tested for : Asbestos
Location : 08. Port Shelving	Result : <0.1%
Description : Card Jointing Roll	:
	:

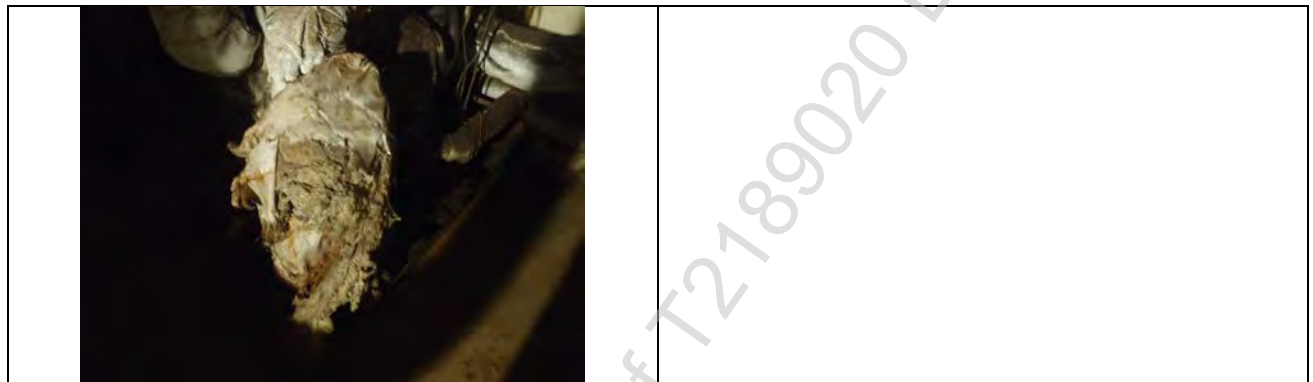
<p>Sample : Visual Location : 08. Steam Pipe Description : Heat Insulation</p>	<p>Observed : Canvas & Rockwool : : :</p>
----------------------------------------------------------------------------------------------------------	--------------------------------------------------------------------------------------------------------------------

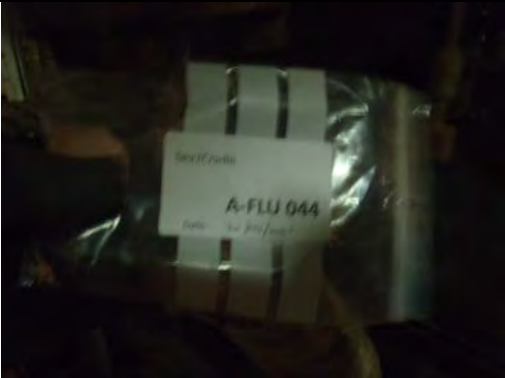
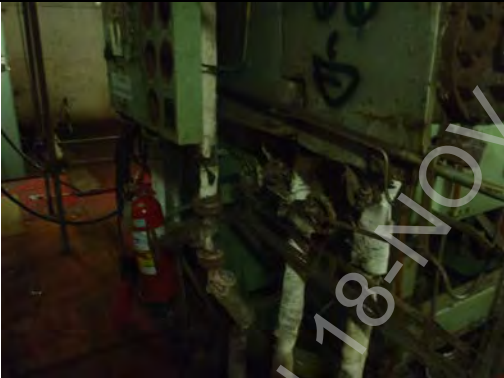
<p>Sample : A-FLU 44 Location : 09. FW Evaporator Feed Description : Heat Insulation (Gypsum)</p>	<p>Tested for : Asbestos Result : <0.1% : :</p>

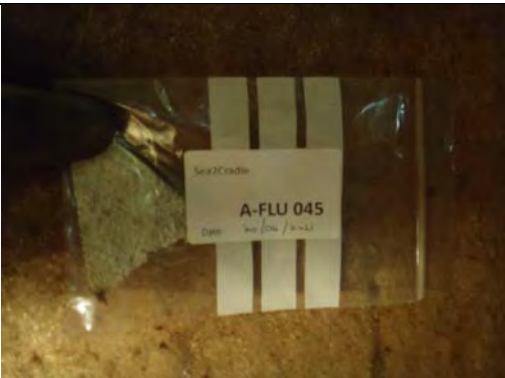
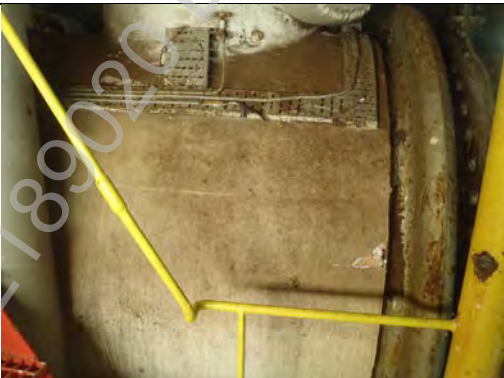
<p>Sample : A-FLU 45 Location : 09. Main Condenser Description : Heat Insulation (Canvas)</p>	<p>Tested for : Asbestos Result : 15% to 30% Chrysotile : 2% to 5% Amosite : :</p>

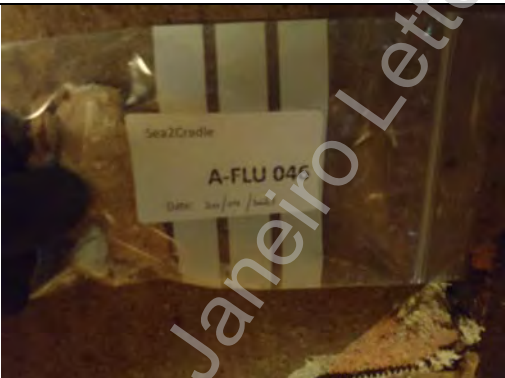
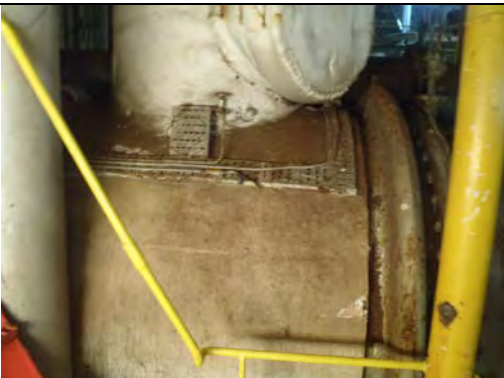
<p>Sample : A-FLU 46 Location : 09. Main Condenser Description : Heat Insulation (Fibre)</p>	<p>Tested for : Asbestos Result : 30% to 60% Chrysotile : 2% to 5% Amosite : :</p>

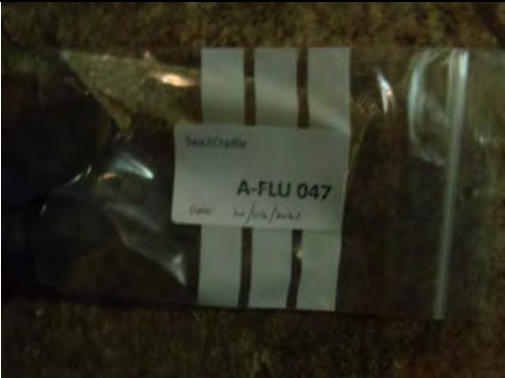
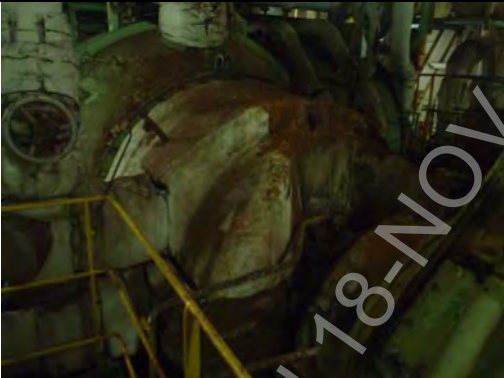
<p>Sample : A-FLU 47 Location : 09. L.P. Turbine Description : Heat Insulation (Canvas)</p>	<p>Tested for : Asbestos Result : <0.1% : :</p>

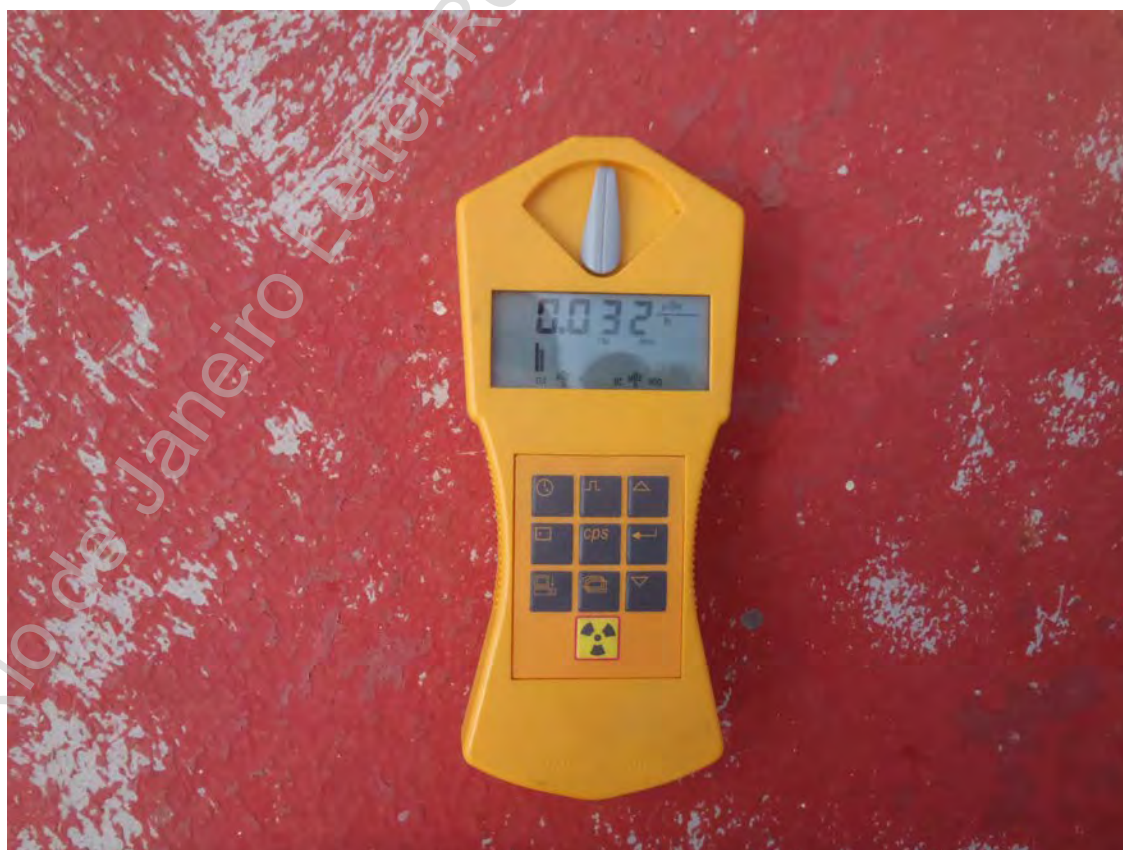
B. Background reading: 0.032 μ Sv/h
 Measured at: 00. Top of Nav. Deck
 Picture:

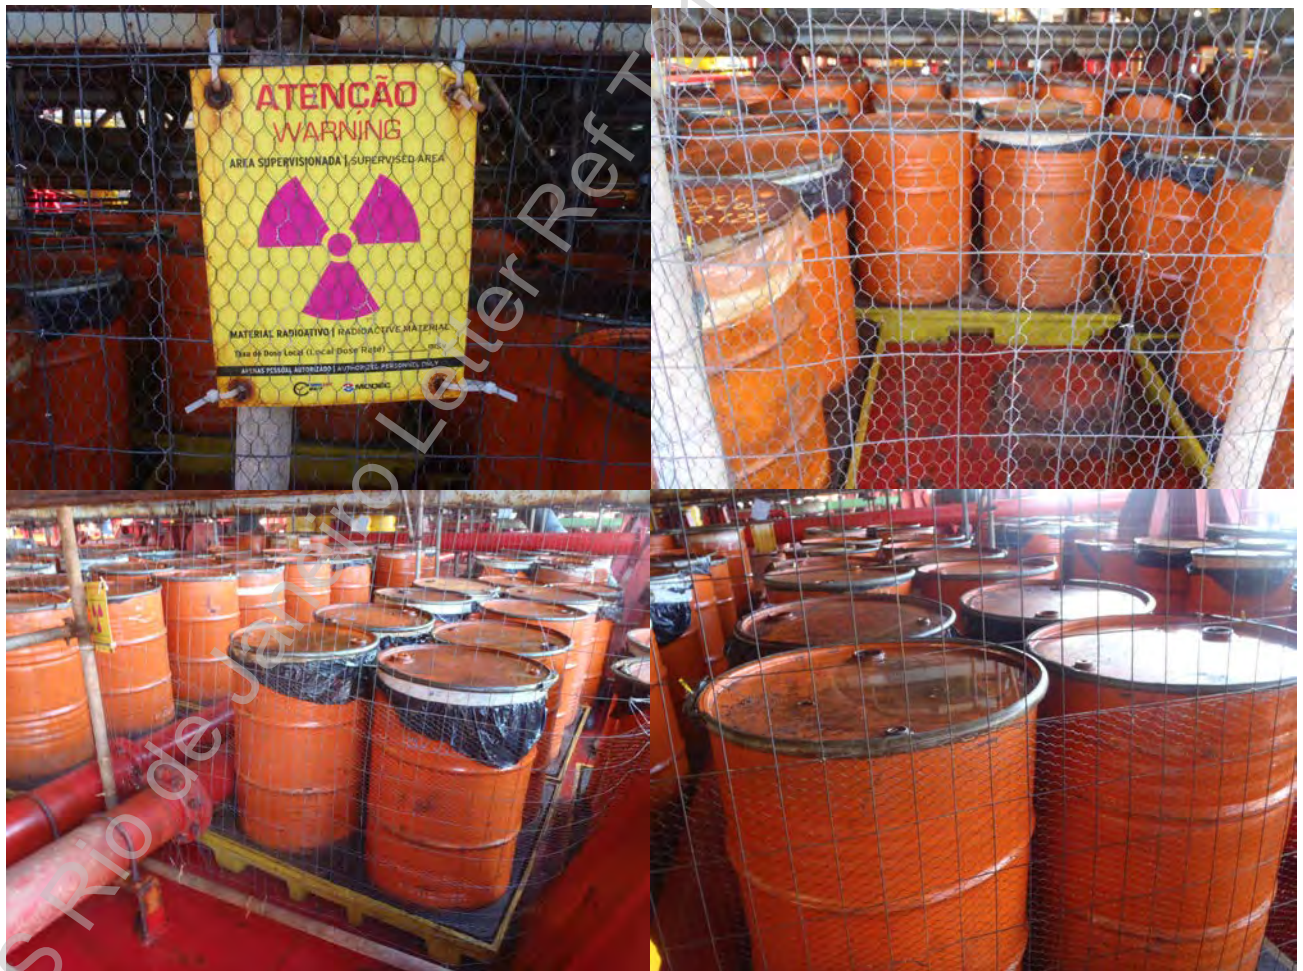
D. NORM Locker

Location	Dose rate ($\mu\text{Sv/h}$)
01. Nav. Deck	0.109
02. D Deck	0.118
03. C Deck + Heli Deck	0.109
04. B Deck	0.092
04A. Topside	0.04
05. Upper Deck Accommodation	0.160
05A. Upper Deck	0.074
06. Upper Platform Engine Room	0.109
07. Boiler Platform Engine Room	0.066
08. Lower Platform Engine Room	0.074
09. Tank Top Engine Room	0.040
In way of Topside Separators (Module 1)	0.308
In way of NORM Locker (Starboard Side under Module 3)	1.924
