Annex 06: Inventory of Hazardous Materials – Complementary Information to Block 12 of the *Notification Document for Transboundary Movements/Shipments of Waste*

Inventory Hazardous Materials FPSO Cidade de Niteroi MV18

FPSO Cidade de Niteroi MV18

PROJECT 193.23

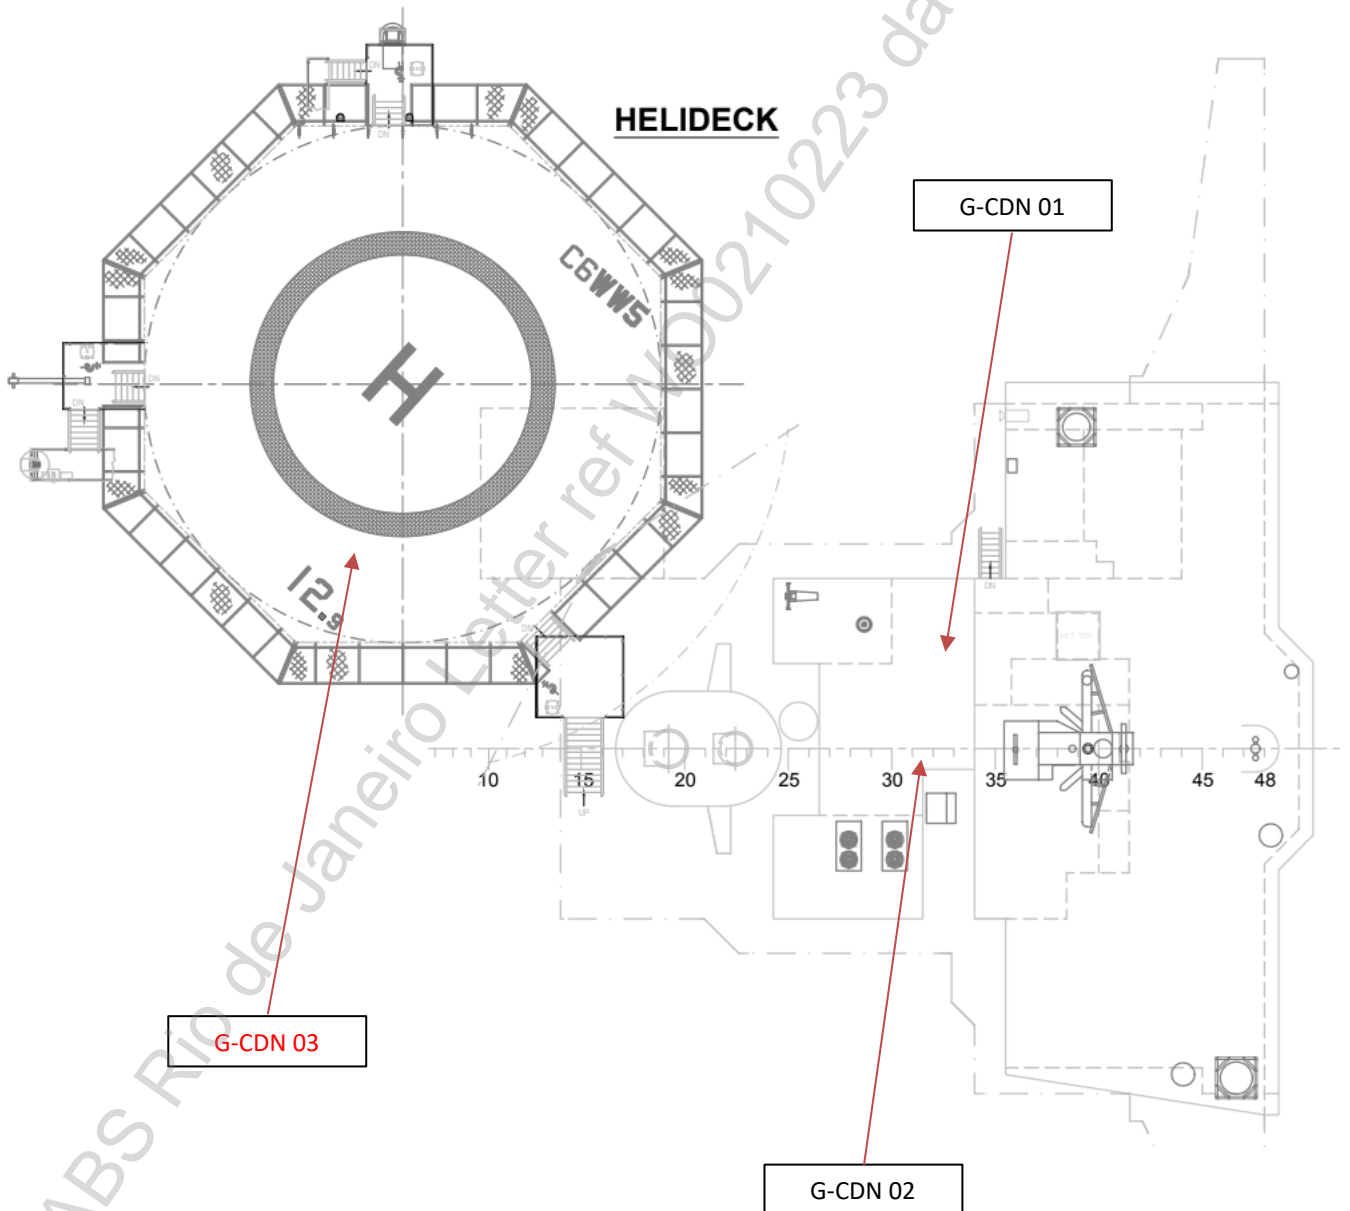
<p>Sample : G CDN 001 Location : 00 Compass Deck + Helipad Description : Deck Paint - Green</p>	<p>Tested for : PCB, Pb, Cd, Cr Result PCB: 0.00 mg/kg Pb: 3.7 mg/kg Cd: 0.21 mg/kg Cr: 70 mg/kg</p>

<p>Sample : G CDN 002 Location : 00 Compass Deck + Helipad Description : Cable Run Wipe</p>	<p>Tested for : PCB Result : 0.00 µg abs : :</p>

<p>Sample : G CDN 003 Location : 00 Compass Deck + Helipad Description : Helipad Special Coating</p>	<p>Tested for : PCB, Pb, Cd, Cr</p> <p>Test results were inconclusive due to limited sample quantity. Paint to be regarded as potentially containing hazardous materials (PCHM) until another sample has been tested.</p>

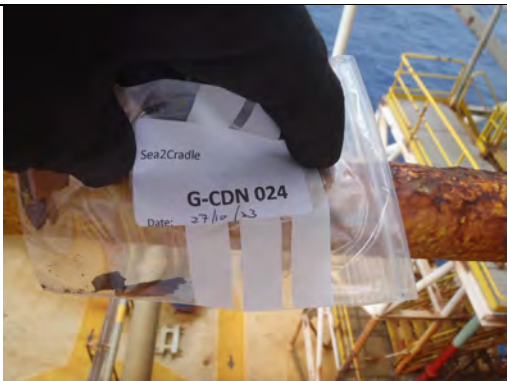
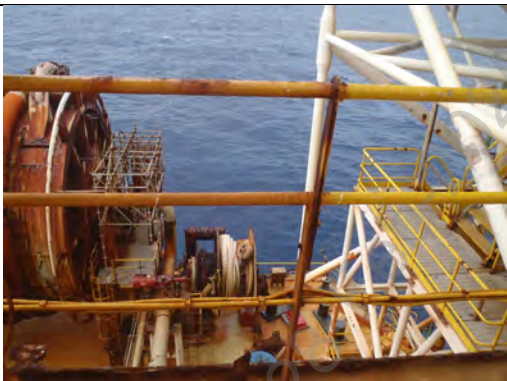
<p>Sample : G CDN 024 Location : 01 Navigation Deck Description : Yellow Paint</p>	<p>Tested for : PCB, Pb, Cd, Cr Result PCB: 0.00 mg/kg Pb: 2160 mg/kg Cd: 0.11 mg/kg Cr: 560 mg/kg</p>

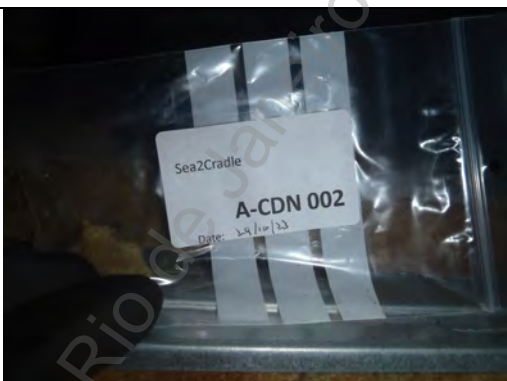
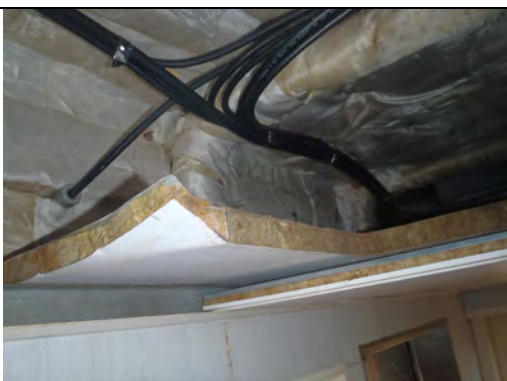
<p>Sample : A CDN 002 Location : 01 Navigation Deck Description : Deckhead Panel Insulation</p>	<p>Tested for : Asbestos Result : <0.1% : :</p>

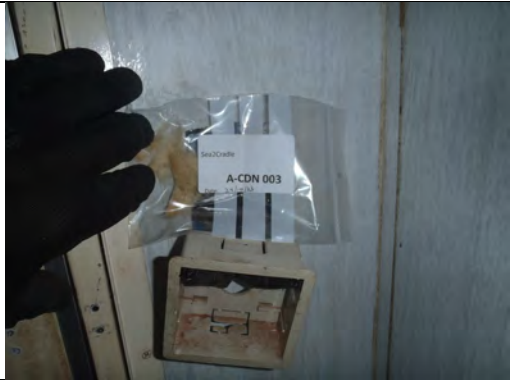
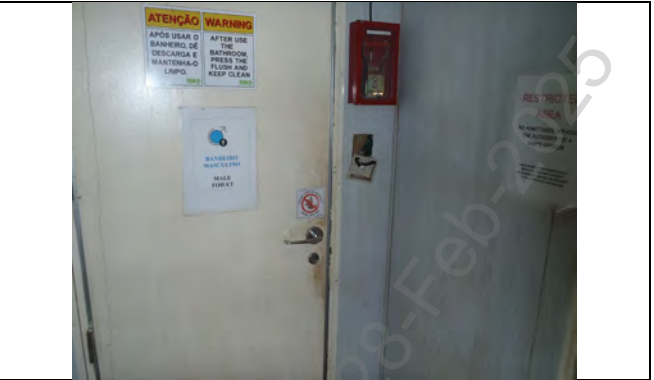
<p>Sample : A CDN 003 Location : 01 Navigation Deck Description : Bulkhead Insulation</p>	<p>Tested for : Asbestos Result : <0.1% : :</p>

<p>Sample : A CDN 004 Location : 01 Navigation Deck Description : Fwd Bridge Bulkhead Insulation</p>	<p>Tested for : Asbestos Result : <0.1% : :</p>

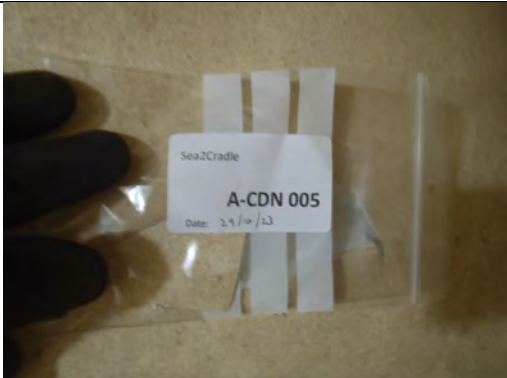
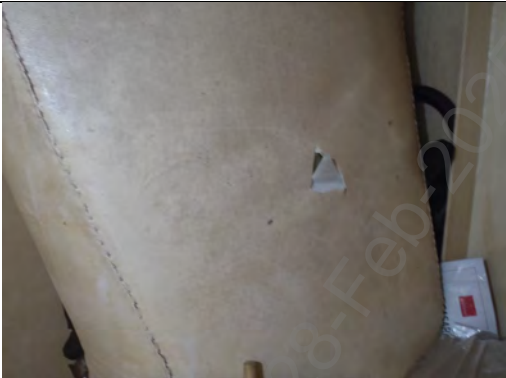
<p>Sample : A CDN 005 Location : 02 5th Deck Description : Vent Trunk Insulation - Canvas</p>	<p>Tested for : Asbestos Result : <0.1% : :</p>

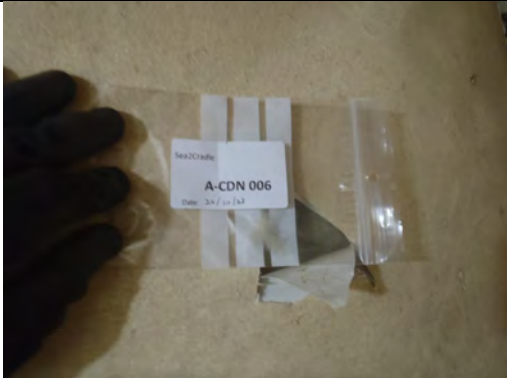
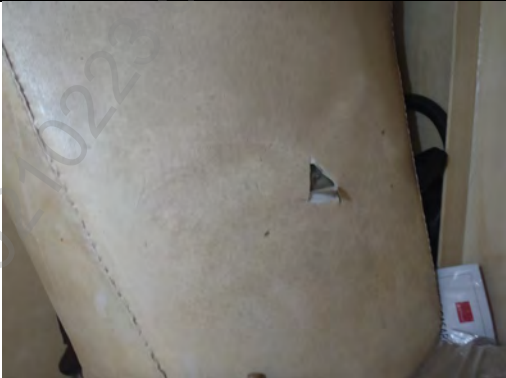
<p>Sample : A CDN 006 Location : 02 5th Deck Description : Vent Trunk Insulation - Fibre</p>	<p>Tested for : Asbestos Result : <0.1% : :</p>

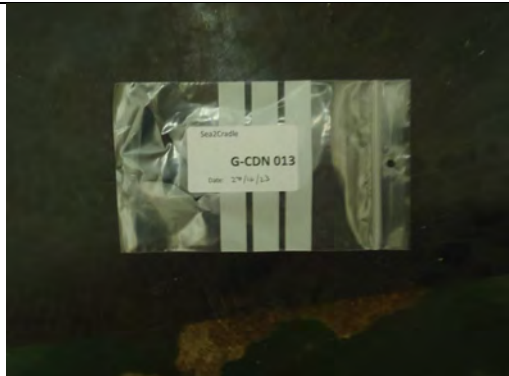
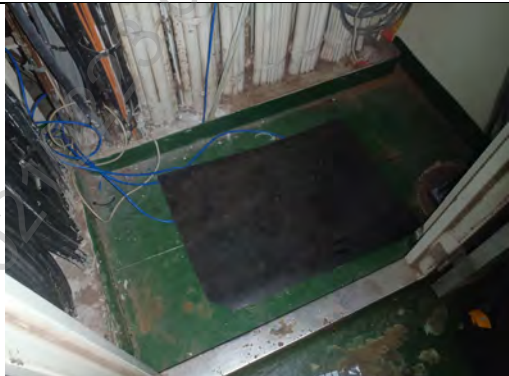
<p>A photograph of a dark green electrical mat on a floor, surrounded by various cables and equipment.</p>
<p>Sample : G CDN 013 Location : 03 4th Deck Description : Electrical Mat</p>	<p>Tested for : PCB Result : 0.00 mg/kg : :</p>

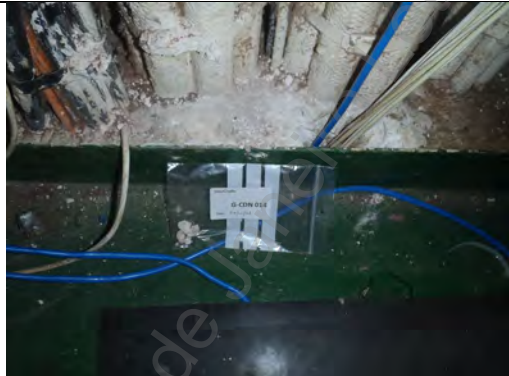
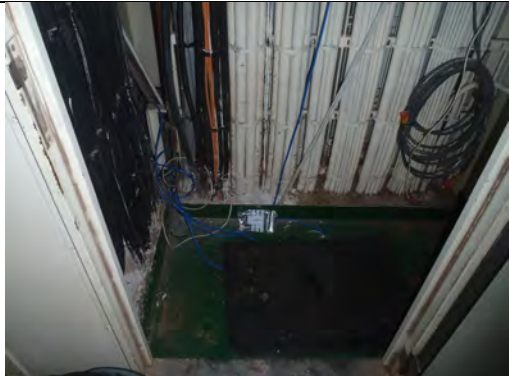
<p>A photograph of a cable tray area with blue cables and white conduit. A sample bag is placed on a green mat in the foreground.</p>
<p>Sample : G CDN 014 Location : 03 4th Deck Description : Cable Conduit Caulking</p>	<p>Tested for : PCB Result : 0.00 mg/kg : :</p>

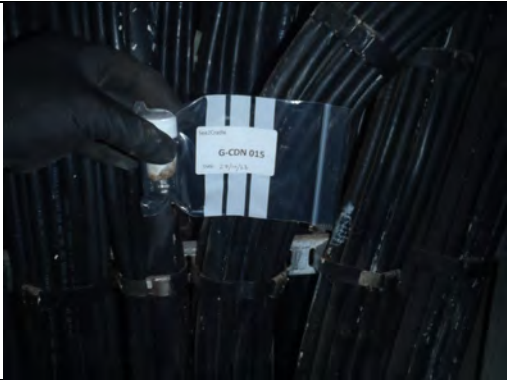
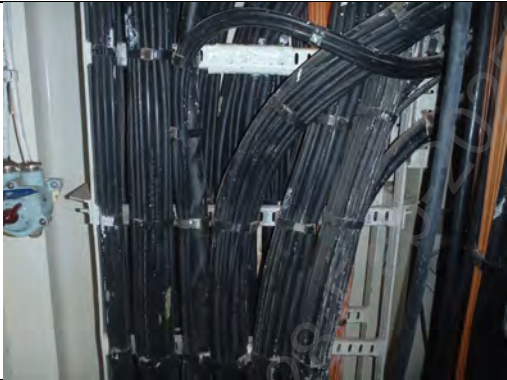
<p>Sample : G CDN 015 Location : 03 4th Deck Description : Cable Run Wipe</p>	<p>Tested for : PCB Result : 0.00 µg abs : :</p>

<p>Sample : G CDN 022 Location : 03 4th Deck Description : Curtain Fabric</p>	<p>Tested for : PFOS Result : <0.01 mg/kg : :</p>

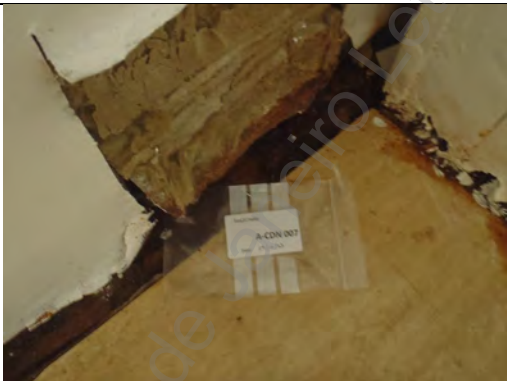
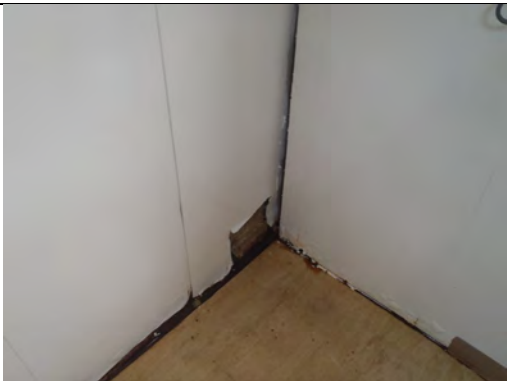
<p>Sample : A CDN 007 Location : 03 4th Deck Description : Bulkhead Insulation</p>	<p>Tested for : Asbestos Result : <0.1% : :</p>

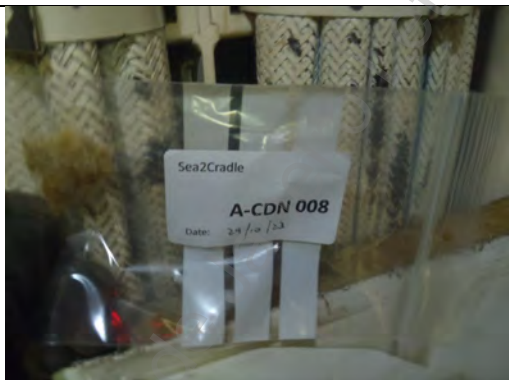
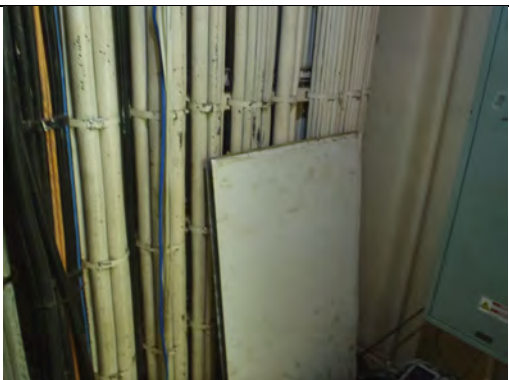
<p>Sample : A CDN 008 Location : 04 3rd Deck Description : Deckhead Panel Insulation</p>	<p>Tested for : Asbestos Result : <0.1% : :</p>

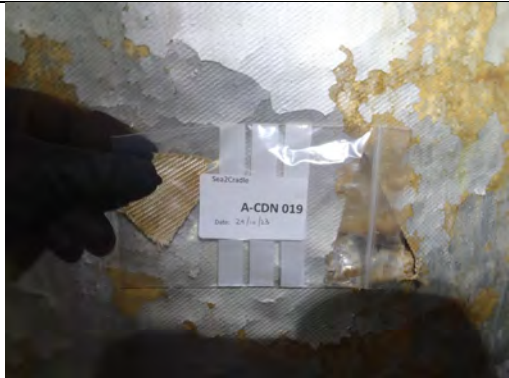
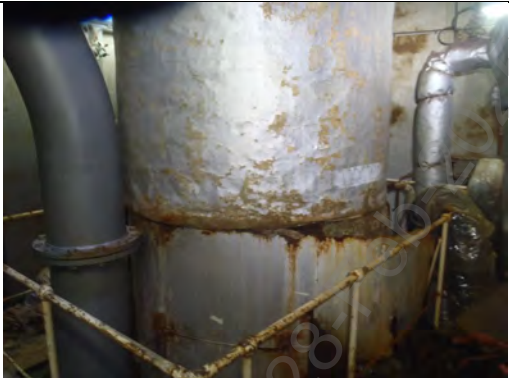
<p>Sample : A CDN 19 Location : 04B Engine Casing Description : Boiler Uptake - Canvas</p>	<p>Tested for : Asbestos Result : <0.1% : :</p>

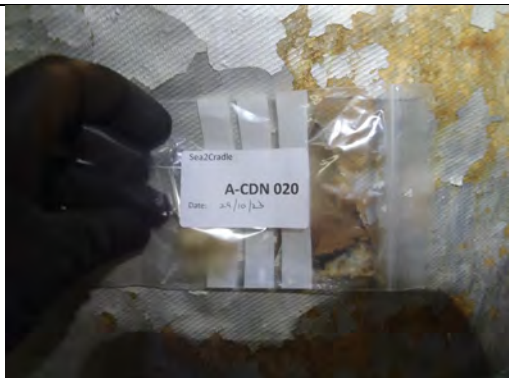
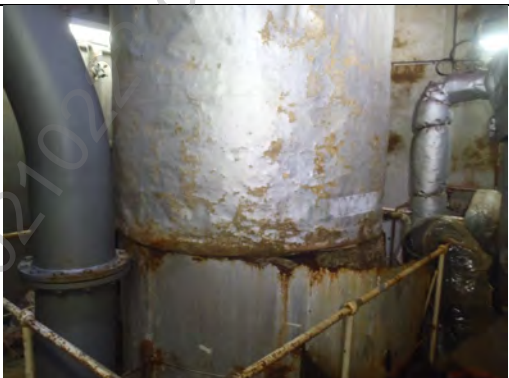
<p>Sample : A CDN 020 Location : 04B Engine Casing Description : Boiler Uptake - Insulation</p>	<p>Tested for : Asbestos Result : <0.1% : :</p>

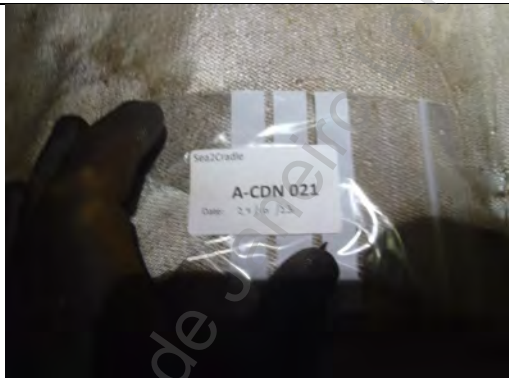
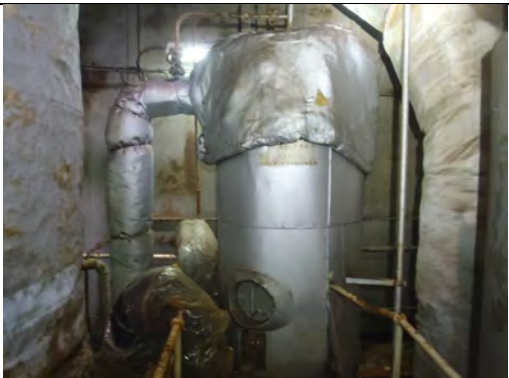
<p>Sample : A CDN 021 Location : 04B Engine Casing Description : Header Tank - Canvas</p>	<p>Tested for : Asbestos Result : <0.1% : :</p>

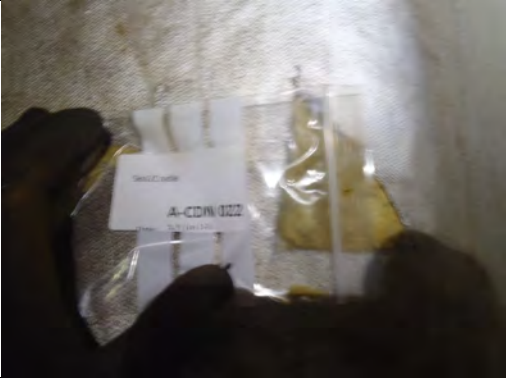
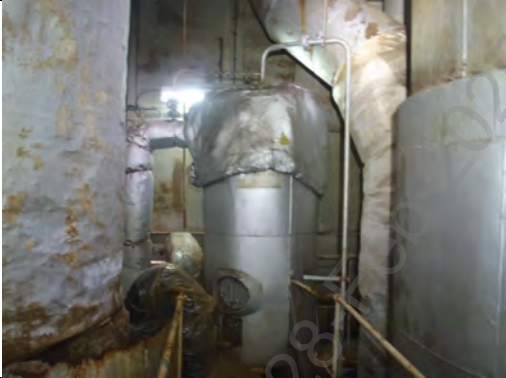
<p>Sample : A CDN 022 Location : 04B Engine Casing Description : Header Tank - Insulation</p>	<p>Tested for : Asbestos Result : <0.1% : :</p>

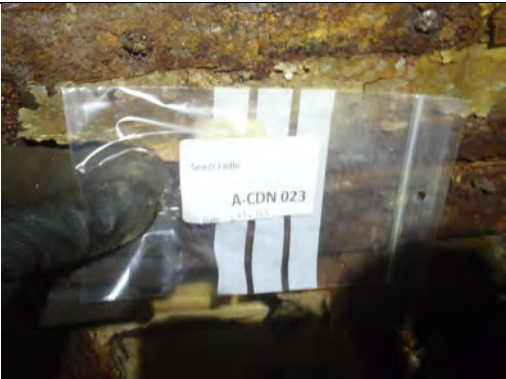
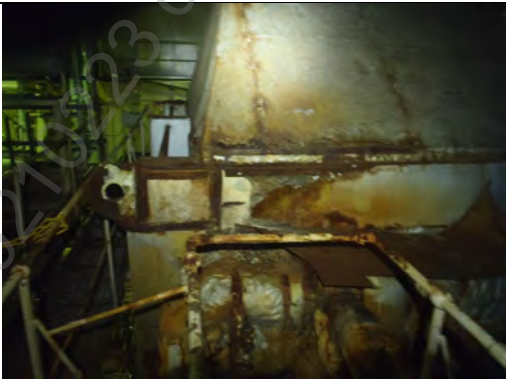
<p>Sample : A CDN 023 Location : 04B Engine Casing Description : E.G. Economiser Insulation</p>	<p>Tested for : Asbestos Result : <0.1% : :</p>

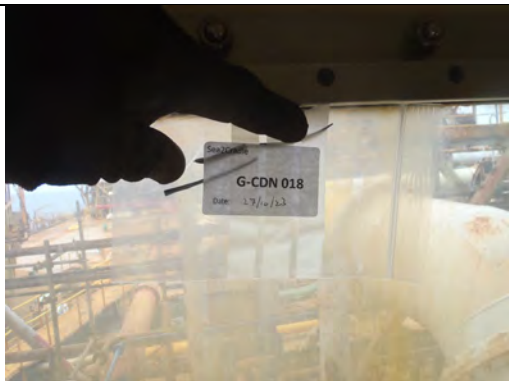
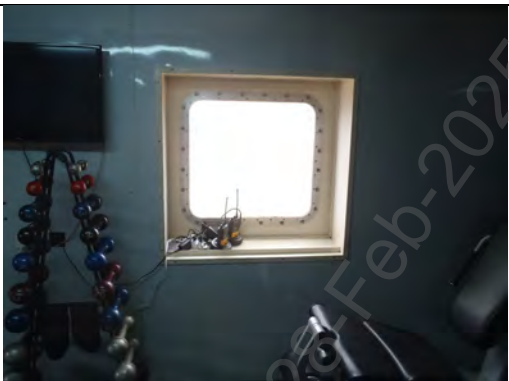
<p>Sample : G CDN 018 Location : 05 2nd Deck Description : Window Seal</p>	<p>Tested for : PCB Result : 0.00 mg/kg : :</p>

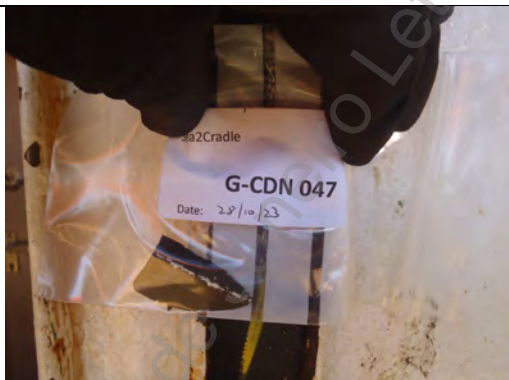
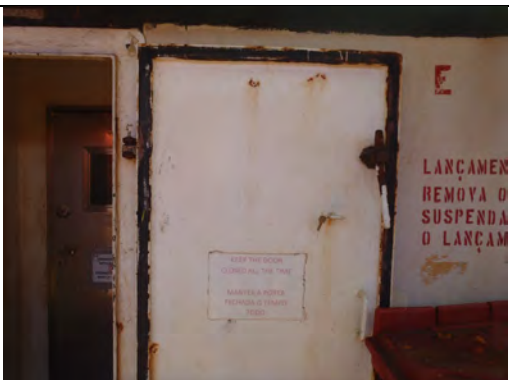
<p>Sample : G CDN 047 Location : 05 2nd Deck Description : W/T Door Seal</p>	<p>Tested for : PCB Result : 0.00 mg/kg : :</p>

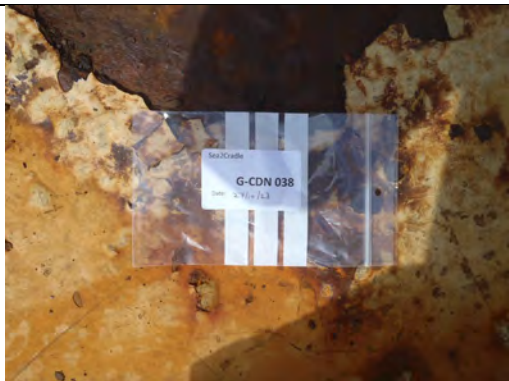
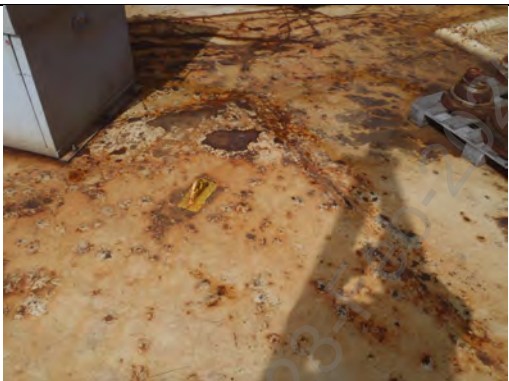
<p>Sample : G CDN 038 Location : 05B Toppers Forward Description : Deck paint - White</p>	<p>Tested for : PCB, Pb, Cd, Cr Result PCB: 0.00 mg/kg Pb: 3.8 mg/kg Cd: <0.1 mg/kg Cr: 210 mg/kg</p>

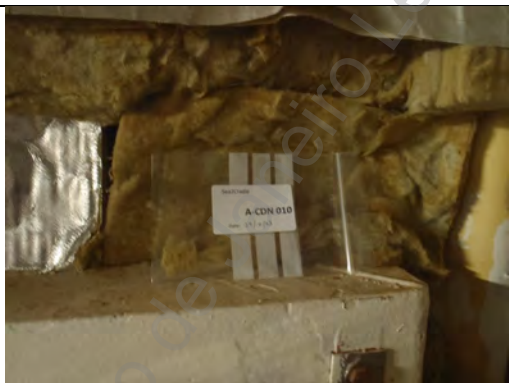
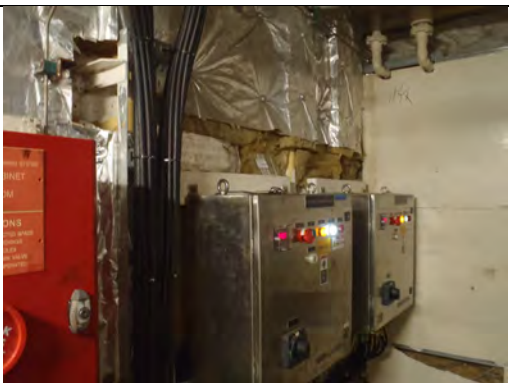
<p>Sample : A CDN 010 Location : 05 2nd Deck Fire Station Description : Bulkhead Insulation</p>	<p>Tested for : Asbestos Result : <0.1% : :</p>

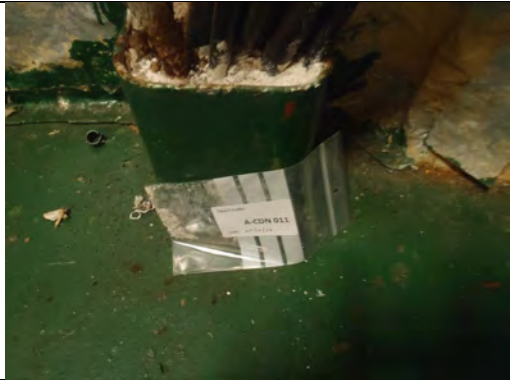
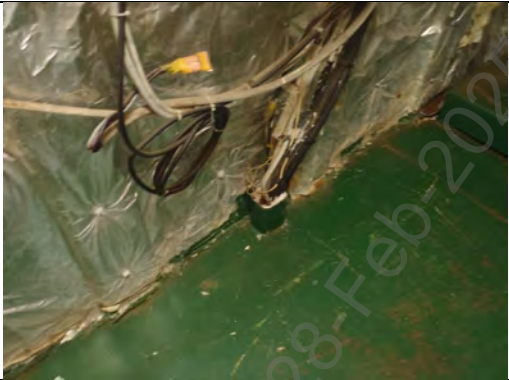
<p>Sample : A CDN 011 Location : 05 2nd Deck Fire Station Description : Gland Caulking</p>	<p>Tested for : Asbestos Result : <0.1% : :</p>

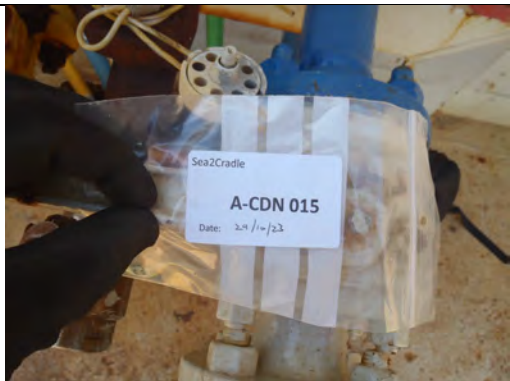
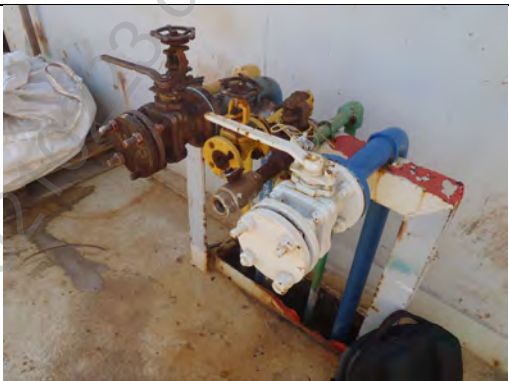
<p>Sample : A CDN 015 Location : 05A Toppides Aft Description : Joint Gasket</p>	<p>Tested for : Asbestos Result : <0.1% : :</p>

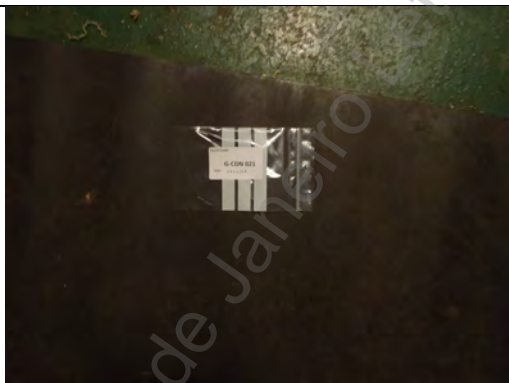
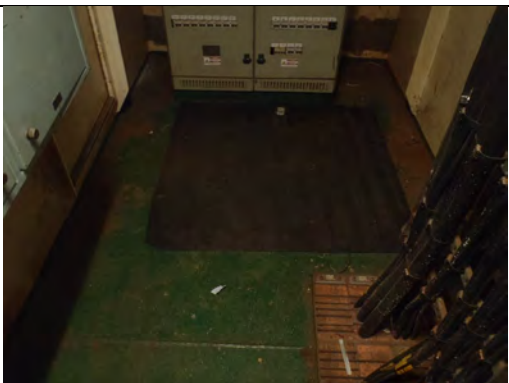
<p>Sample : G CDN 021 Location : 06 Upper Deck Accommodation Description : Electrical Mat</p>	<p>Tested for : PCB Result : 0.00 mg/kg : :</p>

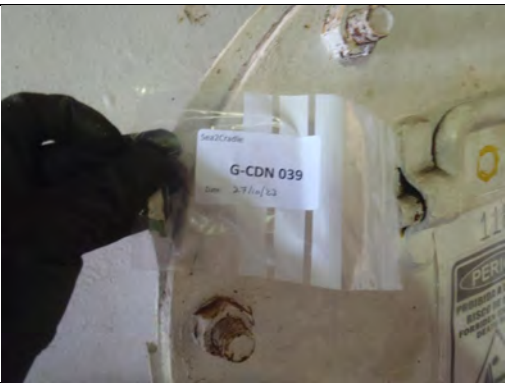
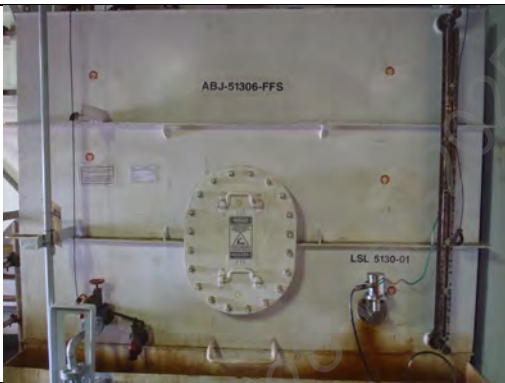
<p>Sample : G CDN 039 Location : 06B Forward Fire Pump Room Description : Manhole Joint</p>	<p>Tested for : PCB Result : 0.00 mg/kg : :</p>

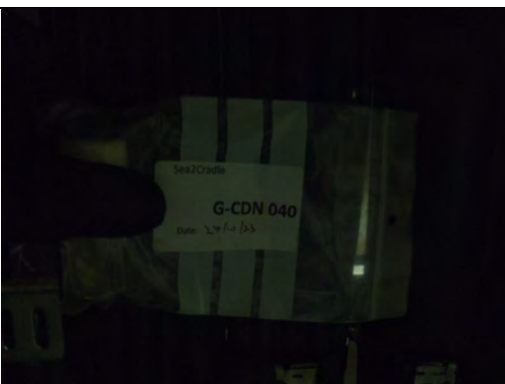
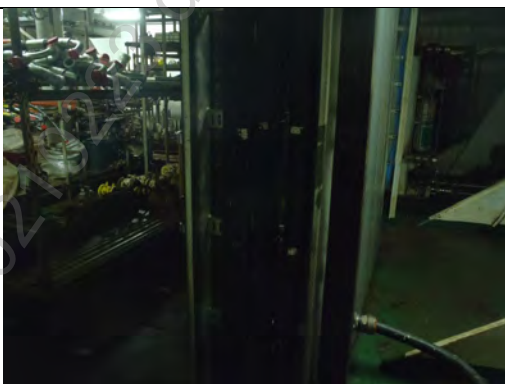
<p>Sample : G CDN 040 Location : 06B Forecastle Head Description : Cable Run Wipe</p>	<p>Tested for : PCB Result : 0.00 µg abs : :</p>

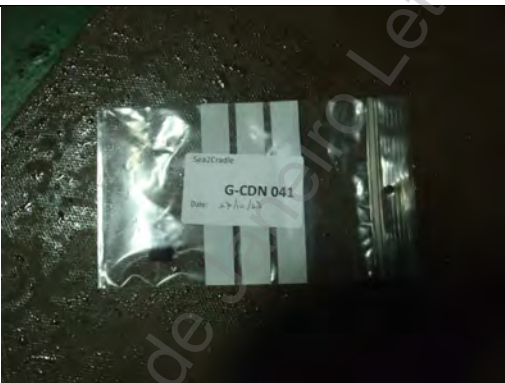
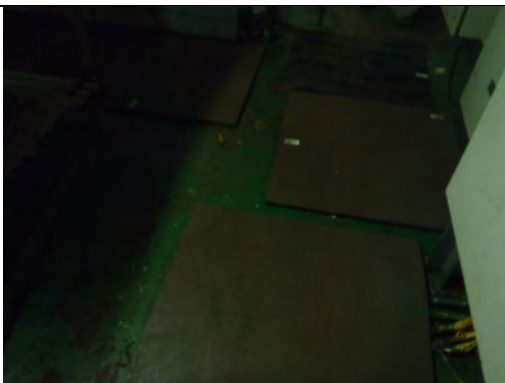
<p>Sample : G CDN 041 Location : 06B Forecastle Head Description : Electrical Mat</p>	<p>Tested for : PCB Result : 0.00 mg/kg : :</p>

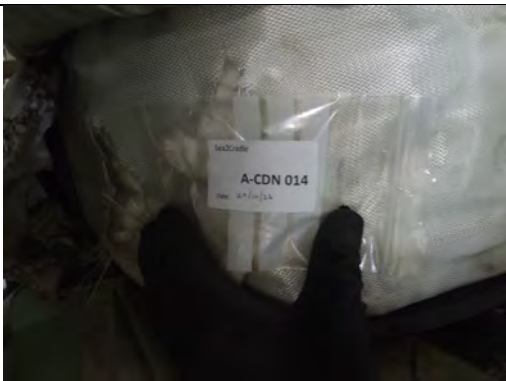
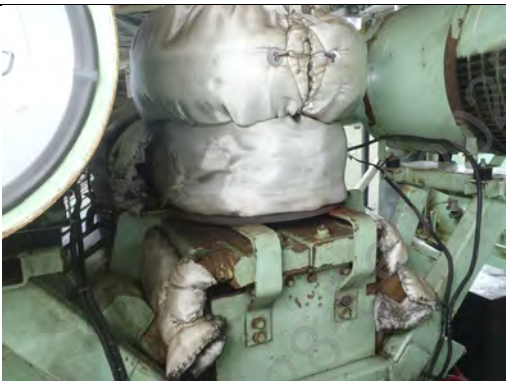
<p>Sample : A CDN 014 Location : 06 Emergency Generator Room Description : Exhaust Lagging - Insulation</p>	<p>Tested for : Asbestos Result : <0.1% : :</p>

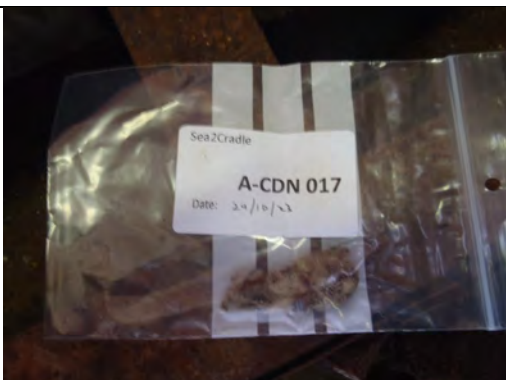
<p>Sample : A CDN 017 Location : 06 CO2 Room Description : Bulkhead Insulation</p>	<p>Tested for : Asbestos Result : <0.1% : :</p>

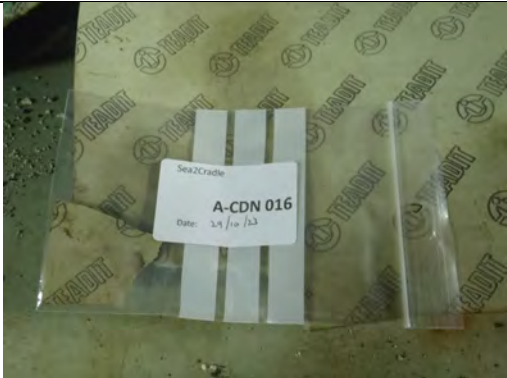
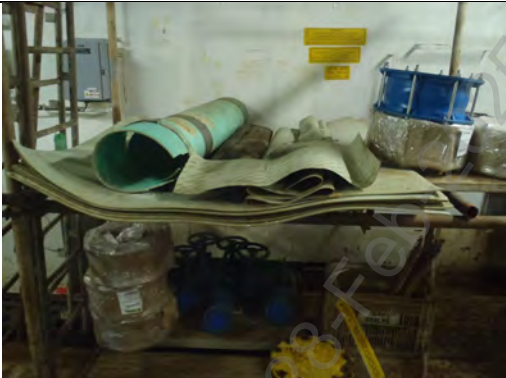
<p>Sample : A CDN 016 Location : 06B Forecastle Head Description : Jointing Roll</p>	<p>Tested for : Asbestos Result : <0.1% : :</p>

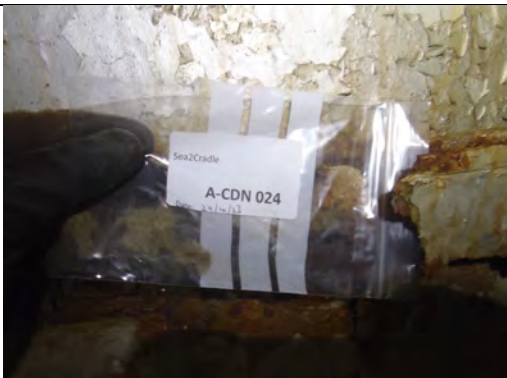
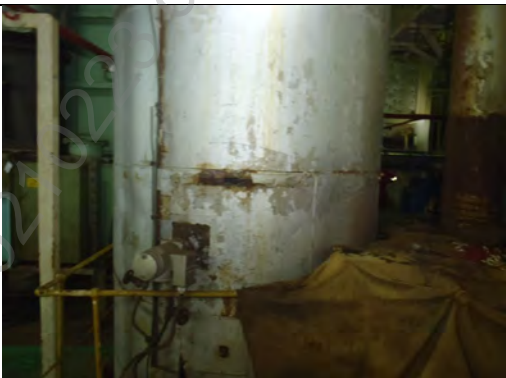
<p>Sample : A CDN 024 Location : 06 ER Upper Deck Description : Aux. Boiler Uptake Insulation</p>	<p>Tested for : Asbestos Result : <0.1% : :</p>

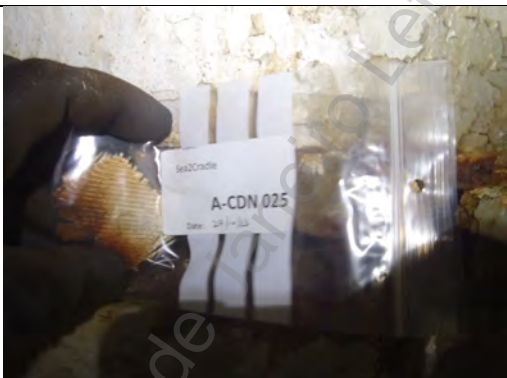
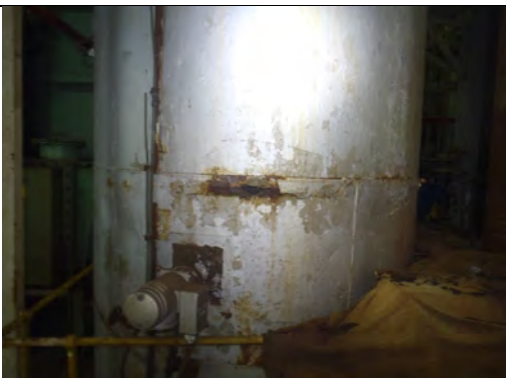
<p>Sample : A CDN 025 Location : 06 ER Upper Deck Description : Aux. Boiler Uptake Canvas</p>	<p>Tested for : Asbestos Result : <0.1% : :</p>

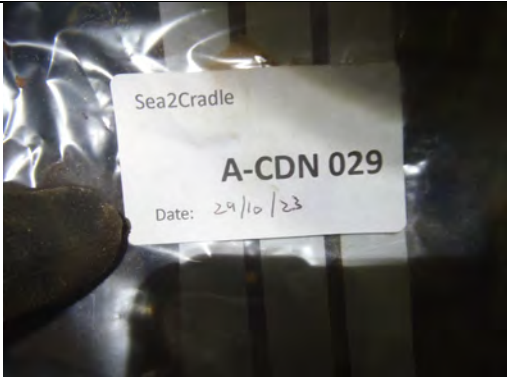
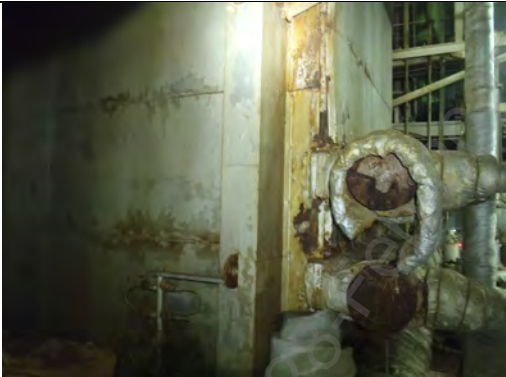
<p>Sample : A CDN 029 Location : 06 ER Upper Deck Description : Economizer Insulation</p>	<p>Tested for : Asbestos Result : <0.1% : :</p>

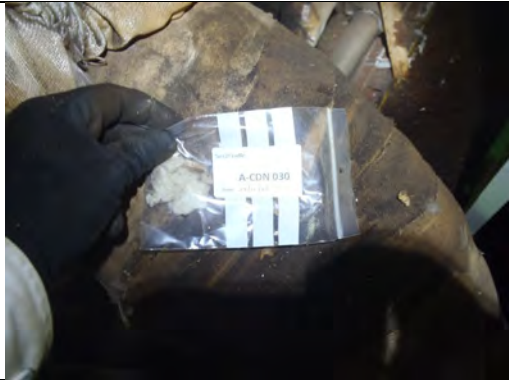
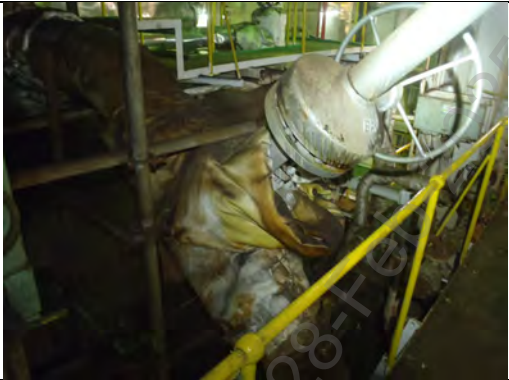
<p>Sample : A CDN 030 Location : 07 Engine Room 2nd Floor Description : Aux. Boiler Main Stop Valve</p>	<p>Tested for : Asbestos Result : <0.1%</p>

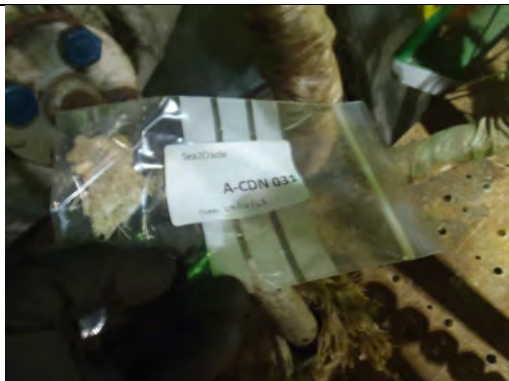
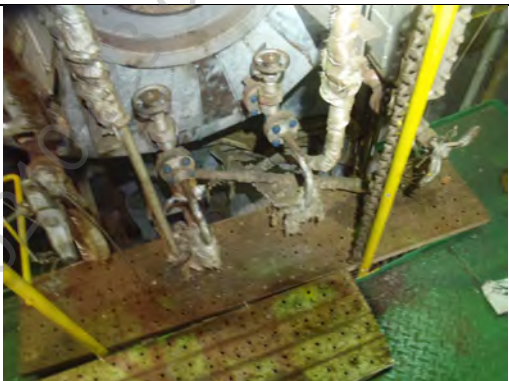
<p>Sample : A CDN 031 Location : 07 Engine Room 2nd Floor Description : Boiler Blow Down - Canvas</p>	<p>Tested for : Asbestos Result : <0.1%</p>

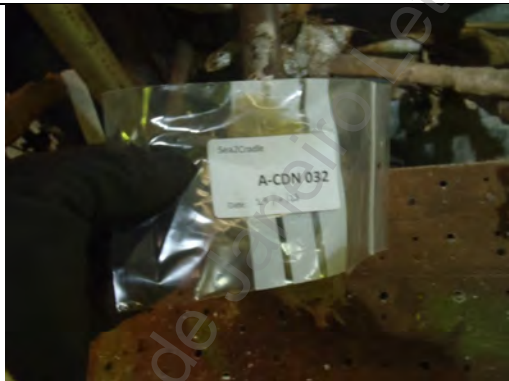
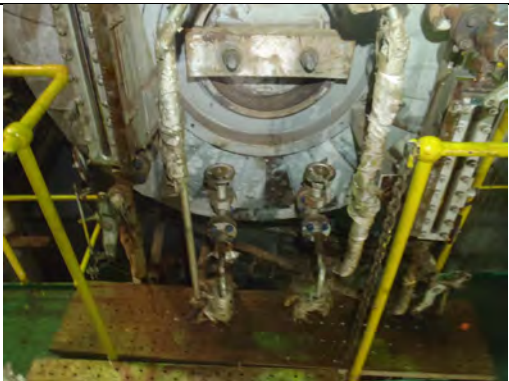
<p>Sample : A CDN 032 Location : 07 Engine Room 2nd Floor Description : Boiler Blowdown - Insulation</p>	<p>Tested for : Asbestos Result : <0.1%</p>

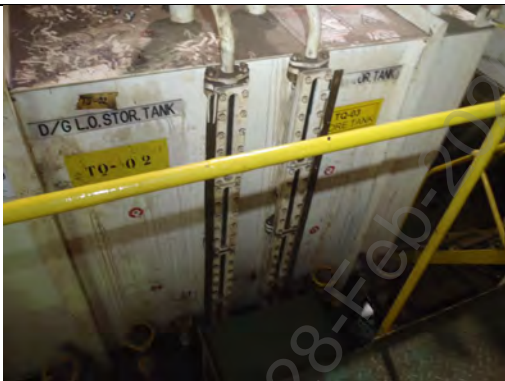
<p>Sample : A CDN 033 Location : 07 Engine Room 2nd Floor Description : Gauge Glass Joint</p>	<p>Tested for : Asbestos Result : Chrysotile >60% : :</p>

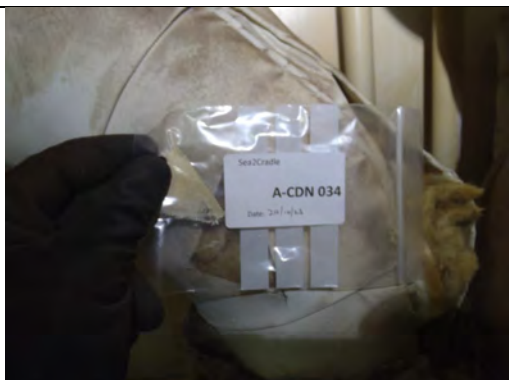
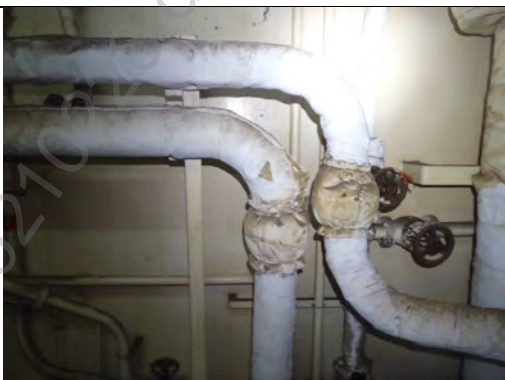
<p>Sample : A CDN 034 Location : 07 Engine Room 2nd Floor Description : HFO Service Line - Canvas</p>	<p>Tested for : Asbestos Result : <0.1% : :</p>

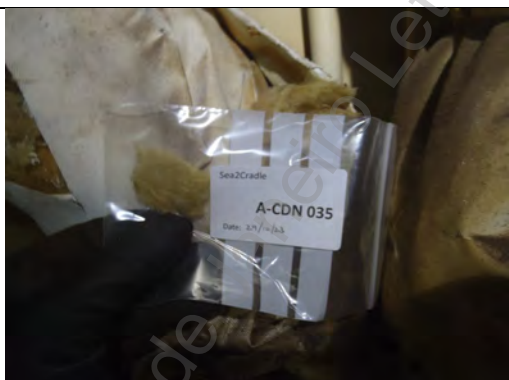
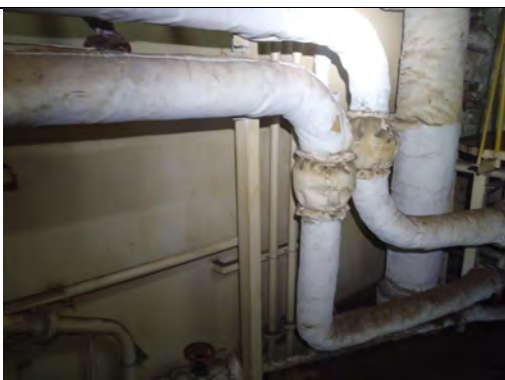
<p>Sample : A CDN 035 Location : 07 Engine Room 2nd Floor Description : HFO Service Line - Insulation</p>	<p>Tested for : Asbestos Result : <0.1% : :</p>

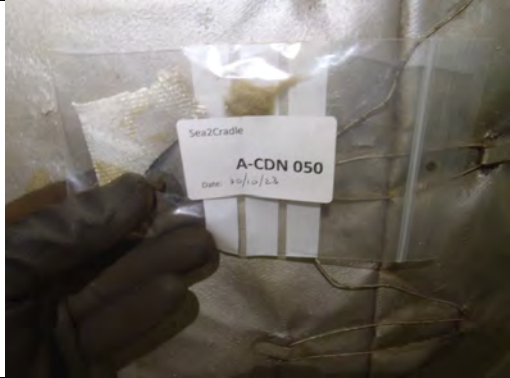
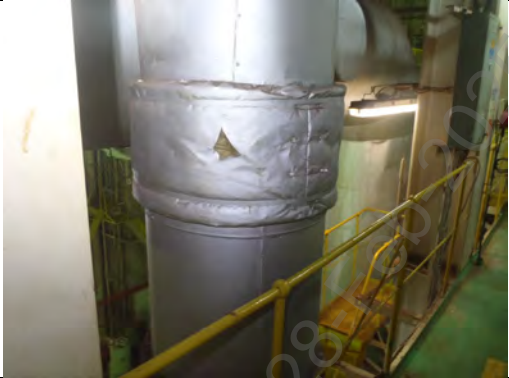
<p>Sample : A CDN 050 Location : 07 Engine Room 2nd Floor Description : Aux. Diesel Exhaust Insulation</p>	<p>Tested for : Asbestos Result : <0.1% : :</p>

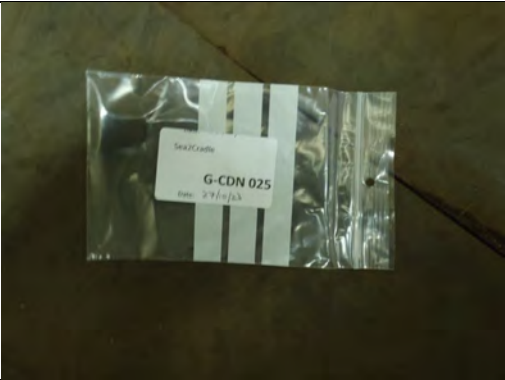
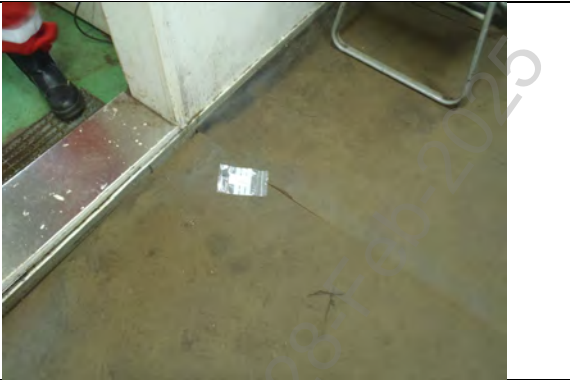
<p>Sample : G CDN 025 Location : 08 Upper Engine Floor Description : Anti-Slip Mat</p>		<p>Tested for : PCB Result : 0.00 mg/kg : :</p>

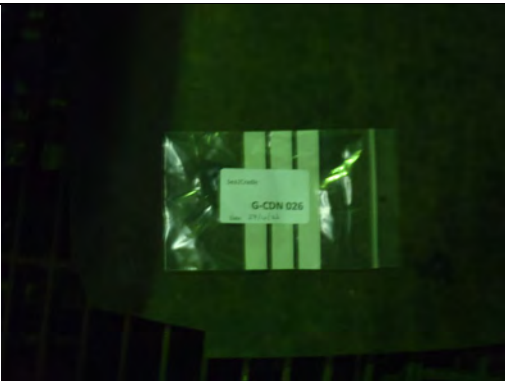
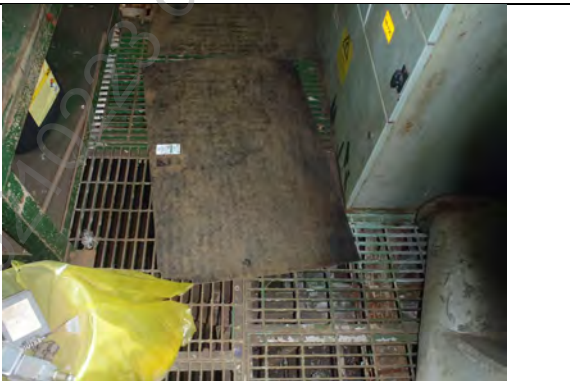
<p>Sample : G CDN 026 Location : 08 Upper Engine Floor Description : Electrical Mat</p>		<p>Tested for : PCB Result : 0.00 mg/kg : :</p>

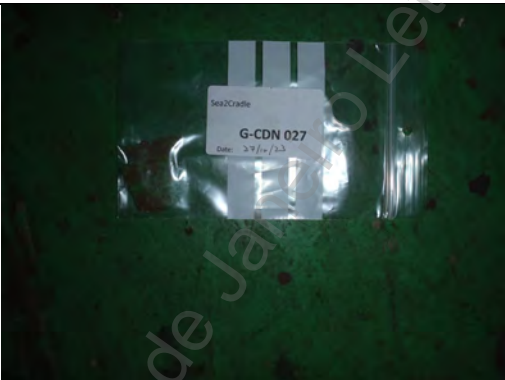
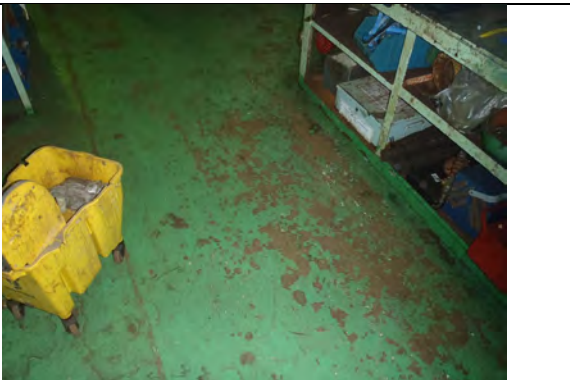
<p>Sample : G CDN 027 Location : 08 Upper Engine Floor Description : Deck Paint - Green</p>		<p>Tested for : PCB, Pb, Cd, Cr Result PCB: 0.00 mg/kg Pb: 29 mg/kg Cd: 0.39 mg/kg Cr: 51 mg/kg</p>

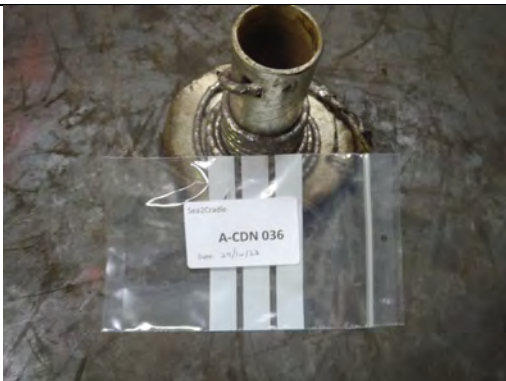
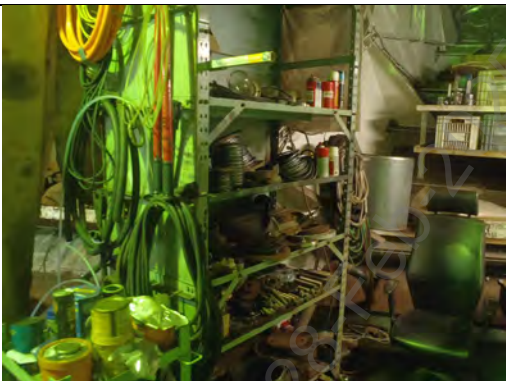
<p>Sample : A CDN 036 Location : 08 ER Upper Floor Stores Description : Packing</p>	<p>Tested for : Asbestos Result : Chrysotile >60% : :</p>

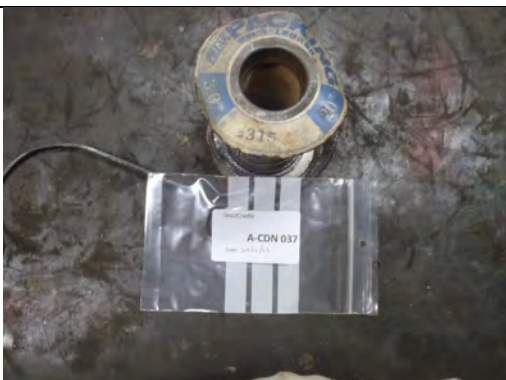
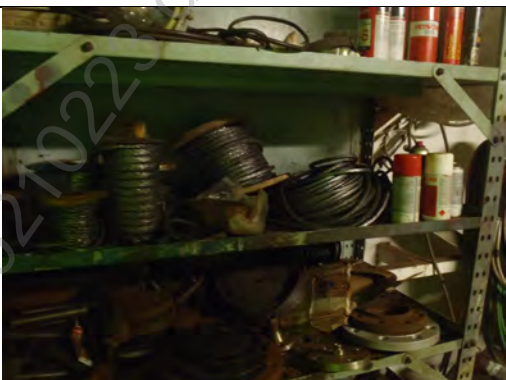
<p>Sample : A CDN 037 Location : 08 ER Upper Floor Stores Description : Packing</p>	<p>Tested for : Asbestos Result : Chrysotile >60% : :</p>

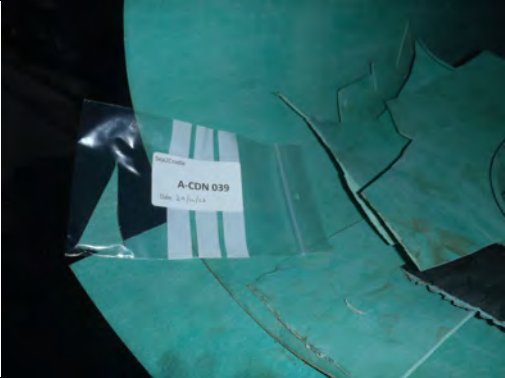
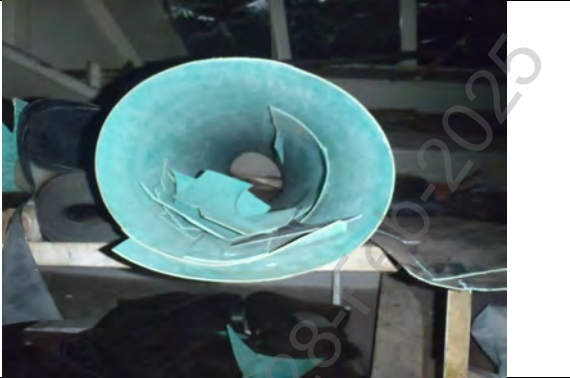
<p>Sample : A CDN 039 Location : 08 ER Upper Floor Stores Description : Jointing</p>	<p>Tested for : Asbestos Result : <0.1% : :</p>

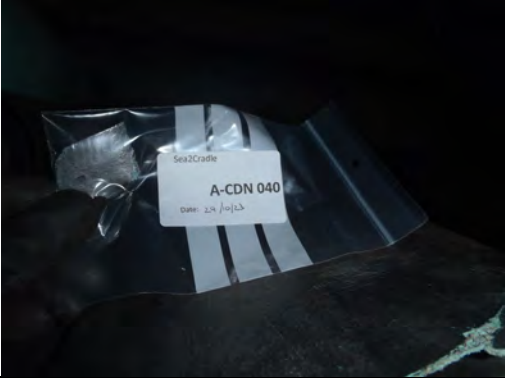
<p>Sample : A CDN 040 Location : 08 ER Upper Floor Stores Description : Jointing</p>	<p>Tested for : Asbestos Result : Chrysotile 15-30% : :</p>

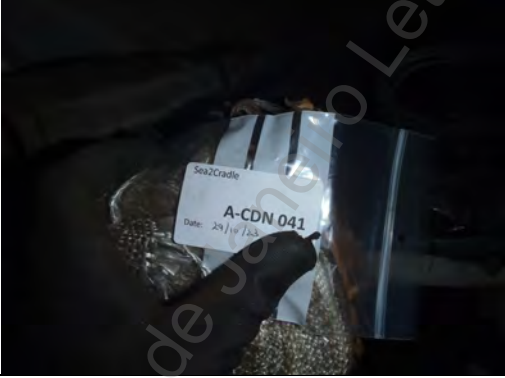
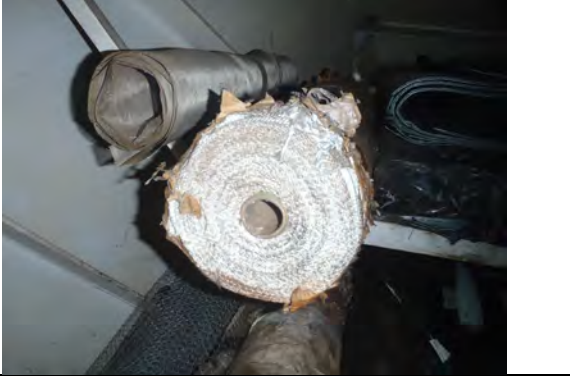
<p>Sample : A CDN 041 Location : 08 ER Upper Floor Stores Description : Cordage</p>	<p>Tested for : Asbestos Result : <0.1% : :</p>

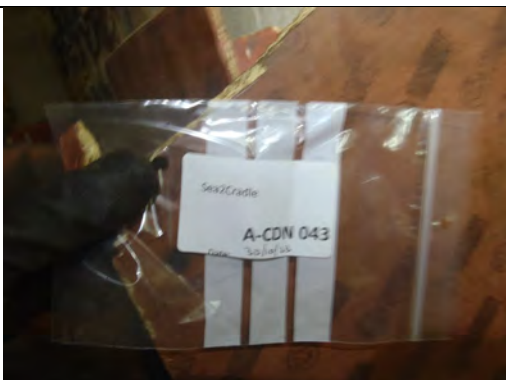
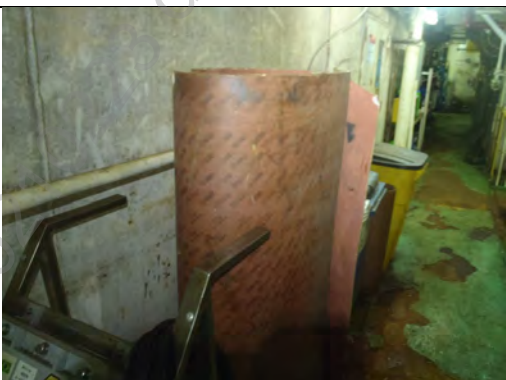
<p>Sample : A CDN 043 Location : 08 ER Upper Floor Stores Description : Jointing</p>	<p>Tested for : Asbestos Result : <0.1% : :</p>

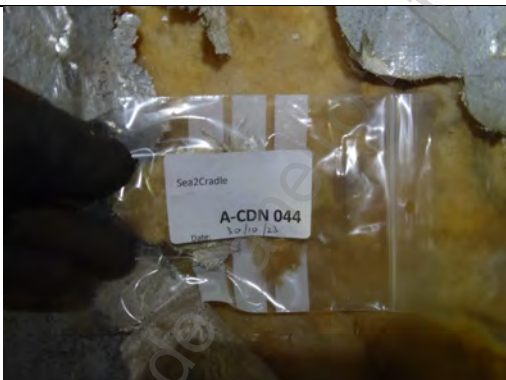
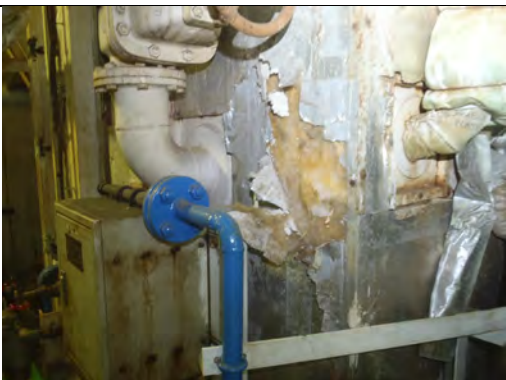
<p>Sample : A CDN 044 Location : 08 ER Upper Floor Description : Drain Tank Insulation</p>	<p>Tested for : Asbestos Result : <0.1% : :</p>

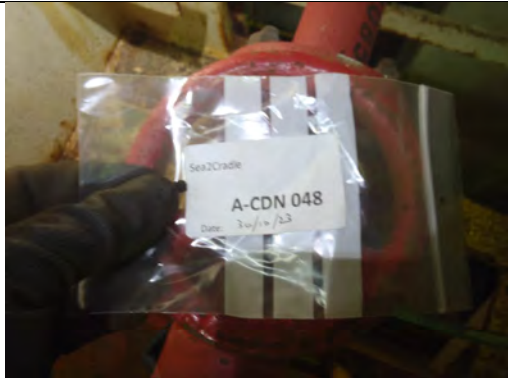
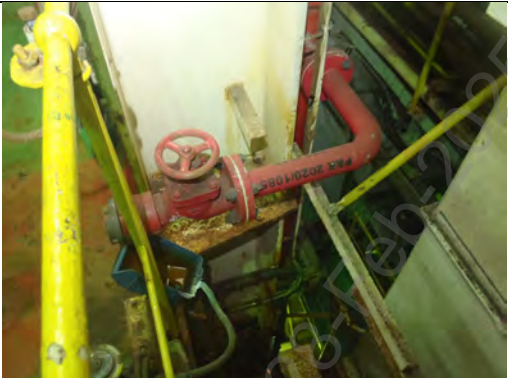
<p>Sample : A CDN 048 Location : 08 ER Upper Floor Description : Fire Main Joint</p>	<p>Tested for : Asbestos Result : Chrysotile 30-60% : :</p>

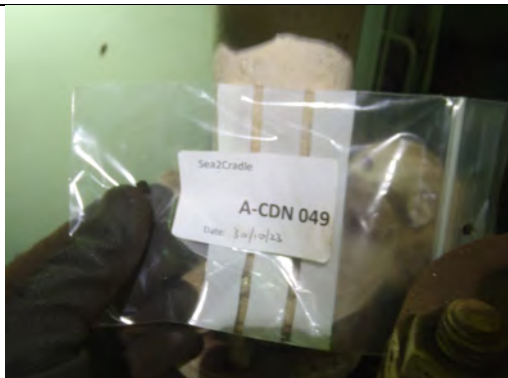
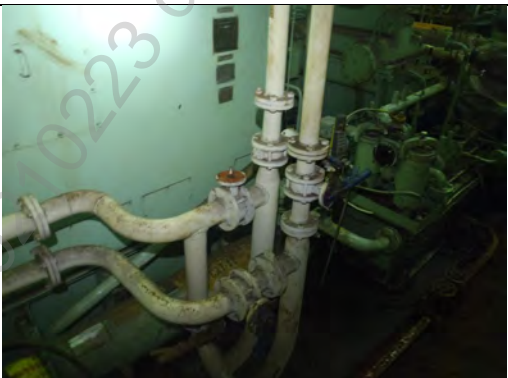
<p>Sample : A CDN 049 Location : 08 ER Upper Floor Description : T/A Set Cooling Water Joint</p>	<p>Tested for : Asbestos Result : Chrysotile 30-60% : :</p>
