Annex 06: Inventory of Hazardous Materials – Complementary Information to Block 12 of the *Notification Document for Transboundary Movements/Shipments of Waste*

Inventory Hazardous Materials FPSO Cidade de Niteroi MV18

FPSO Cidade de Niteroi MV18

PROJECT 193.23

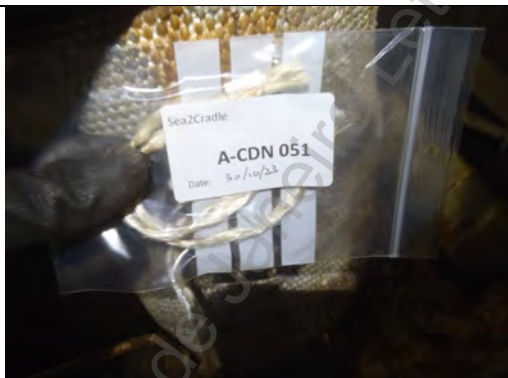
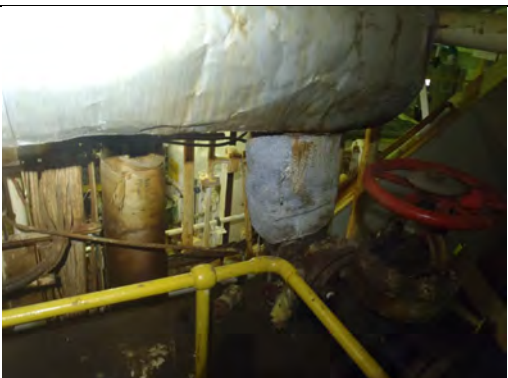
<p>Sample : A CDN 051 Location : 08 ER Upper Floor Description : Boiler Burner Line Lagging</p>	<p>Tested for : Asbestos Result : <0.1% : :</p>

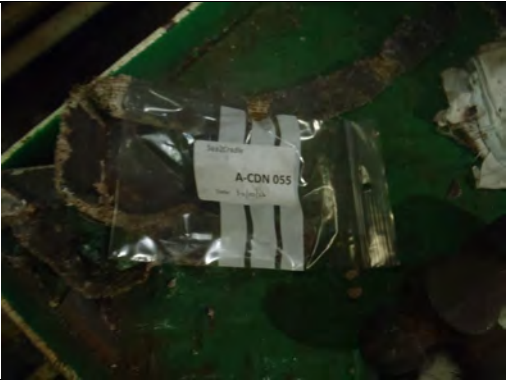
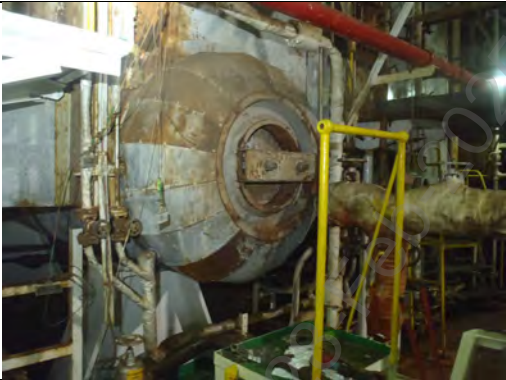
Sample : A CDN 055 Location : 08 ER Upper Floor Description : Aux. Boiler Water Drum Joint	Tested for : Asbestos Result : Chrysotile 30-60% : : :

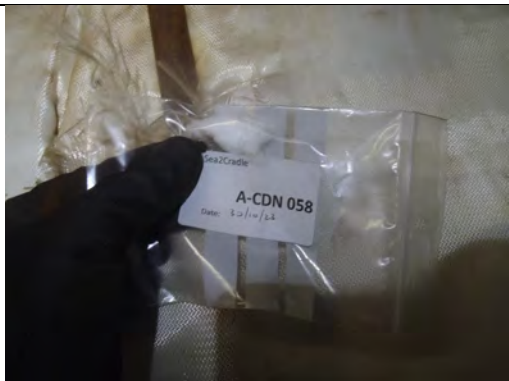
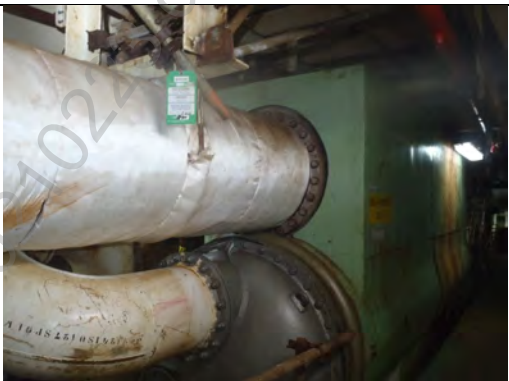
<p>Sample : A CDN 057 Location : 09 ER Lower Floor Description : Tank Cleaning Pipe Lagging</p>	<p>Tested for : Asbestos Result : <0.1% : :</p>

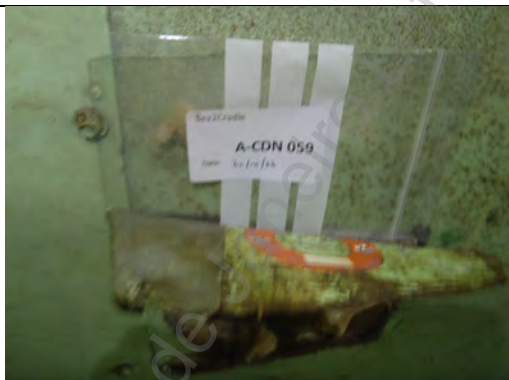
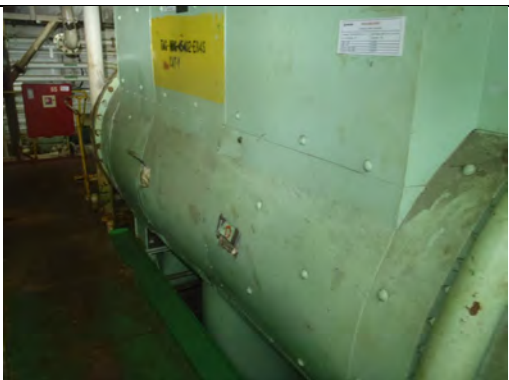
<p>Sample : A CDN 058 Location : 09 ER Lower Floor Description : Main Condenser Insulation</p>	<p>Tested for : Asbestos Result : <0.1% : :</p>

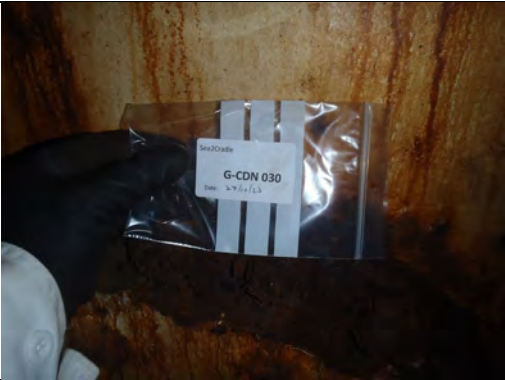
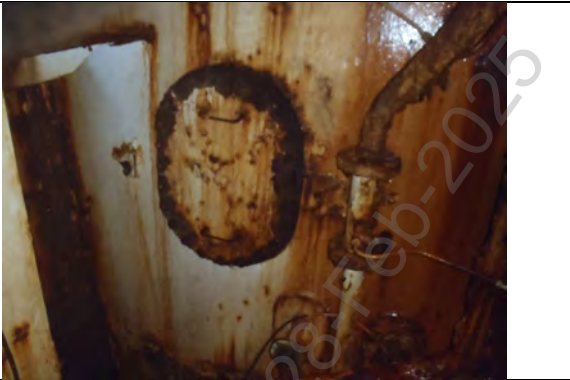
<p>Sample : G CDN 030 Location : 10 Engine Room Main Floor Description : Manhole Door Joint</p>		<p>Tested for : PCB Result : 0.00 mg/kg : :</p>

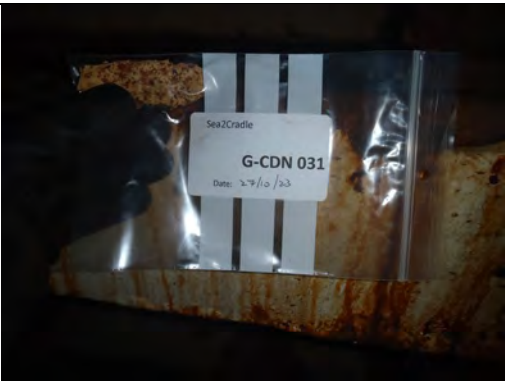
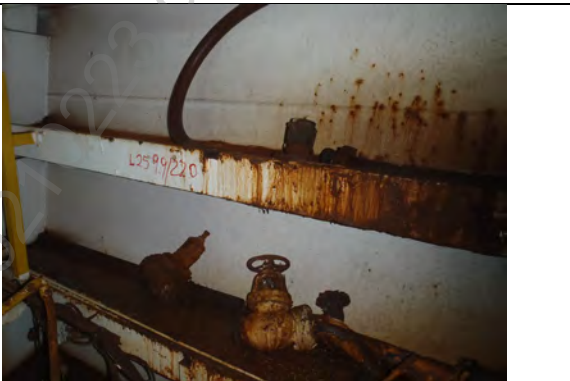
<p>Sample : G CDN 031 Location : 10 Engine Room Main Floor Description : Bulkhead Paint - White</p>		<p>Tested for : PCB, Pb, Cd, Cr Result PCB: 0.00 mg/kg Pb: 42 mg/kg Cd: <0.5mg/kg Cr: 130 mg/kg</p>

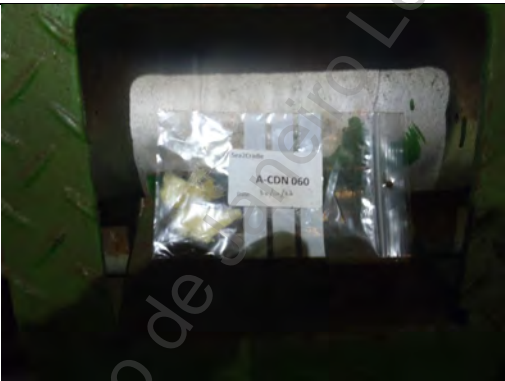
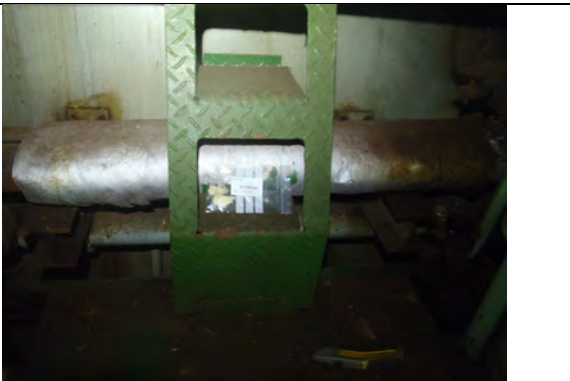
<p>Sample : A CDN 060 Location : 10 Engine Room Main Floor Description : Main Engine Fuel Rail</p>		<p>Tested for : Asbestos Result : <0.1% : :</p>

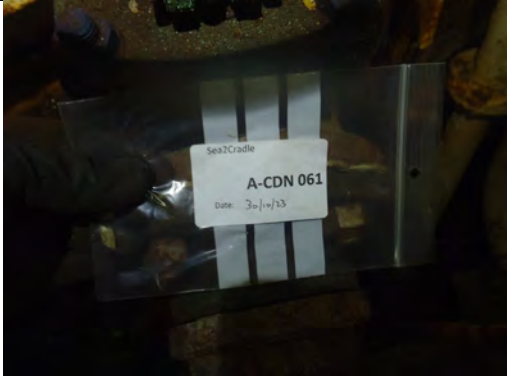
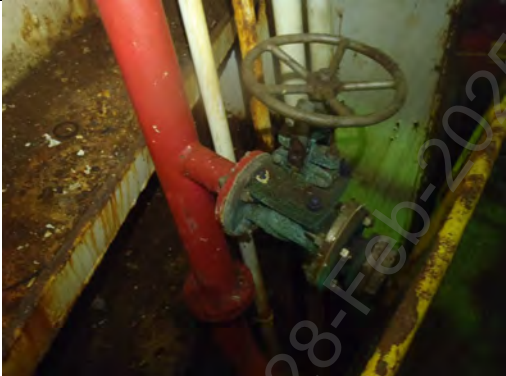
<p>Sample : A CDN 061 Location : 10 Engine Room Main Floor Description : Fire Main Joint</p>		<p>Tested for : Asbestos Result : <0.1% : :</p>
